INTEGRATING RIPARIAN ZONES WITH RIGHTOFWAY MANAGEMENT

MASTER OF SCIENCE

NATURAL RESOURCE MANAGEMENT

THE UNIVERSITY OF NORTHERN BRITISH COLUMBIA

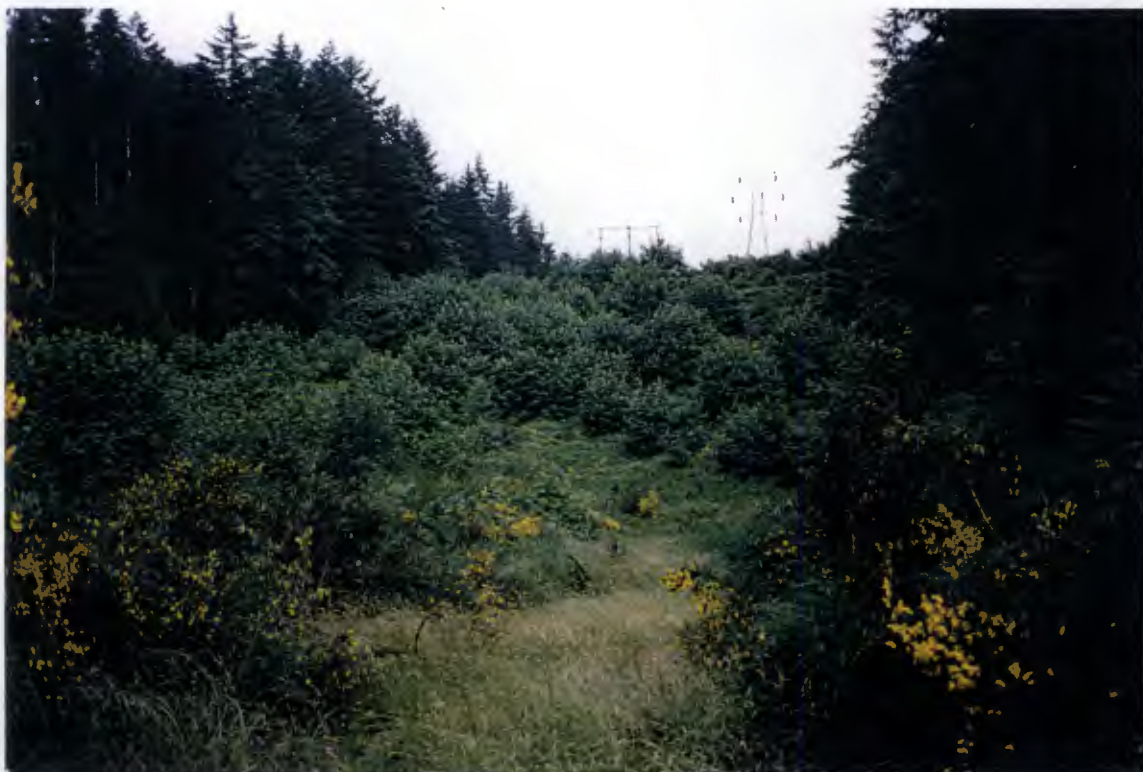
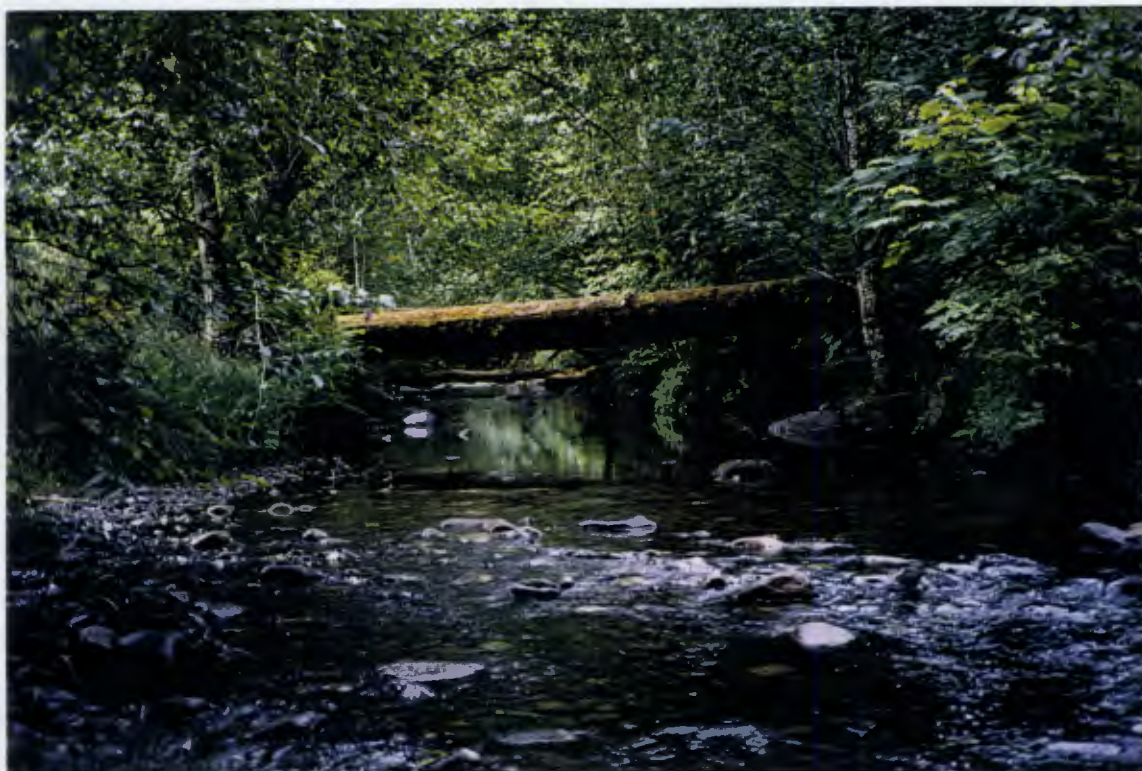
The trends for habitat complexity across the three stream segments is reduced pool volume from 60% deep pool in the upstream control, to 63% shallow pool (run) across the ROW, to 20% pool in the downstream section. This trend is correlated to a decline in LWD from 0.17pieces/m stream in the upstream section, to 0.05 pieces/m stream across the ROW, and 0.06pieces/m stream downstream. The LWD in the upstream segment results in complexity including bars, pools and undercut banks, but the ROW and downstream segments have less LWD, less complexity and much longer riffle stretches.

Photograph 1. Kelvin Creek and the Rightofway.

Photograph 2. Looking upstream through the Rightofway.

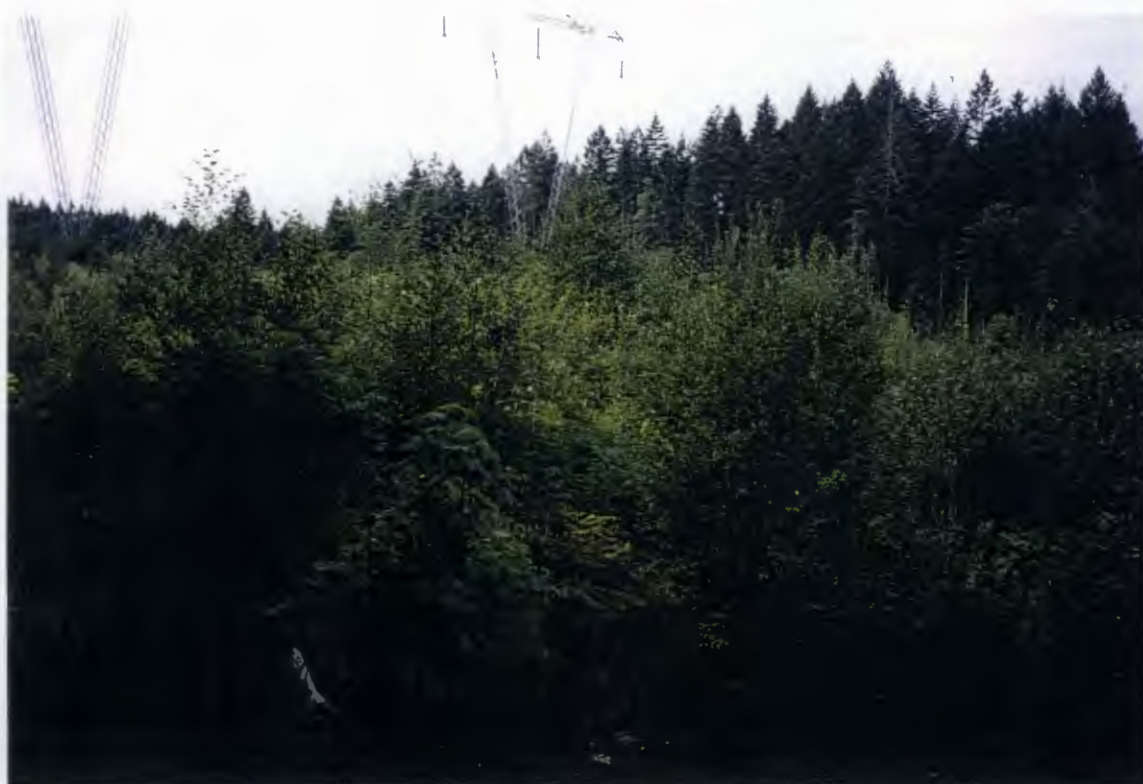
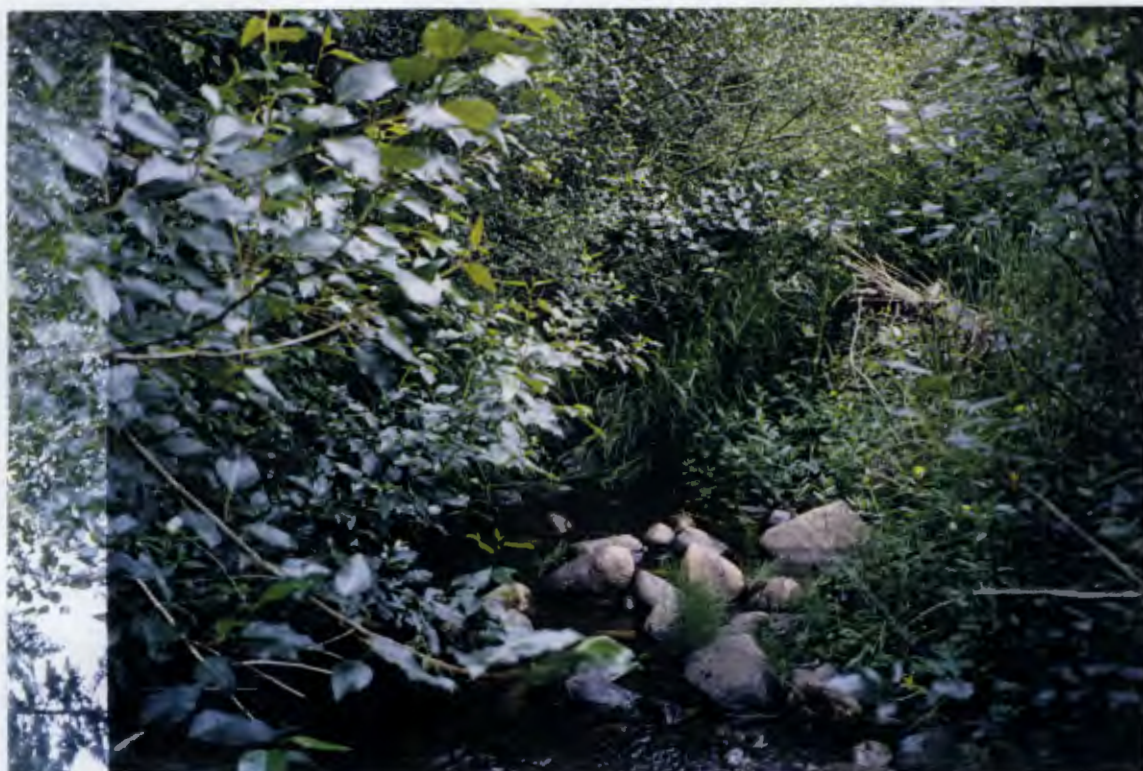
One trend in habitat complexity observed across the two sections is an increase from 39% pool habitat and no LWD in the upstream section (excluding debris jam) to 48% pool habitat and 0.05pieces LWD/m stream across the ROW. The increase in pool habitat through the ROW stream segment is often associated with old-growth root wads but in some cases, it is associated with undercut banks, covered by dense grasses and bushes.

Photograph 3. Currie Creek and the Rightofway.

Photograph 4. Looking upstream through the Rightofway.

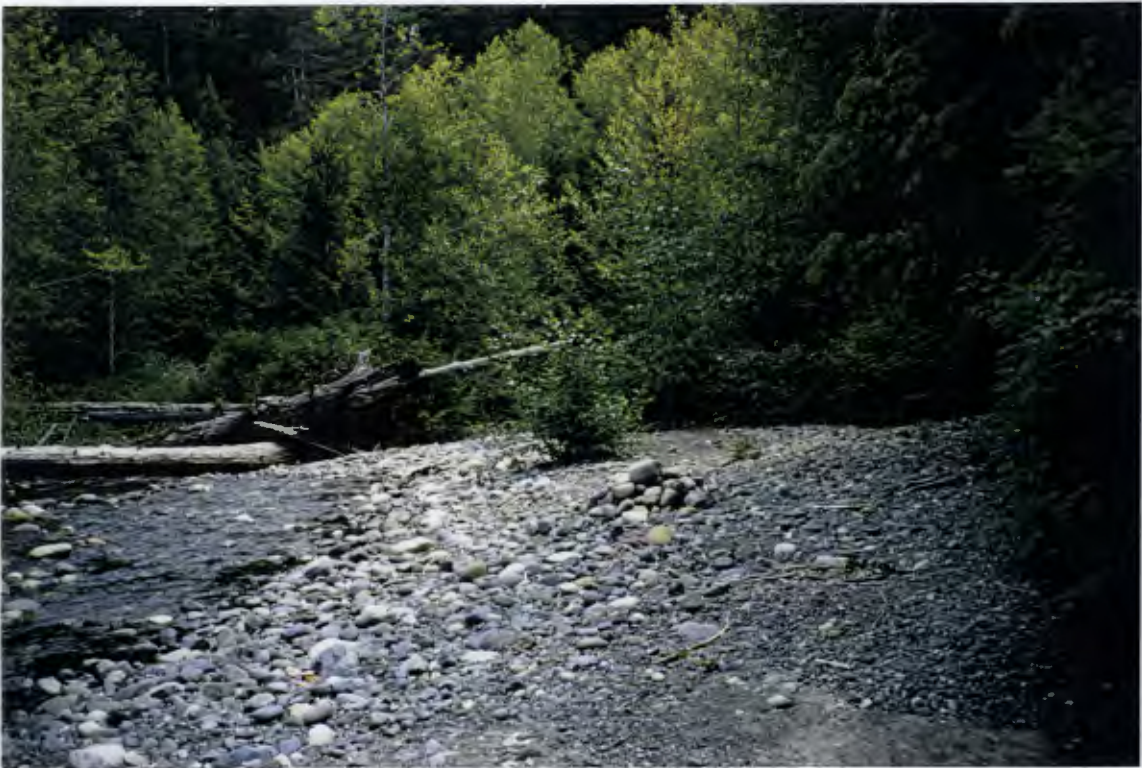
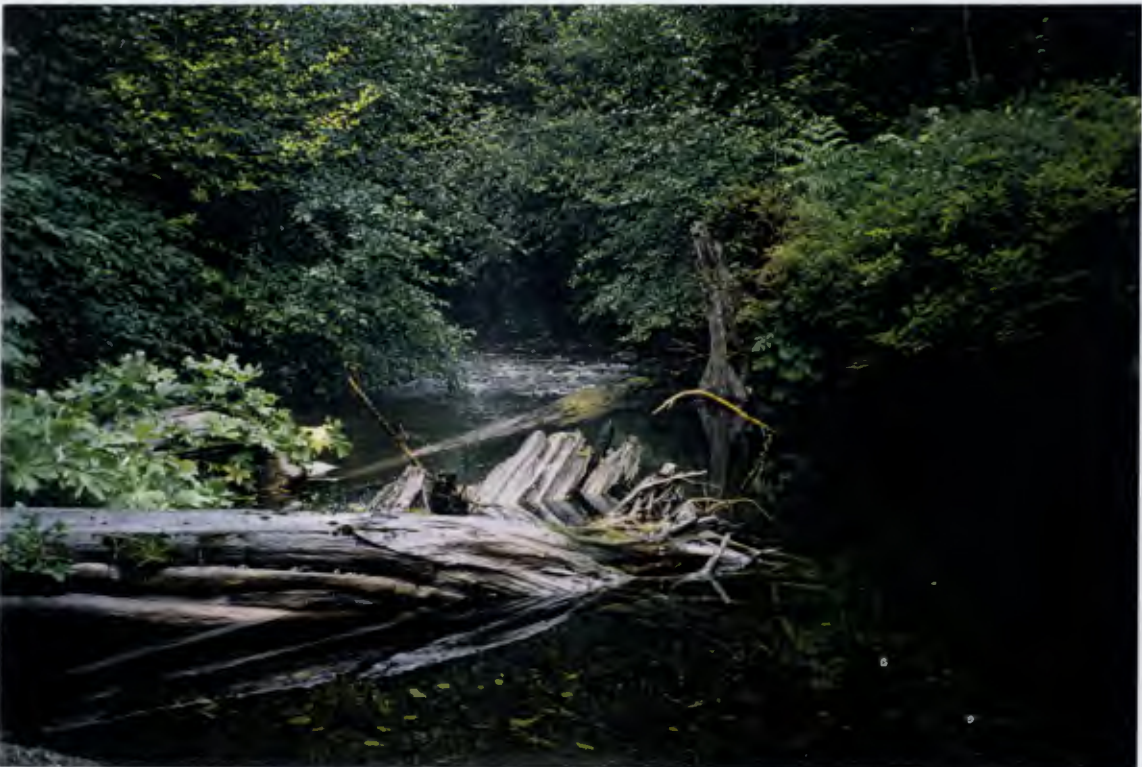
One trend in habitat complexity across the three segments is a steady reduction in pool habitat from 54% in the upstream segment to 34% across the ROW to 31% in the downstream section. Despite reducing pools the amount of LWD stays relatively constant across all three sites and is large old conifer trees. Although the LWD forming the debris jam in the middle of the ROW was included in relevant calculations it would be inundated only at high flows. There are few pools caused by undercut banks at the site.

Photograph 5. Nile Creek and the Rightofway.

Photograph 6. Looking upstream from the end of the ROW.

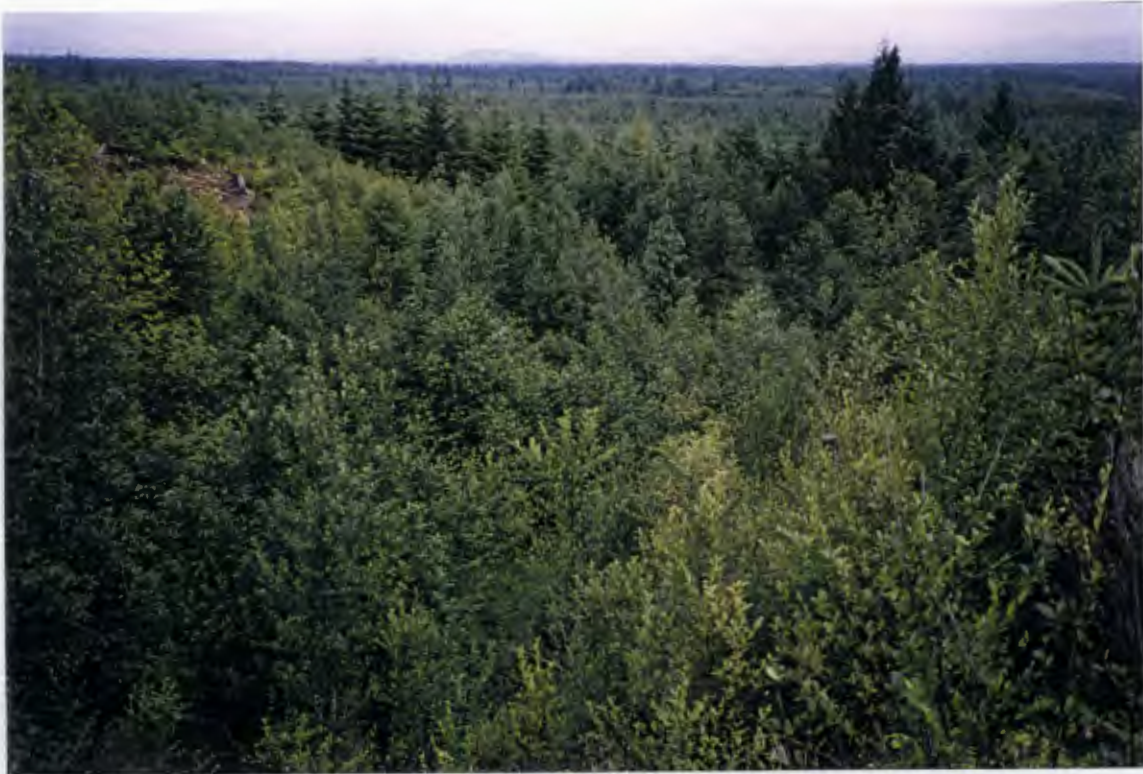
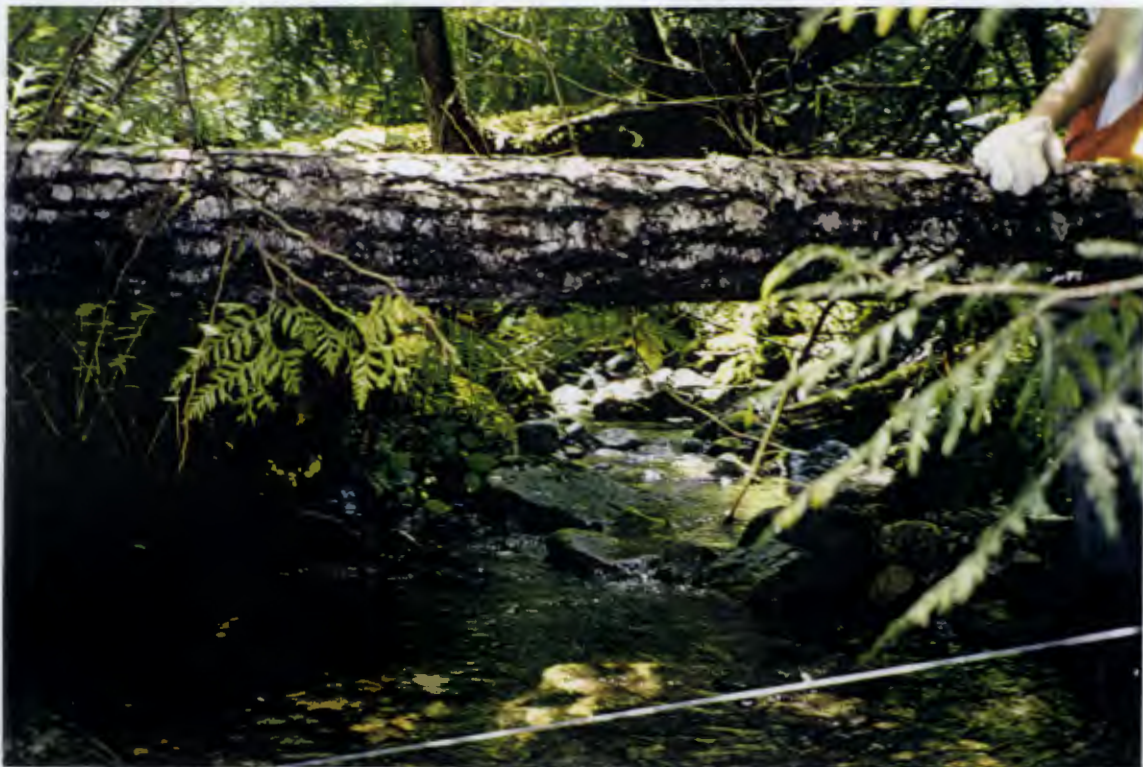
There is a trend for more pool habitat through the segments from 36% in the upstream site to 37% at the ROW to 53% in the downstream site. As alluded to, much of the downstream pools were associated with debris leading to heating of the water; further, the functional LWD found at all three sites is large and old.

Photograph 7. French Creek Tributary gully and vegetation downstream of Rightofway.

Photograph 8. Looking upstream through lower end of the ROW stream section.

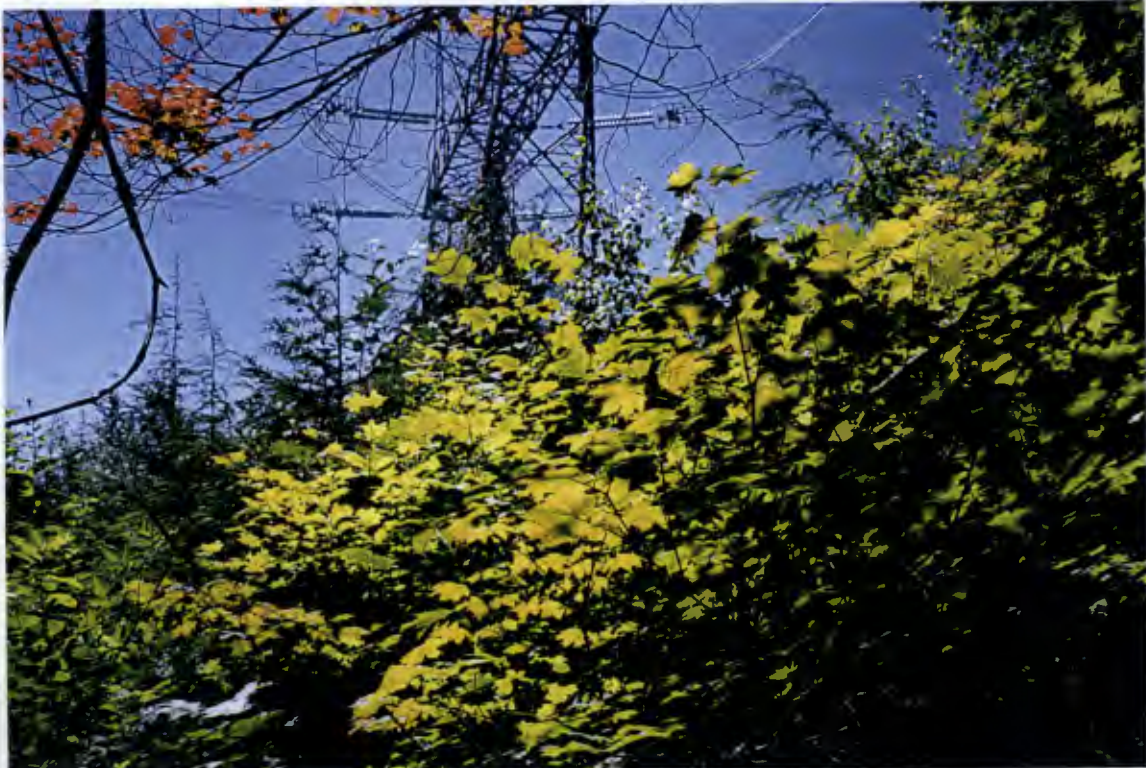
With habitat complexity, the volume of pools drops from 46% in the upstream segment to 35% across the ROW. This is accompanied by a reduction in LWD from 1.57pieces/m stream upstream to 0.06pieces/m stream across the ROW. Upstream it is probable that there is too much LWD and is impacting site morphology. Conversely, the ROW stream segment is wetted bank to bank with only a few pieces of LWD at its most upstream end. Habitat complexity and pools in this segment are most often associated with boulders, bedrock, and in a few cases, undercutting of banks that are protected by willow trees.

Photograph 9. Vegetation across Rightofway at Noons Creek

Photograph 10. Looking upstream from the lower end of the ROW stream section.

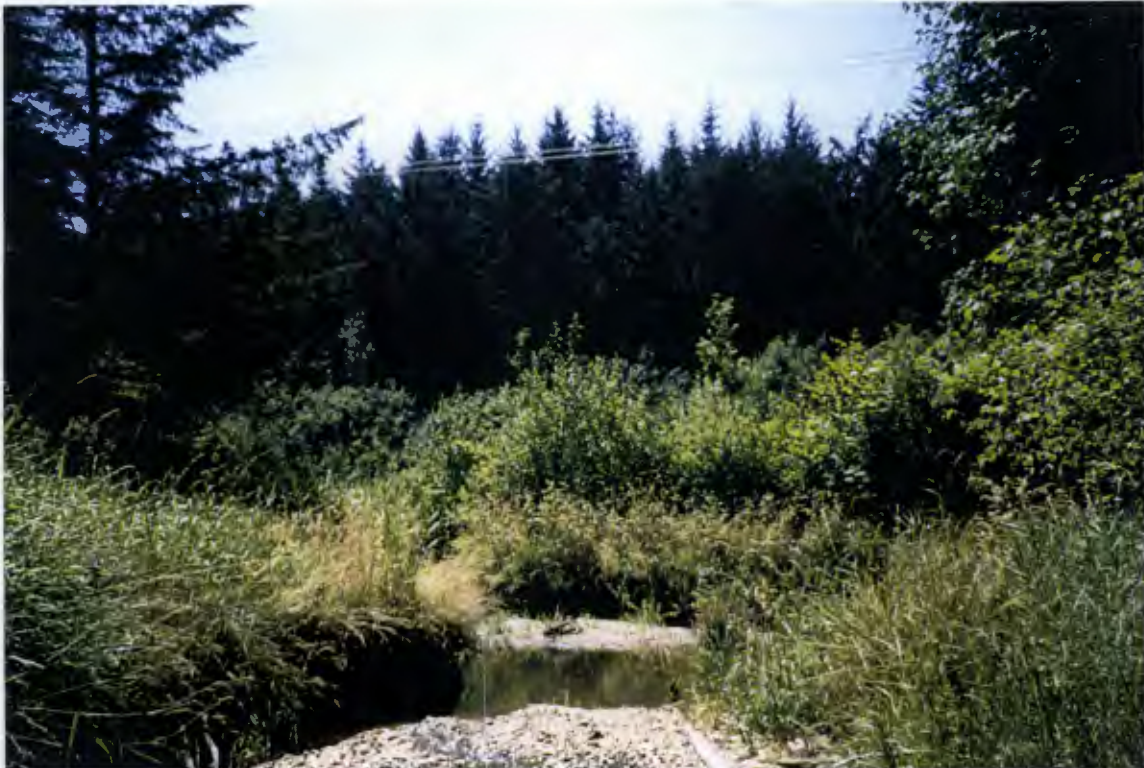
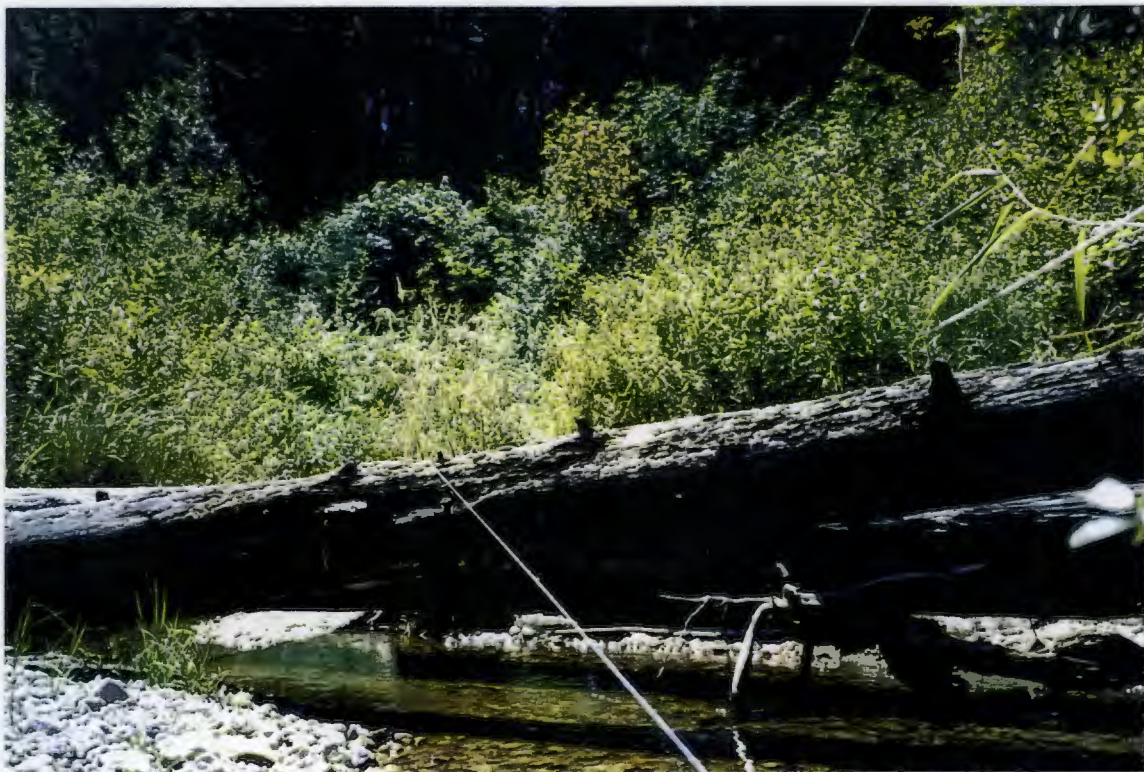
The results for habitat complexity demonstrate the close relationship between LWD and complexity as pool area increases from 48% upstream, to 62% at the ROW and decreases to 46% downstream. This is correlated to an increase in LWD from 0.043pieces/m stream upstream, to 0.12 pieces/m stream at the ROW and a decrease to 0.05pieces/m stream downstream. All LWD is embedded and originated from an old growth conifer forest.

Photograph 11. ROW and stream facing downstream section at Donegani Creek

Photograph 12. Looking upstream in the middle of the ROW stream section.

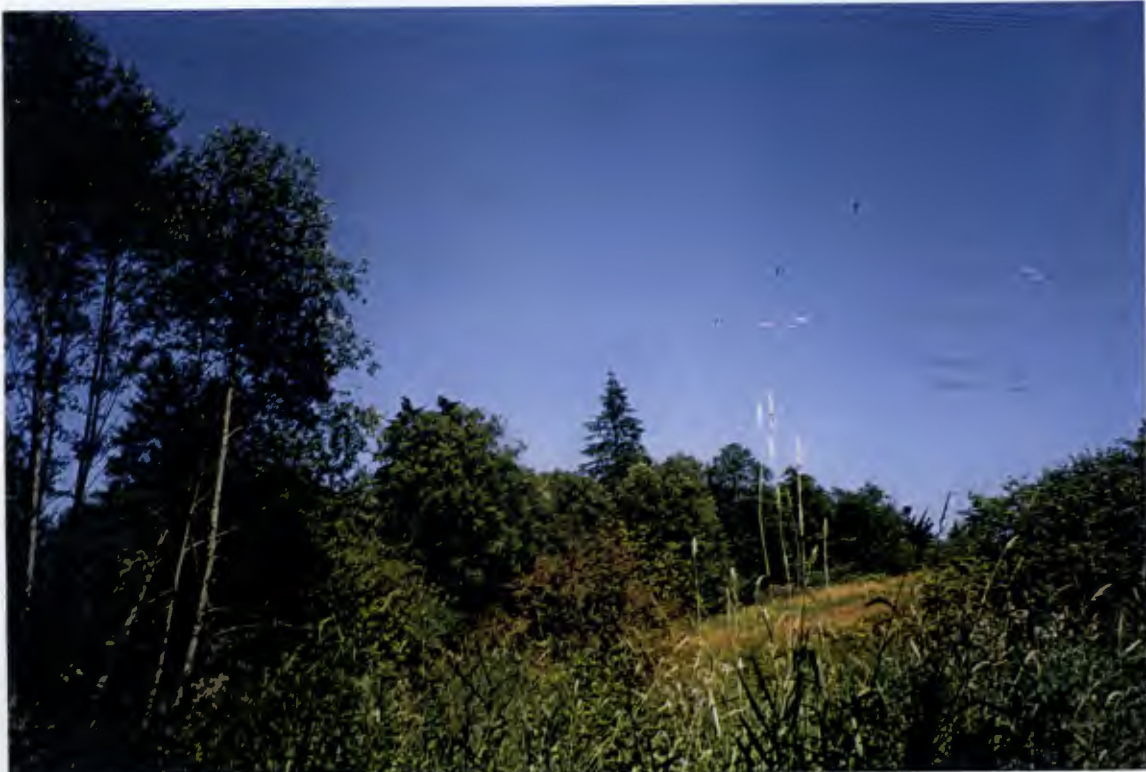
The trend in habitat complexity is for more pool habitat and more LWD upstream and downstream of the ROW. The pool results are 82%(upstream), 55%(ROW) and 85% downstream while LWD results are 0.04 pieces/m stream (upstream), 0.02 pieces/m stream (ROW) and 0.08 pieces/m stream (downstream). Although the pools in the upstream and downstream segments are deeper, the trend is confounded because flow through the ROW is separated into two channels.

Photograph 13. East side of ROW with groomed section and riparian trees.

Photograph 14. Looking upstream in the middle of the ROW stream section.

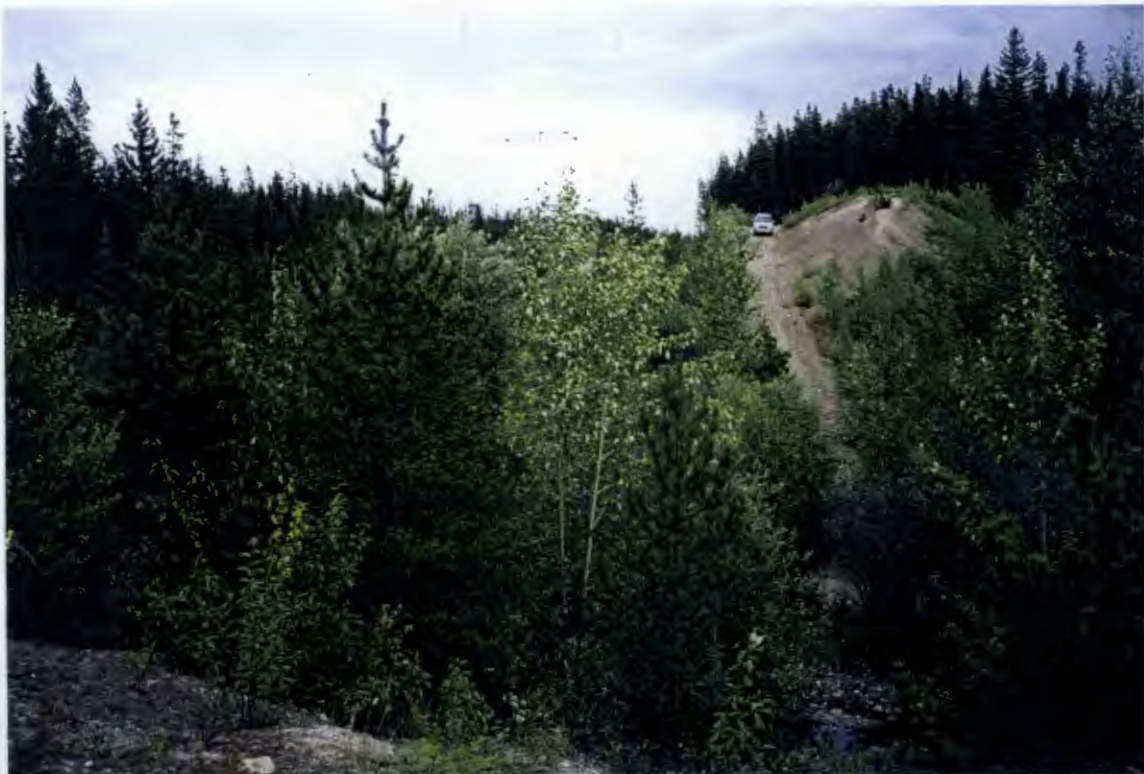
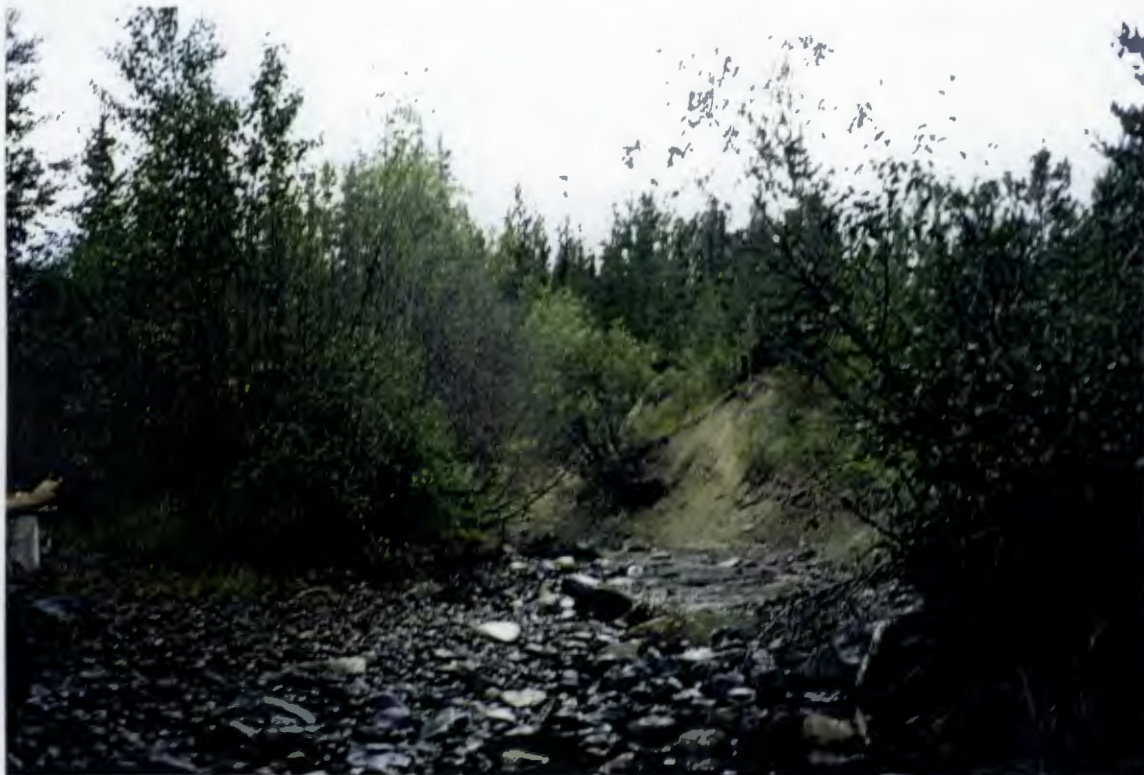
The information for the downstream section was accidentally destroyed. The other two segments show a reduction from 50% pool habitat upstream to 34% pool habitat across the ROW. Correspondingly LWD reduces from 0.05 pieces/m stream upstream to 0.01 across the ROW. Anecdotally, the downstream section had similar morphology to the ROW including significant stretches of exposed bedrock and little LWD.

Photograph 15. The east side of ROW with access road and mixed vegetation.

Photograph 16. Looking upstream in the middle of the ROW stream section.

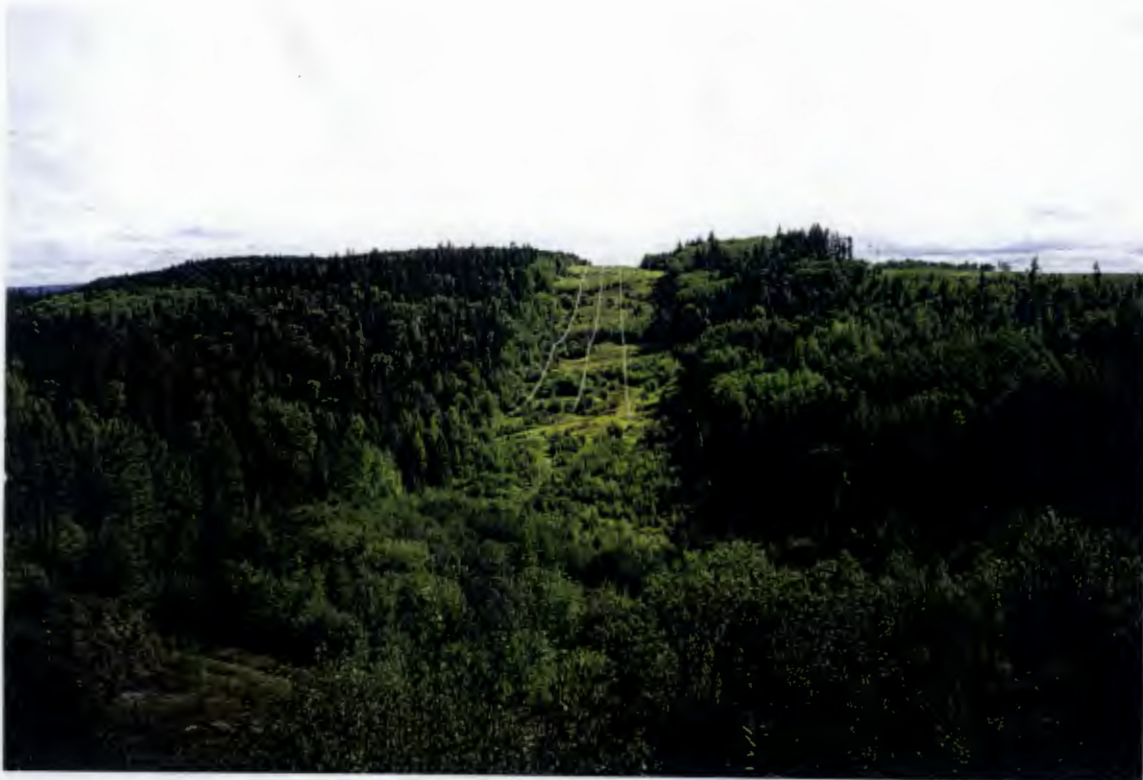
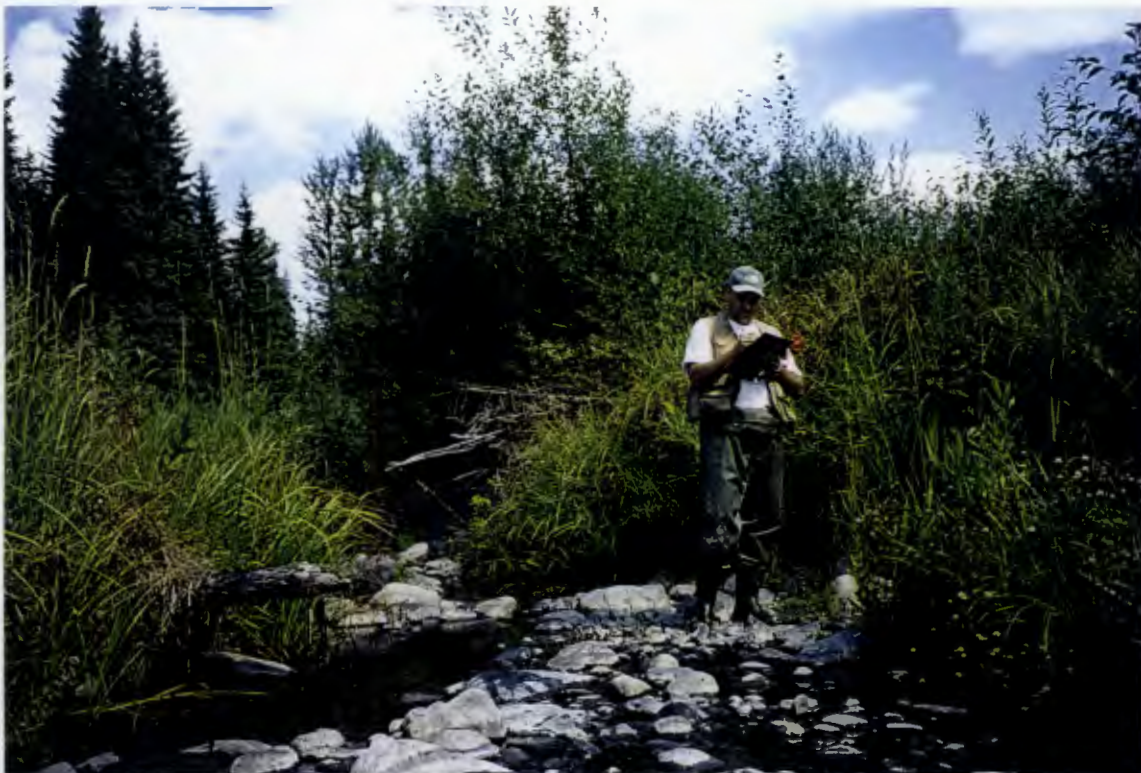
There was no trend between the upstream segment and the ROW segment in terms of the amount of pool habitat. However, there was a trend across all three of the sites for an increase in LWD from 0.06 pieces/m stream in the upstream section to 0.08 pieces/m stream across the ROW to 0.12 pieces/m stream downstream. The LWD in the upstream segment and across the ROW was composed of large old growth conifers well embedded in the banks. Although LWD in the downstream segment often spanned across both banks and was associated with small woody debris it did not create much pool habitat.

Photograph 17. The vegetation, and stream across the ROW.

Photograph 18. Looking downstream at the lower end of the ROW stream section.

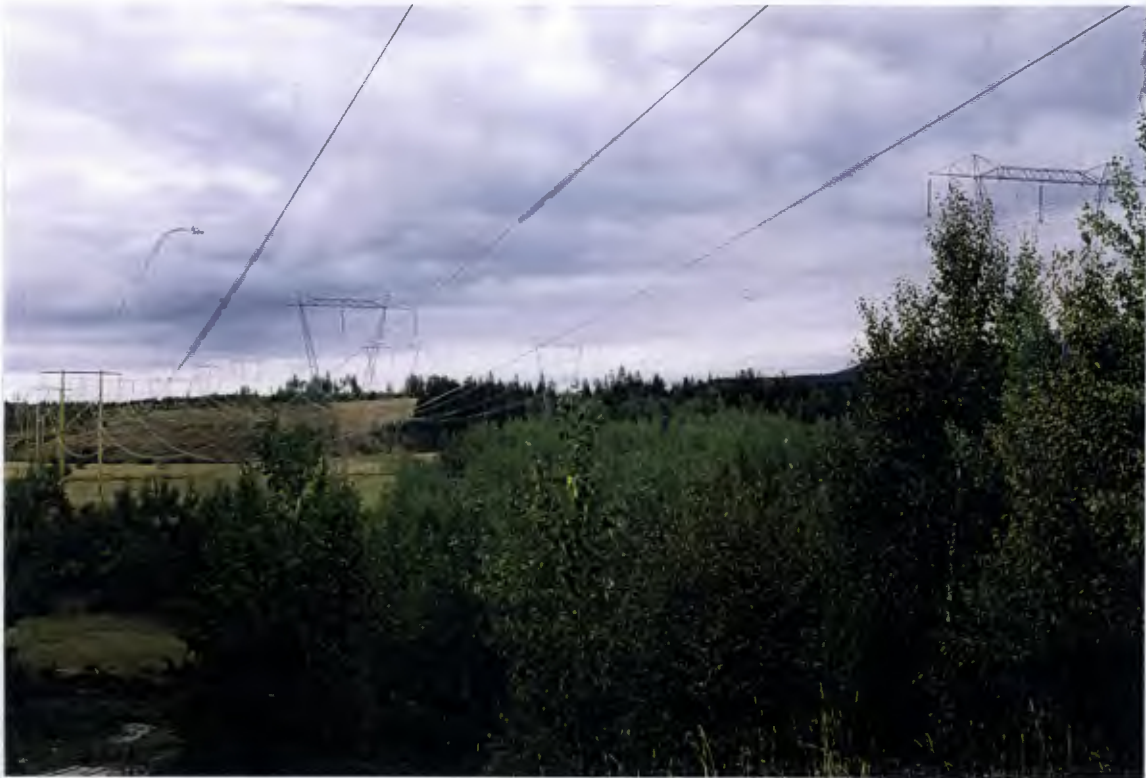
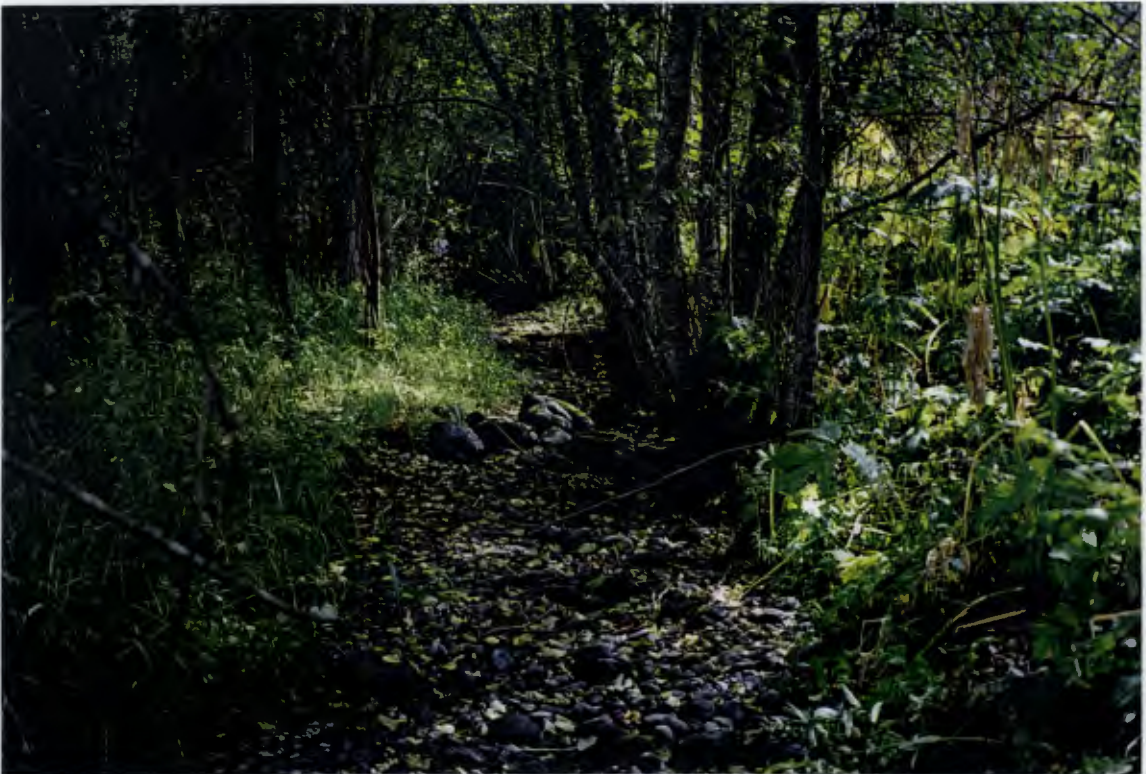
There was no trend in habitat distribution (amount of pools) between the upstream and the ROW. However, when the data from all three segments is used there is a increase in LWD from 0.16pieces/m in the upstream section and a similar amount of 0.13pieces/m stream across the ROW up to 0.56pieces/m in the downstream section. The LWD upstream and across the ROW is composed mostly of large old conifer debris that is functioning and well embedded in undercut banks. It should be noted that some potential LWD in the upstream section has been cut by chainsaw and removed thereby reducing the amounts potentially observed. Downstream, the LWD was smaller (10-20cm), accompanied accumulations of small debris and did not often contribute to forming pools.

Photograph 19. The ROW, creek and vegetation looking north.

Photograph 20. Looking upstream through the middle of the ROW stream section.

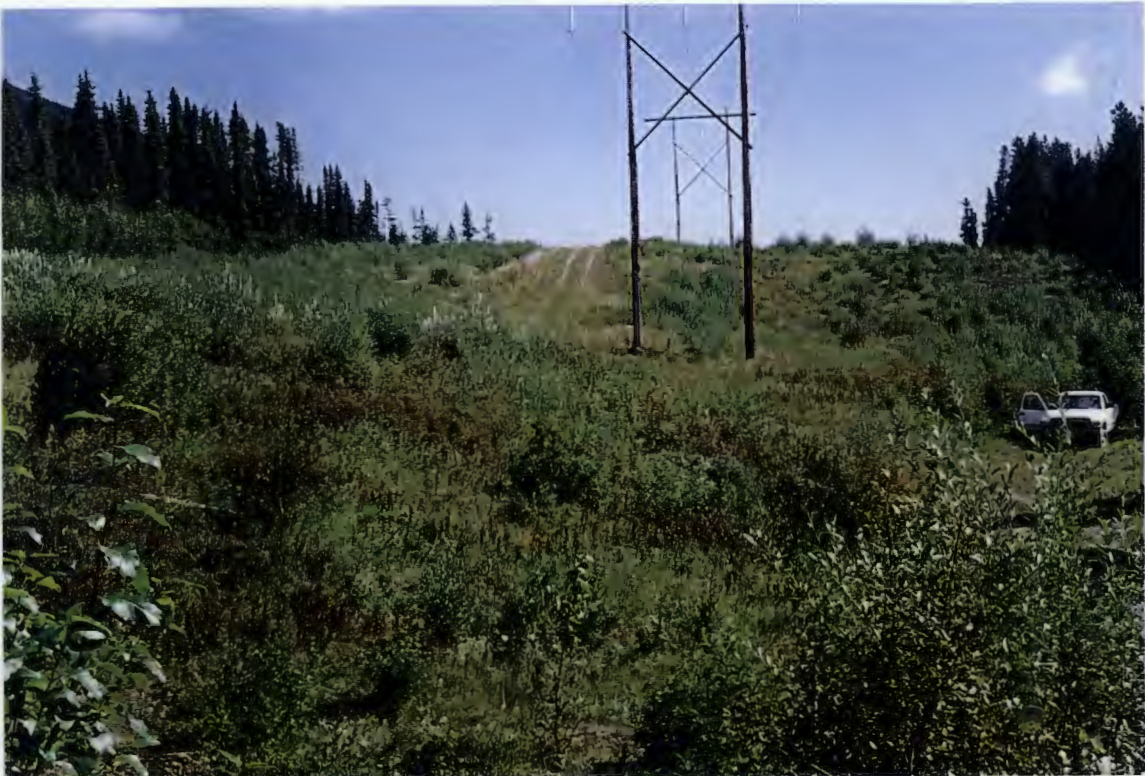
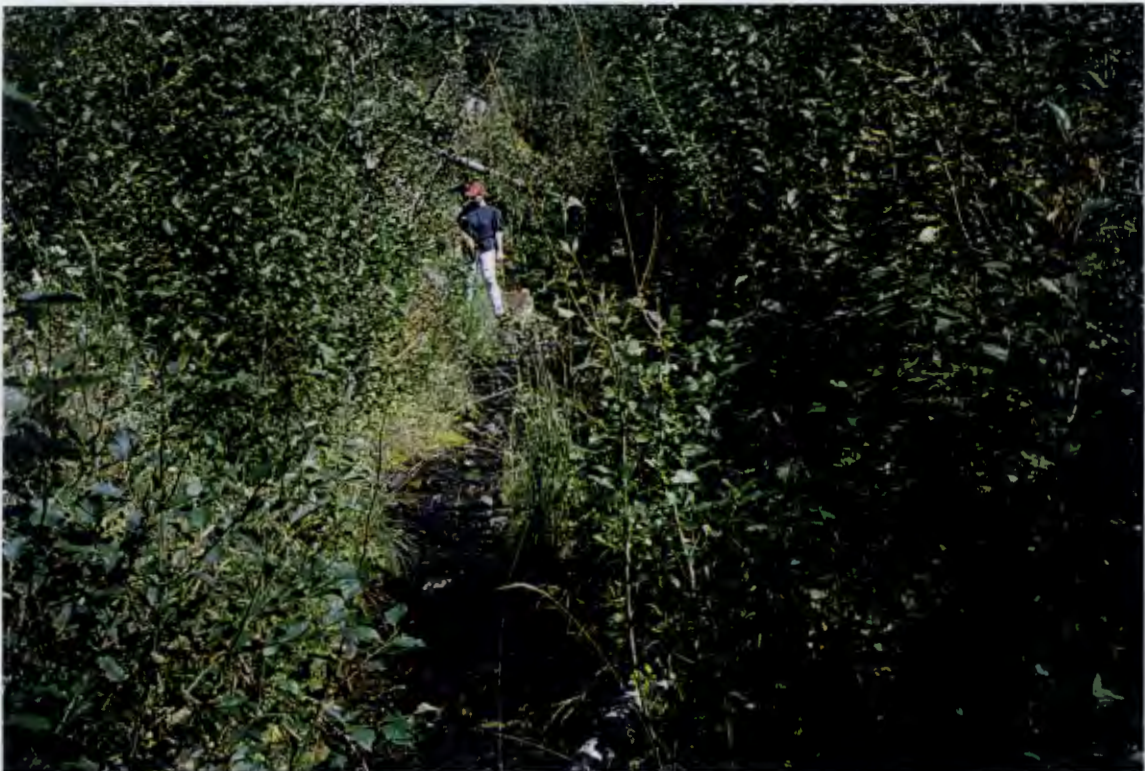
One trend across the two stream segments is a reduction in pools from 25% upstream to only 13% pool habitat across the ROW stream segment. In addition, the ROW is dominated by a long continuous riffle while the upstream section has more complexity and alternating habitats. LWD also decreases moving downstream (excluding the debris jam) from 0.20 pieces/m stream upstream to 0.02 pieces/m stream across the ROW and in both cases invariably involves pieces of conifer between 10 to 30cm in diameter.

Photograph 21. The ROW looking south from the left bank of the creek.

Photograph 22. Looking upstream from the middle of the ROW.

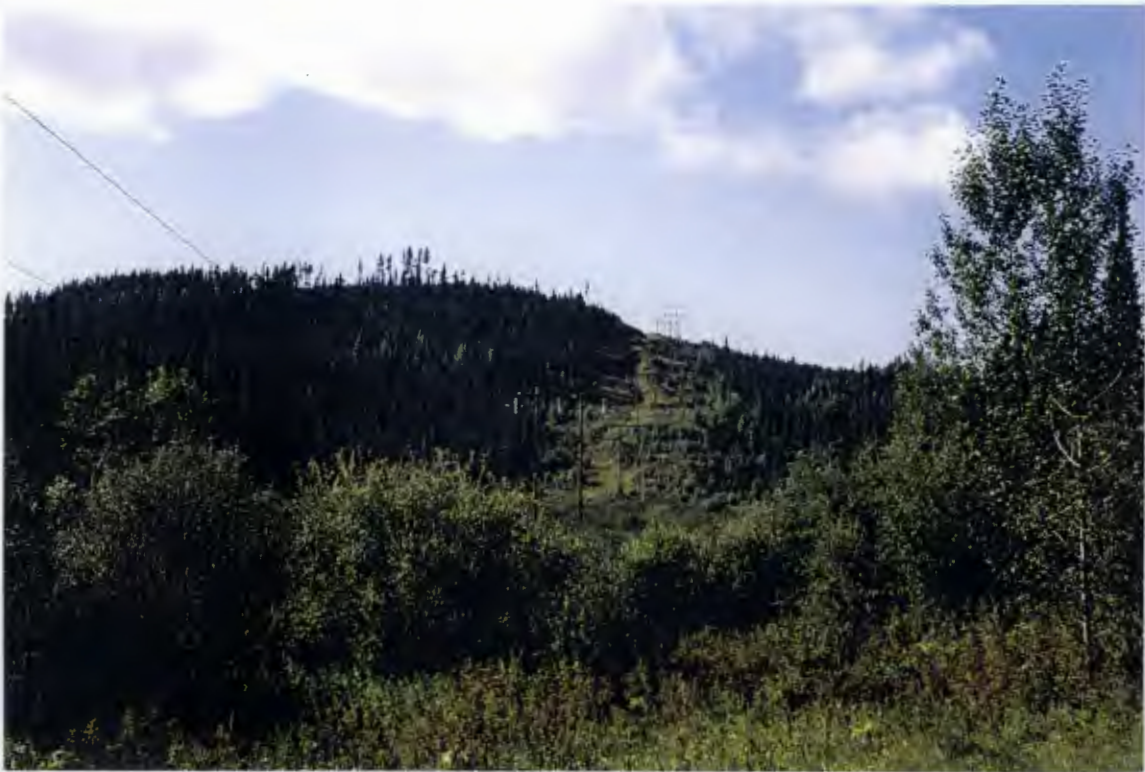
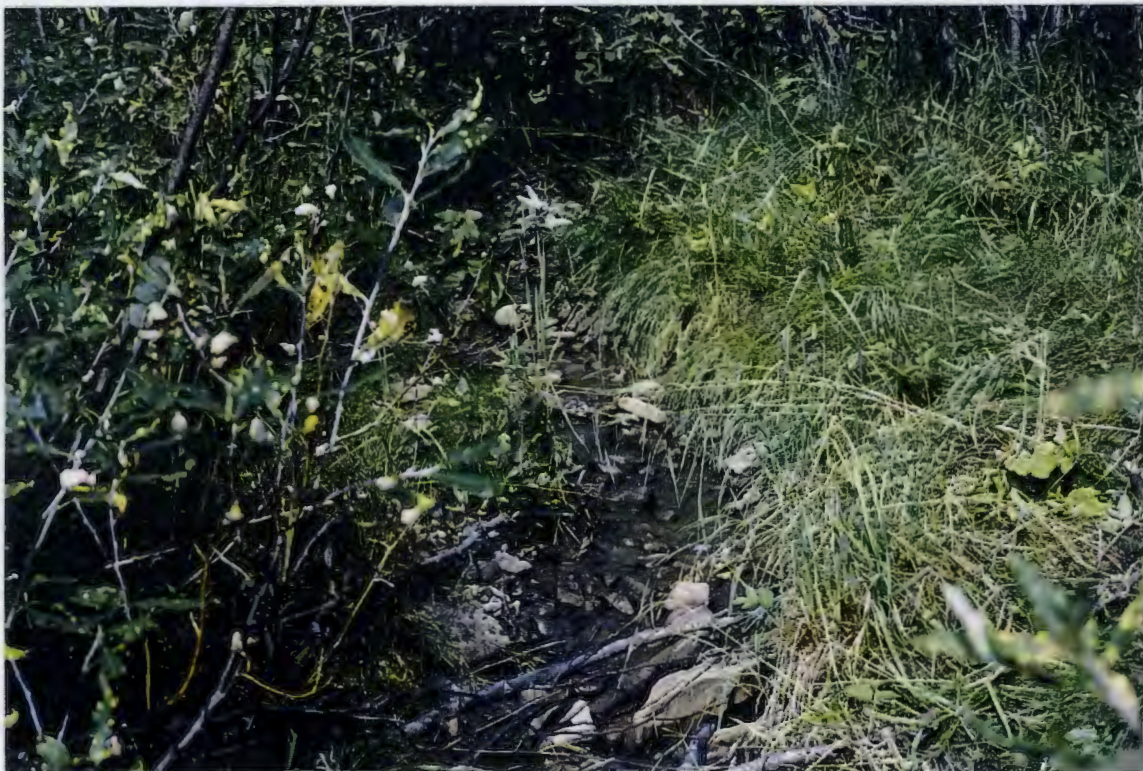
While there is no trend involving pool habitat the lower section has more LWD. The ROW section has 0.07 pieces/m stream whereas the upstream section has 0.02 pieces/m stream. The upstream section ended at a large debris jam 42m upstream of the ROW.

Photograph 23. The ROW and crossing looking north along the corridor.

Photograph 24. Looking upstream from the middle of the ROW.

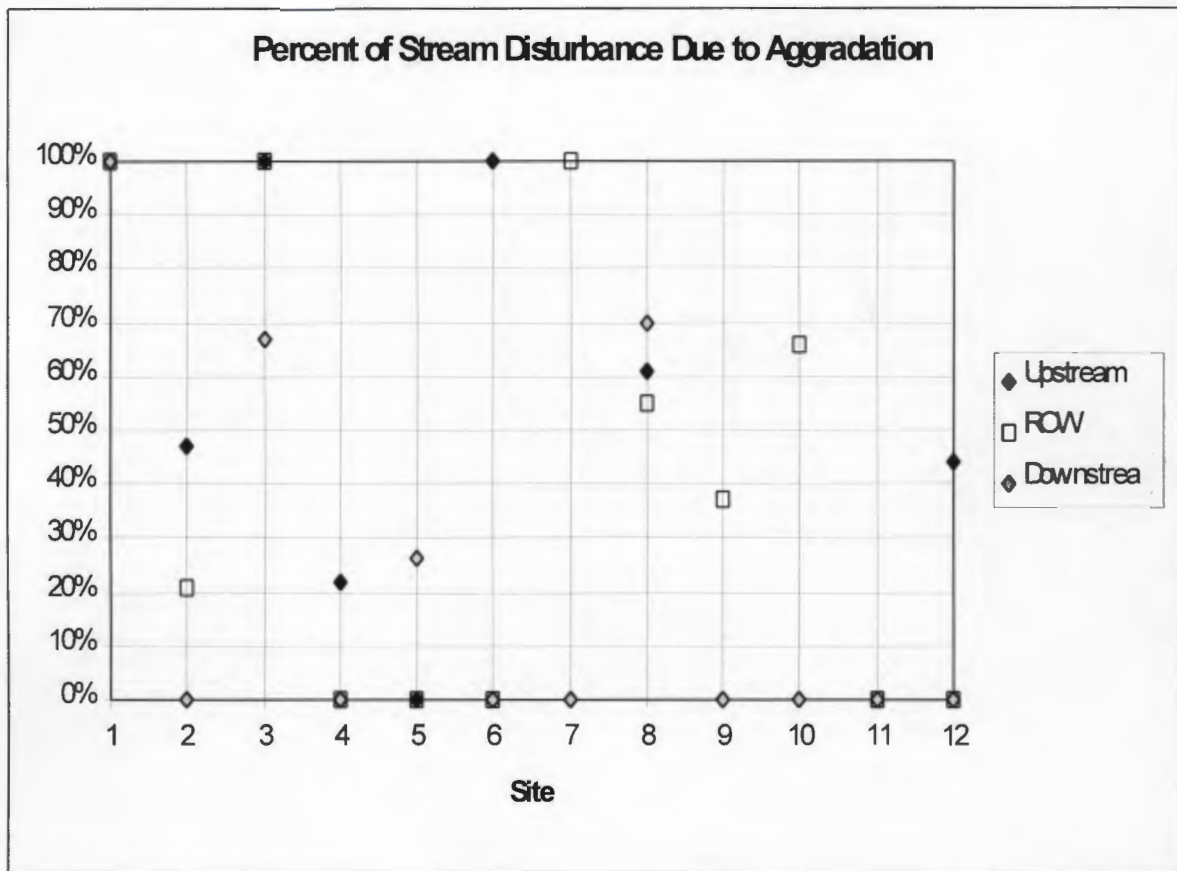
Figure 4: Distribution of Aggradation Across the Case Study Sites.

Each of the stream morphologies used in this study were controlled by volume and function of LWD. As a result, the volume and function of LWD determines the in-stream habitat complexity across stream reaches. In general, the amount of pool habitat in the streams studied was most often associated with, and created by, individual pieces of LWD. Across the ROW stream
