INTEGRATING RIPARIAN ZONES WITH RIGHTOFWAY MANAGEMENT

MASTER OF SCIENCE

NATURAL RESOURCE MANAGEMENT

THE UNIVERSITY OF NORTHERN BRITISH COLUMBIA

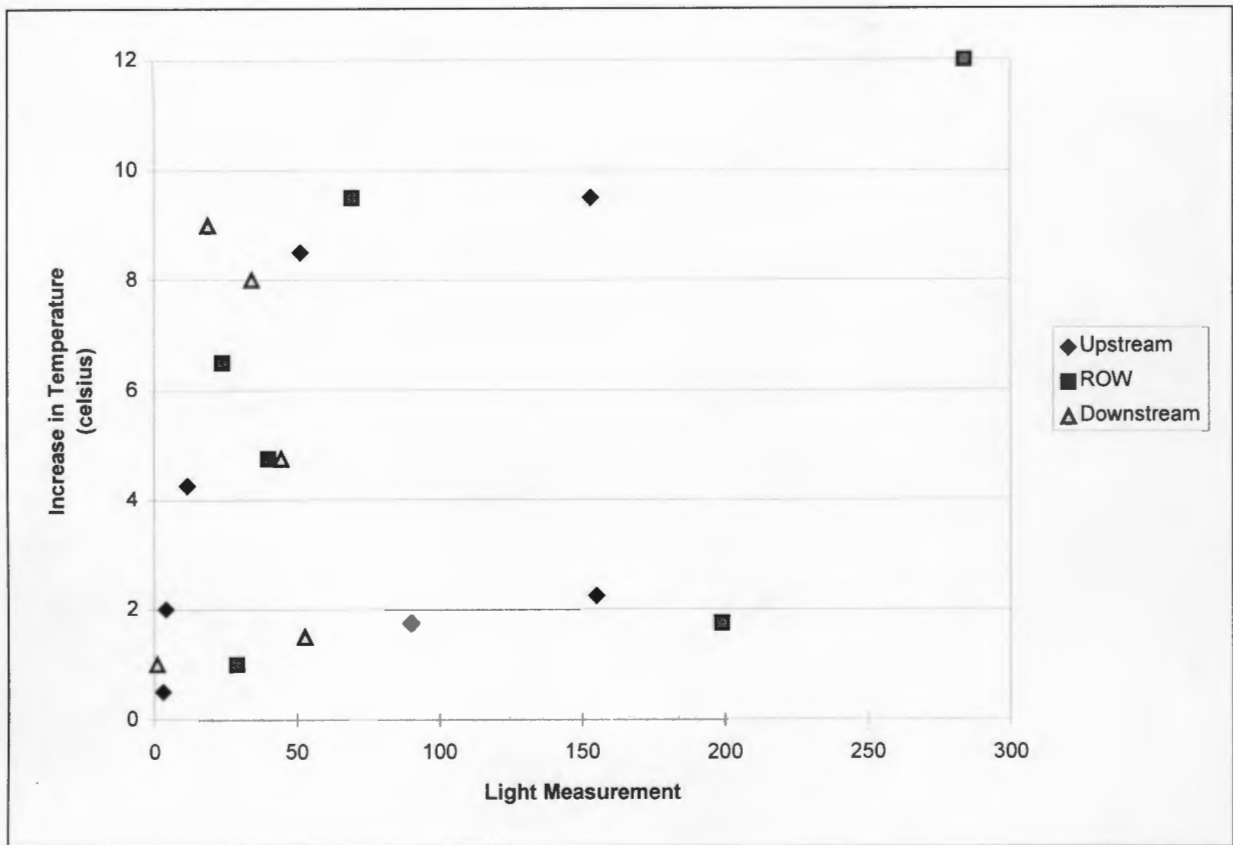
Figure 5. Correlation Between Light Levels and Increases in Water Temperatures.

On the warmest day of the collection period the maximum increase in water temperature adjacent to the ROW ranged between 0.0 and 3.5°C. These increases are smaller than those observed elsewhere in BC. Brownlee (1988) found the maximum water temperatures in some smaller streams flowing through logged areas near Prince George, BC increased between 5.5 and 9 °C. Holtby and Newcombe (1982) found mean water temperatures in Carnation Creek increased by 7°C when 39% of the watershed had been logged. Still others have documented 15°C
