SELECTED ECOLOGICAL IMPACTS OF OUTDOOR RECREATION:  
THE BERG LAKE TRAIL IN MOUNT ROBSON PROVINCIAL PARK

PROJECT SUBMITTED IN PARTIAL FULFILLMENT OF  
THE REQUIREMENTS FOR THE DEGREE OF  
MASTER OF NATURAL RESOURCES AND ENVIRONMENTAL STUDIES

THE UNIVERSITY OF NORTHERN BRITISH COLUMBIA

April 2003

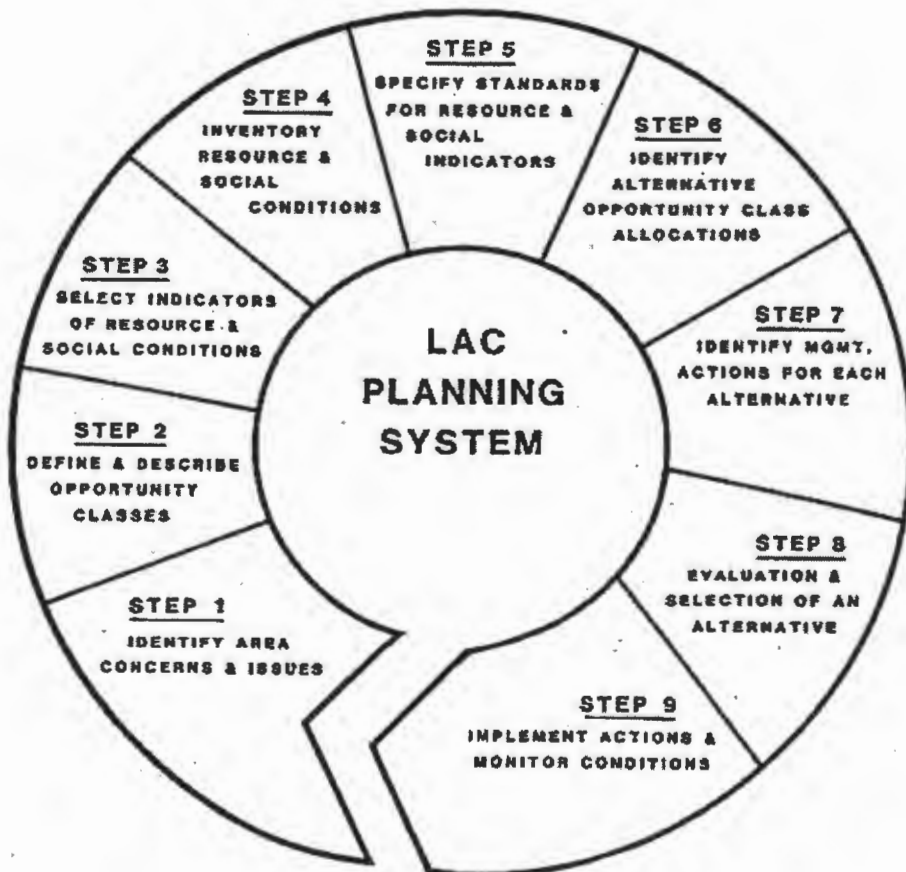
Fig. 1: The Limit of Acceptable Change (LAC) planning system

Based on these four components the LAC planning process involves nine steps, as noted below in Figure 1:

One of the positive aspects of the LAC planning process is the public consultation. The environmental and social acceptability of resource conditions seek public input in the LAC planning process. It is based on the transactive planning model, and offers desired conditions of visitor experiences and expectations in making ecological and social elements standard to enjoy a maximum number of visitors in different opportunity classes. Selecting proper indicators and acceptable standards from the public point of view is an important step toward visitor management (White et al., 2001). LAC also offers how much change in resource and social conditions will be allowed, and where changes occurs and what management actions are needed to maintain acceptable conditions (McCoy et al., 1995). However, continual monitoring is essential to determine relative effectiveness and success of this process.

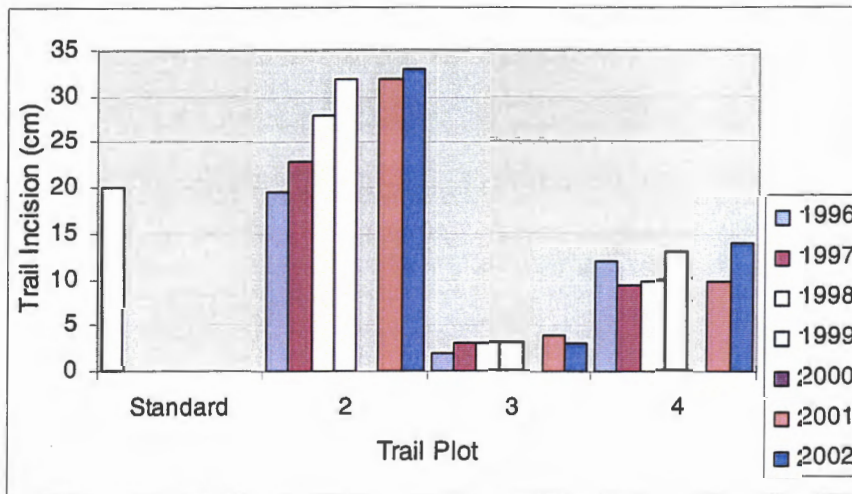
Fig.11: Trail incision over time (Plots 2, 3 & 4)

*Kinney Lake Area (Plots 2, 3, & 4):* Plot 2 is located adjacent to Kinney Lake, on a slightly undulating terrain. At this location, over-story is semi-open, and the trail is partially graveled. It is one of the most incised trail points on the Berg Lake trail. Data show that the rate of incision during the first four years of trail construction was very high and has leveled off since

1999. The 2002 data show trail incision to be 33 cm and is 13 cm higher than the standard set by BC Parks (Fig.11).

Data for Plot 3 show that trail incision is not a major problem at this location (Fig. 11). Comparison of trail surface photos taken in 1996 and 2002 indicates that there has been no loss of trail side (edges) vegetation. On the contrary, there has been a remarkable improvement in vegetation cover (Plates 3 and 4). This section of the trail is well-aligned with the contour of the topography. The drainage system in this area seems to be working well, which could have helped in reducing trail surface erosion. Data on Plot 4 show that between 1996 and 2002, the ratio of change in incision is not very significant (Fig. 11). The data must be interpreted cautiously. Trail depth (incision) in 1996 was 12 cm which reduced to less than 2 cm in 1997 and 1998, but increased again in 1999. Trail depth reduced again in 2001 but increased significantly in 2002. It is possible that there were discrepancies in measurement, mainly

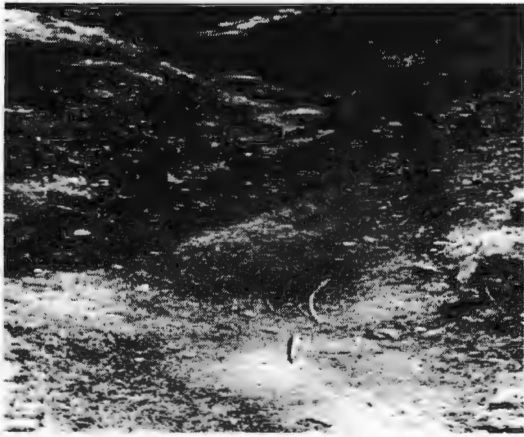
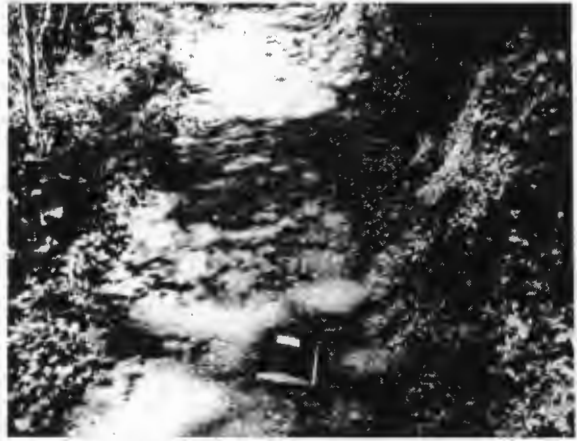
because the person taking the measurements is not always the same. In the absence of proper formal training, such measurements can be subjective.

Plate: 3: Plot 3 (1996)

Plate: 4: Plot 3 (2002)

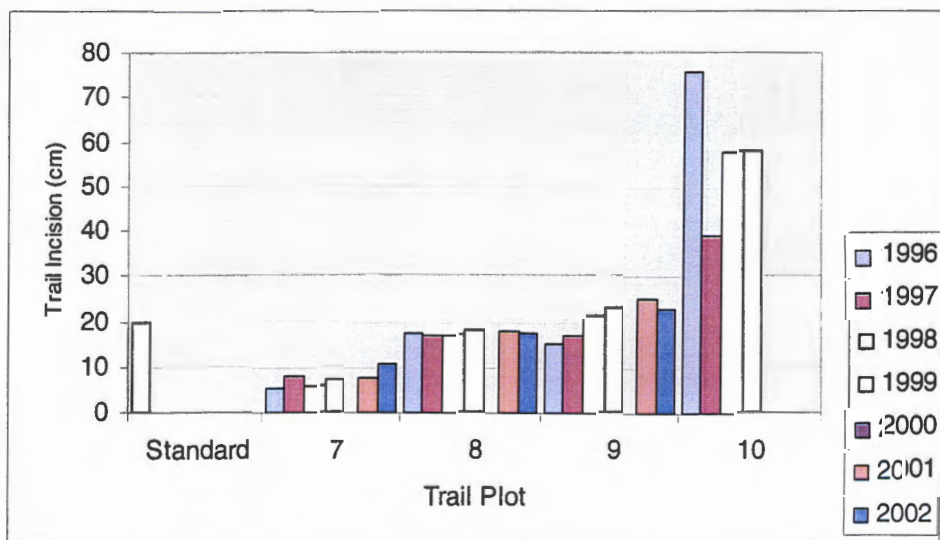
Fig. 13: Trail incision over time (Plots 7, 8, 9 & 10)

*Emperor Hill Area* (Plots 7, 8, 9, & 10): This section of the trail is located on a steep slope. Trail surfaces of plots 7 and 8 are hard, where chances of soil compaction and erosion are minimal (see Appendix, Plates k & l). Compared to the previous year, trail surface of Plot 7 has eroded, but is well within the standard (Fig. 13).

Trail depth on Plot 8 is much higher compared to Plot 7; however, the overall rate of change is negligible, and between 2001 and 2002, depth was reduced by 0.5 cm. What is noticeable on Plot 8 (Fig. 13) is that erosion has occurred on the upper slope of the trail, and deposition has occurred on the bottom of the trail (Plates 5 & 6). Trail width has increased, as hikers tend to go around it to avoid the rocky and eroded section of the trail. Data on Plot 9 (Fig. 13) show a striking difference in trail surface characteristics between 1996 and 2002 (Plates 7 & 8). Compared to the 1996 photo, the 2002 photo show excessive amount of bedrocks exposed, probably a result of downhill soil erosion. Trail depth has increased significantly over the last seven years; a net increase of 7 cm. This section is located on a rocky outcrop where light penetration is high due to the absence of tree canopy.

Plot number 10 is now closed off (in 2000) due to high levels of soil erosion. Available data show that trail depth had increased considerably since 1997 and greatly exceeds the standard set by the Park management (Fig. 13).

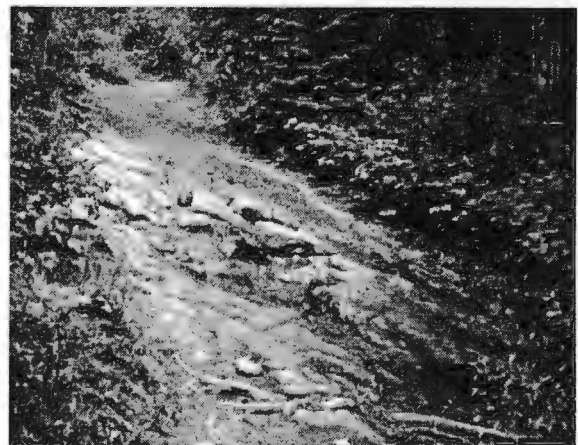
Plate 5: Plot 8 (1996)

Plate 6: Plot 8 (2002)

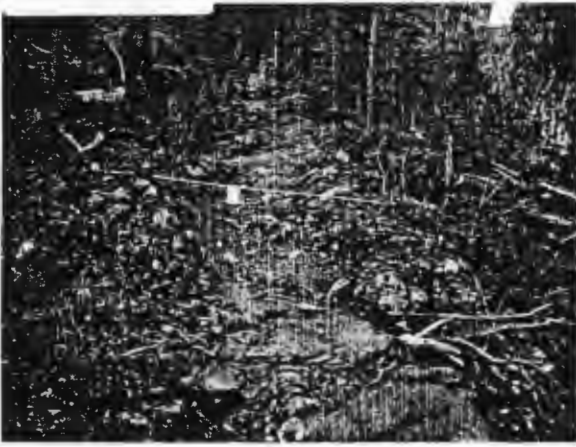
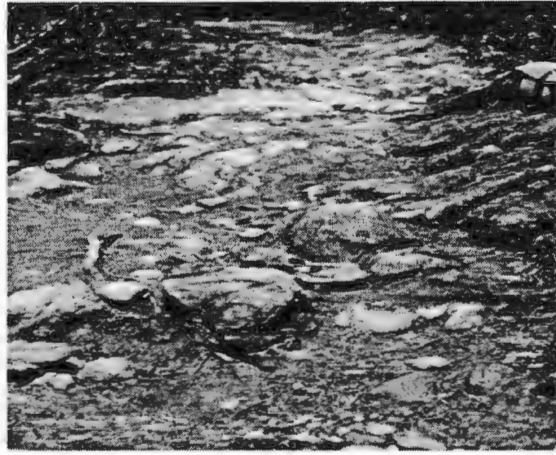
Plate 7: Plot 9 (1996)

Plate 8: Plot 9 (2002)

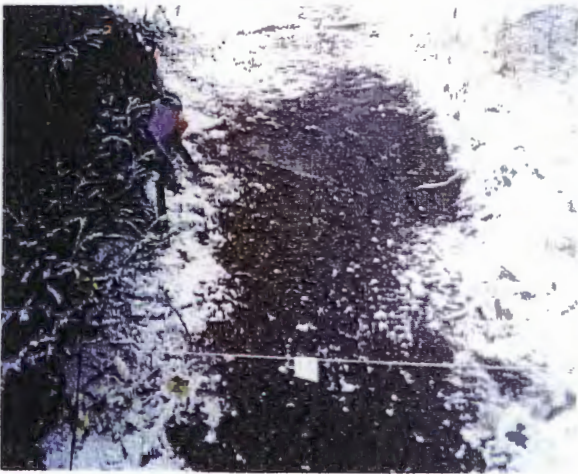
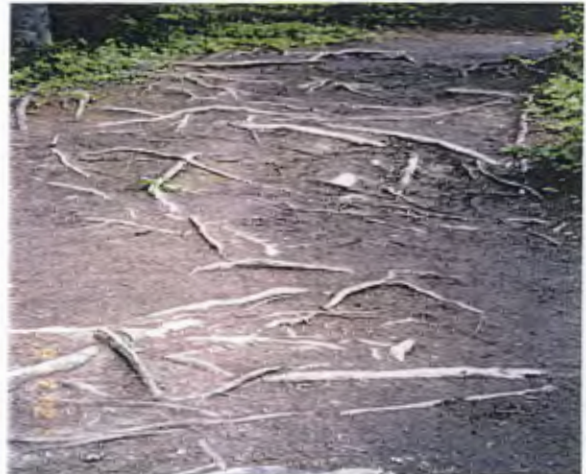
*Berg Lake area* (Plots 11& 12): Plot 11 is located near the Berg Lake Campground. Data show that trail depth has not increased so much (Fig. 14). However, this should be taken cautiously. Root exposure on this trail has now become a problem. Compared with the 1996 photo, excessive amount of root exposure is visible on the 2002 photo (Plates 9 and 10). This is another example of data inconsistency and measurement error. Root exposure is usually associated with soil erosion and compaction. The net increase in soil depth is only 2 cm while the photos indicate that it could have been greater than 2 cm, as indicated by extensive root exposure at this location. Therefore, taking incision measurement at one point (the most deeply incised part of the trail surface) can be misleading. This calls for more accurate measurement techniques to be applied in trail monitoring. Trail depth on Plot 12 is also within the standard. The rate of change is very negligible (Fig. 14). This plot is no longer monitored, and a new trail has been constructed on the gravel flats where erosion is not an issue.

Plate 9: Plot 11 (1996)

Plate 10: Plot 11 (2002)

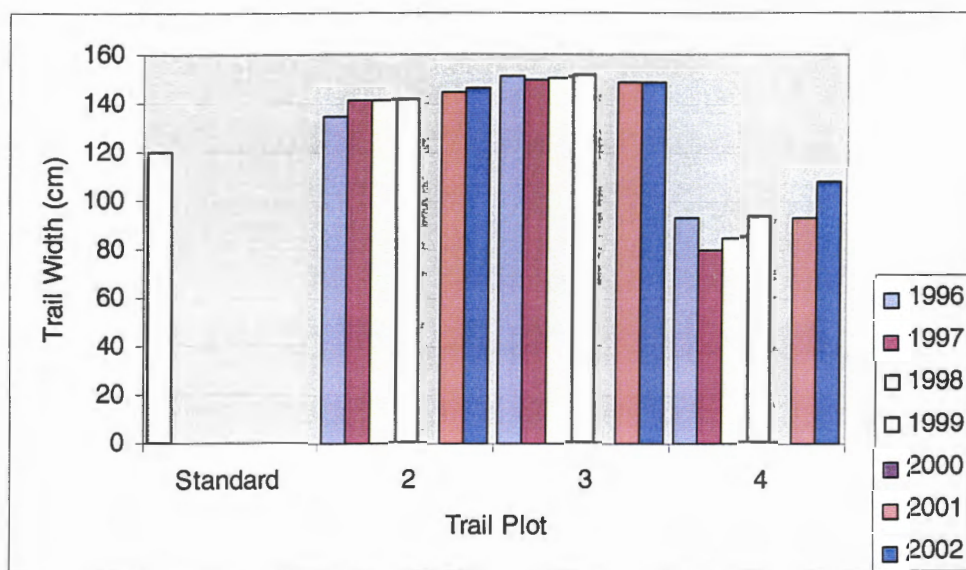
Fig. 16: Trail width over time (Plots 2, 3 & 4)

*Kinney Lake Area (Plots 2, 3, & 4):* Width standard for the trail (Type 2) is set at 120 cm. Trail width on Plot 2 exceeds the standards by more than 30 cm (Fig. 16). Width has gradually increased over time. Plot 3 also exhibits similar pattern, though difference in increase or decrease in width over time is negligible (Fig. 16). Plot 4 is still within the standards; however, past trends indicate that this standard will be exceeded very soon if adequate measures are not taken. The difference in trail width between 1996 and 2002 is almost 15 cm. The graph shows a clear pattern of increasing width compared to the previous years (Fig. 16).
