**EXPERIMENTAL INVESTIGATION ON THE STRUCTURAL PERFORMANCE  
OF TWO-STOREY CROSS-LAMINATED TIMBER SHEAR WALLS**

**Sedigheh Gheisari**

THESIS SUBMITTED IN PARTIAL FULFILLMENT OF  
THE REQUIREMENTS FOR THE DEGREE OF  
ENTER DEGREE NAME  
IN  
ENGINEERING

UNIVERSITY OF NORTHERN BRITISH COLUMBIA

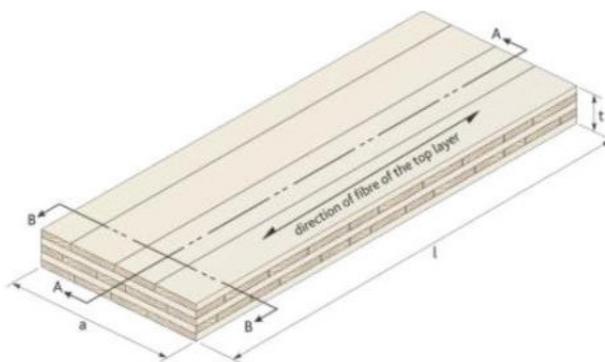
Figure 2.1. CLT panel configuration [3]

Engineered mass-timber products have been developed to address the challenges of traditional lumber products, such as limited size, low fire resistance, and low dimensional stability [8]. In the 1990s, CLT was introduced in Austria and Germany. As shown in Figure 2.1, CLT commonly consists of an odd number of layers (lamellas) orthogonally glued and pressed together [12]. The panel dimensions can be produced up to 19.5 m in length, 3 m in width, and 400 mm in thickness [7]. In addition to advantageous thermal, acoustic, and fire-resistant characteristics, CLT structures can be quickly erected, leading to a rapid construction process [13] [8]. Moreover, CLT provides high level of prefabrication during the manufacturing process [14]. Owing to its high in-and out-of-plane strength, stiffness, and in-plane dimensional stability, CLT has found its place in construction of roofs, floors, and shear walls [15]. The amount of plastic deformation a material can tolerate before reaching failure is called ductility. CLT shear walls, however, behave as rigid bodies and do not exhibit any ductility: therefore, in CLT buildings, connections are responsible for providing ductility [16].

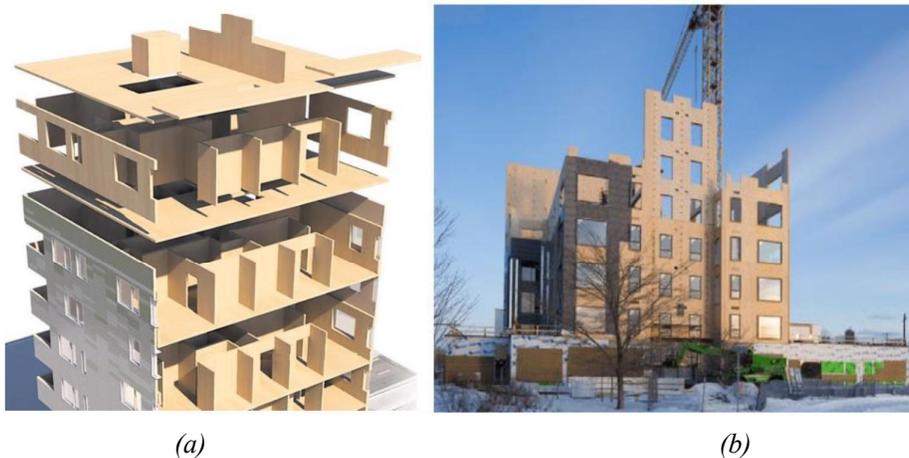
Figure 2.2. CLT construction: a) platform-type b) balloon-type [10]

There are two CLT building construction methods [3]: i) balloon-type buildings, where CLT walls span over multiple stories; and ii) platform-type buildings, where the floor of each level is the base for the next, see Figure 2.2.

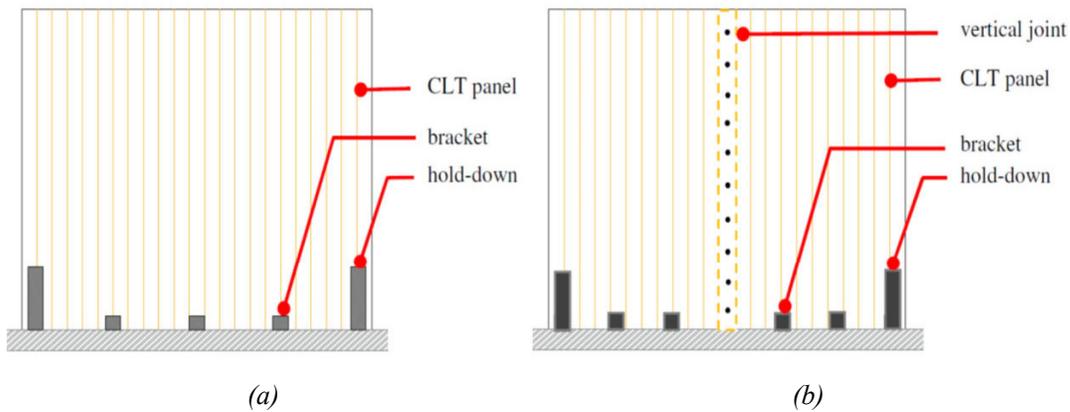
Figure 2.3. CLT shear wall: a) single panel and b) coupled panel [19]

According to the number of attached panels in each shear wall, they are categorized as single wall (SW) and coupled CLT shear walls (CP), see Figure 2.3. To enhance the lateral stiffness and promote a monolithic behavior (referred to as SW behavior), relatively rigid vertical joints with high yield strength are employed. However, in cases where greater wall ductility is desired, vertical joints are designed to yield and effectively dissipate energy, exhibiting what is known as coupled panel behavior (CP behavior).

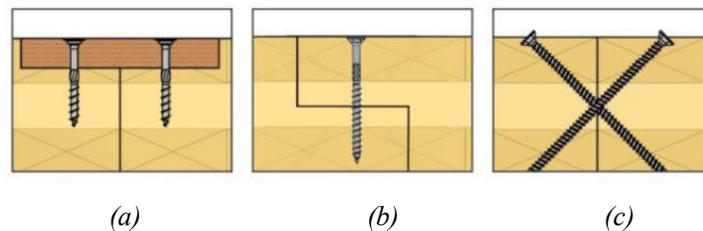
Figure 2.4. Panel-to-panel connections a) spline; b) half-lap, and c) butt joint [20]

or floor-to-floor connection, wall-to-foundation connection, and wall-to-floor connection are the three types of connections in CLT shear walls. Half-lap joint, spline joint, and butt joints are typical panel-to-panel connection; see Figure 2.4. Splines made of plywood or LVL can be put into the CLT panels on one or both sides or placed on their surface in conjunction with nails or screws. Commonly, STS or nails are the preferred fastener when CLT panels are coupled.

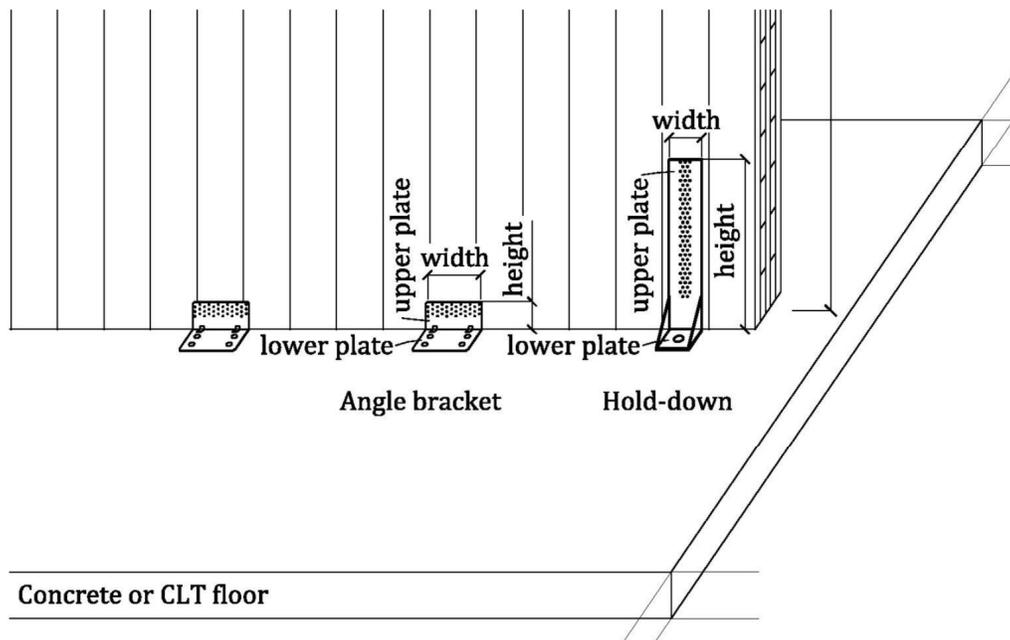
Figure 2.5 HD and SB connected to a concrete floor [29]

SB and HD are used to link CLT shear walls to the foundation, the concrete podium, or the CLT slab below, using metal fasteners [19], as shown in Figure 2.5. At the corners of CLT shear walls, L-shaped steel anchors have been employed as HD to resist uplifting. Nails are used to fasten the vertical legs to the walls, while anchorage bolts secure the horizontal leg to the foundation. SB are used to attach walls and floors; their primary function, according to Pozza et al. [25], is to handle shear forces, even if some SB can support both horizontal and vertical loads [13]. Shen et al. [26] conducted experimental tests and numerical studies on seven types of bracket connections regarding the tension and shear forces. They compared five analysis methods for the determination of yield points of CLT connections and concluded that based on the bilinear approach Yasumura & Kawai method improved results compared to ASTM E2126 [27] and EN12512 [28].

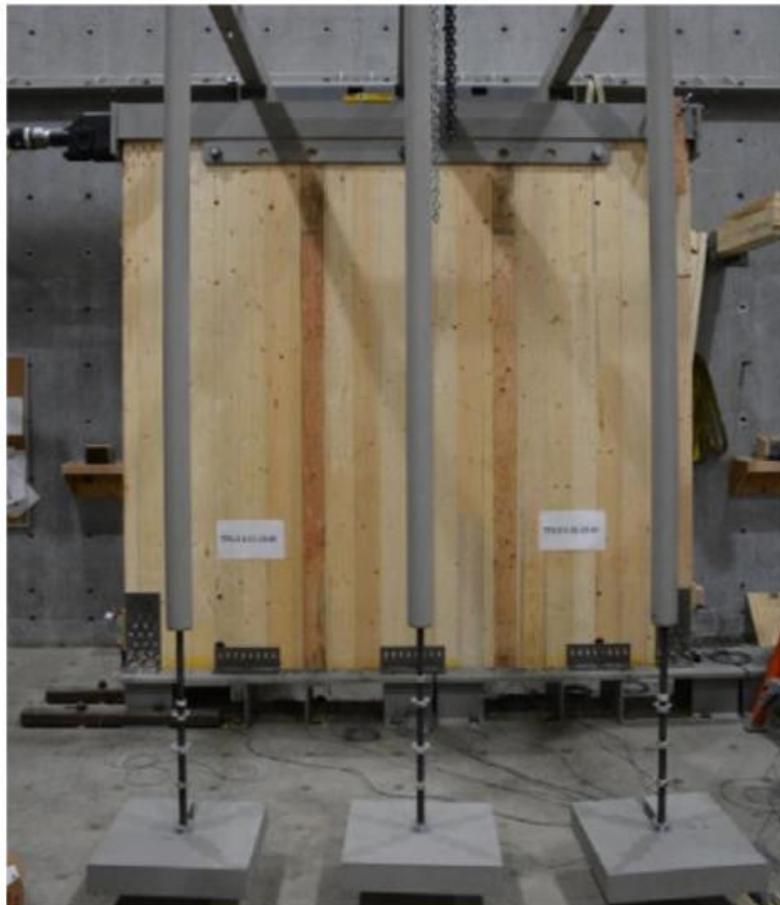
*Figure 2.6. Test setup (coupled two-panel shear wall) [37]*

The behavior of CLT shear walls with STS connections was investigated at the UNBC Wood Innovation and Research Laboratory in Prince George [37], as illustrated in Figure 2.6. A total of 26 one-storey shear walls were tested under monotonic push-over and reverse cyclic loading. Shear walls consisted of 5-ply grade VJ-1 panels with two aspect ratios (2:1 and 3:1) and different configurations (single-panel couple-panel and triple-panel) were tested. D-Fir plywood splines were used for panel-to-panel connection, attached with partially threaded  $\varnothing 8 \times 100$  mm STSs. Two HD were used in all

configurations, these were attached to the outer edge of the shear wall. One shear bracket (SB) was installed in the middle of each panel. D-Fir plywood splines, 3000 mm x 140 mm x 25 mm, were flush mounted in rabbets. The number of screws that attached the spline to the panel in the different layouts were 11, 13, 16 or 19 per panel edge side. All HD and SB were connected with ASSY Kombi LT fully threaded STSs  $\varnothing 12 \times 120$  mm. Throughout all tests, a dead load of 10 kN/m was applied to the shear walls; the monotonic pushover tests were carried out at a loading rate of 15 mm/min until the wall resistance fell below 80% of the applied maximum force  $F_{\max}$ . Following the condensed CUREE loading history [27], the reversed cyclic tests had a target displacement of 65% of the displacement attained in the monotonic tests when the load fell to 80%  $F_{\max}$ .

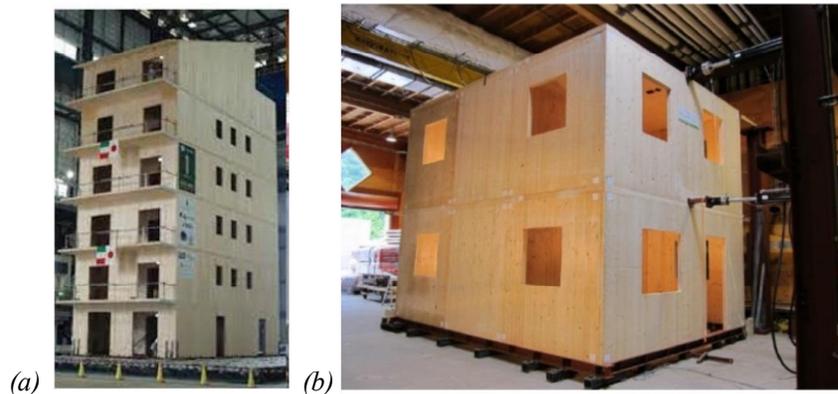
*Figure 2.7 CLT structure tests: a) SOFIE project [38]; (b) FPInnovations [39]*

Ceccotti et al. conducted the most extensive research, named SOFIE, on CLT buildings regarding their seismic behavior, fire, and durability. Three full-scale structures (one-storey, three-storey, and seven-storey), as illustrated in Figure 2.7a, were subjected to earthquakes using a 3D shake table. The findings showed that CLT panels behave as rigid bodies while connections dissipate energy. Moreover, the pattern, type, and number of the connectors significantly affected the behavior of CLT shear walls. [38]

At FPInnovations, Popovski and Gavric [39] performed monotonic and cyclic tests on a two-storey CLT structure to study the behavior of the structure, see Figure 2.7b. The finding showed that the type and number of fasteners and panel aspect ratio affect the displacement behavior of shear walls. The primary goal of the test was to study the 3-D

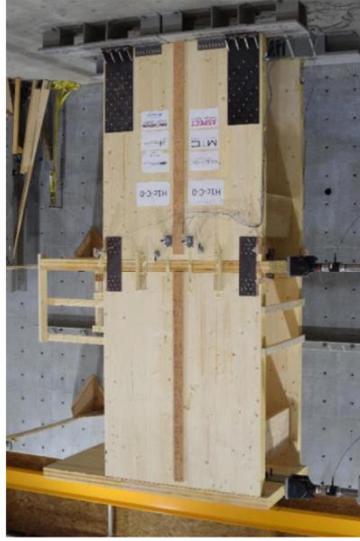
Figure 3.1. Two-storey CLT structure

The structures were 1.5 m x 2.0 m in plan and 5.3 m tall. The shear walls were 2.5 m tall, and the first and second storey slab thicknesses were 0.139 m. A representative photo is shown in Figure 3.1, the plan and elevations of the structure are shown in Figure 3.2.

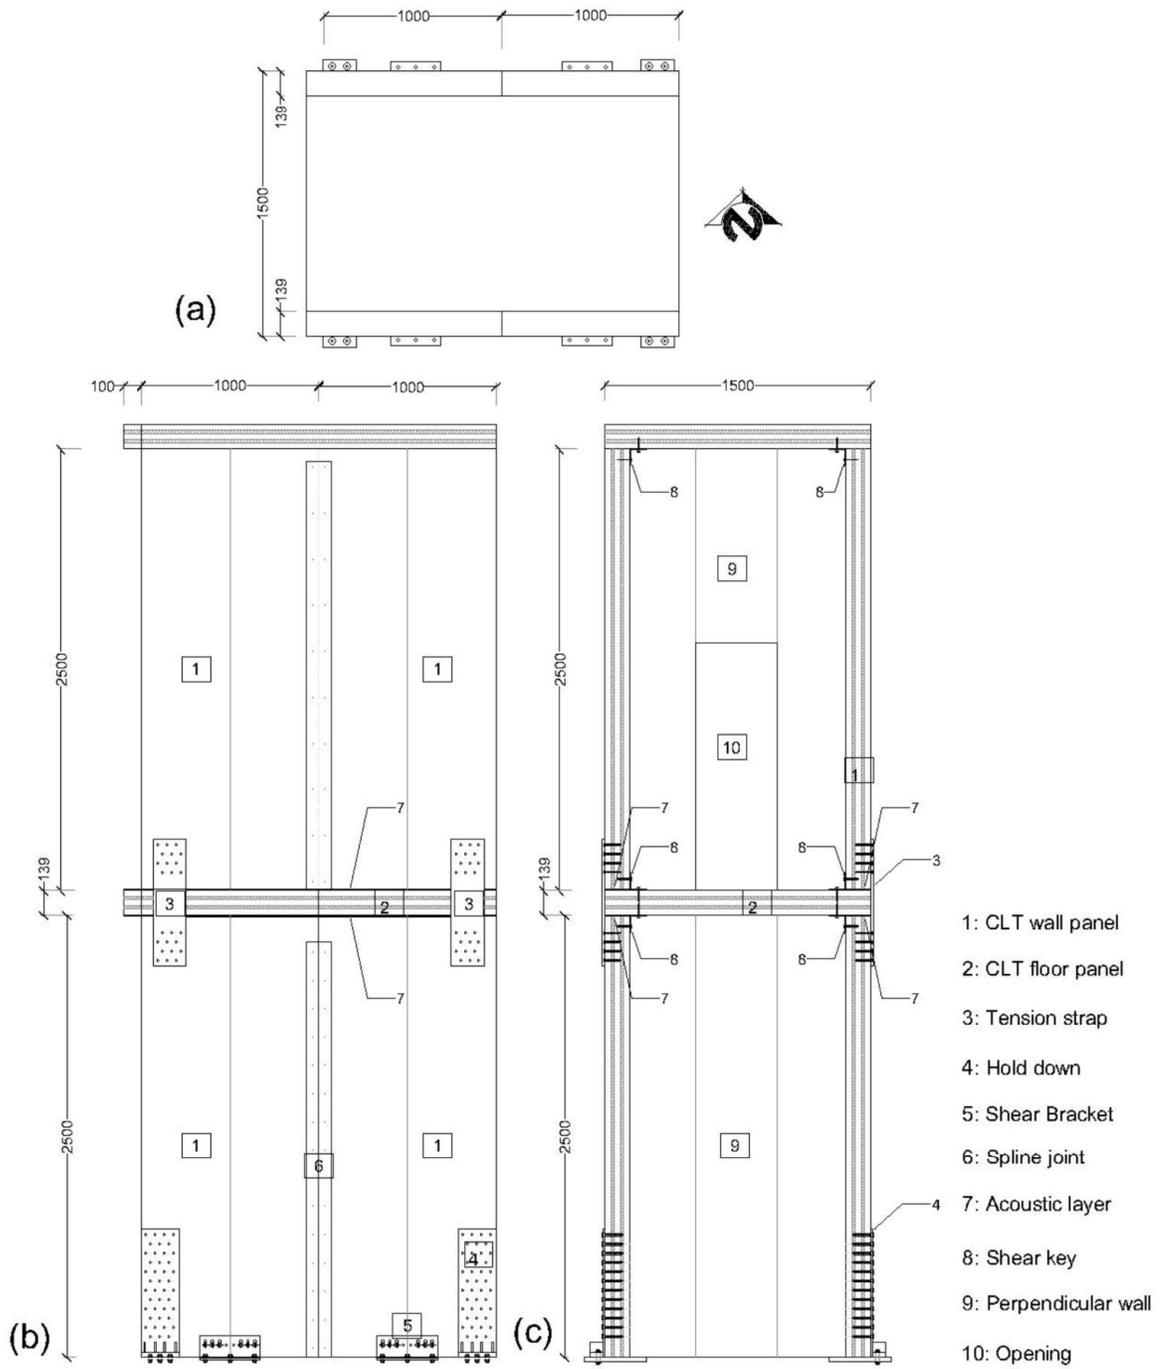
Figure 3.2. Two-storey CLT structure a) plan, b) front view, c) side view

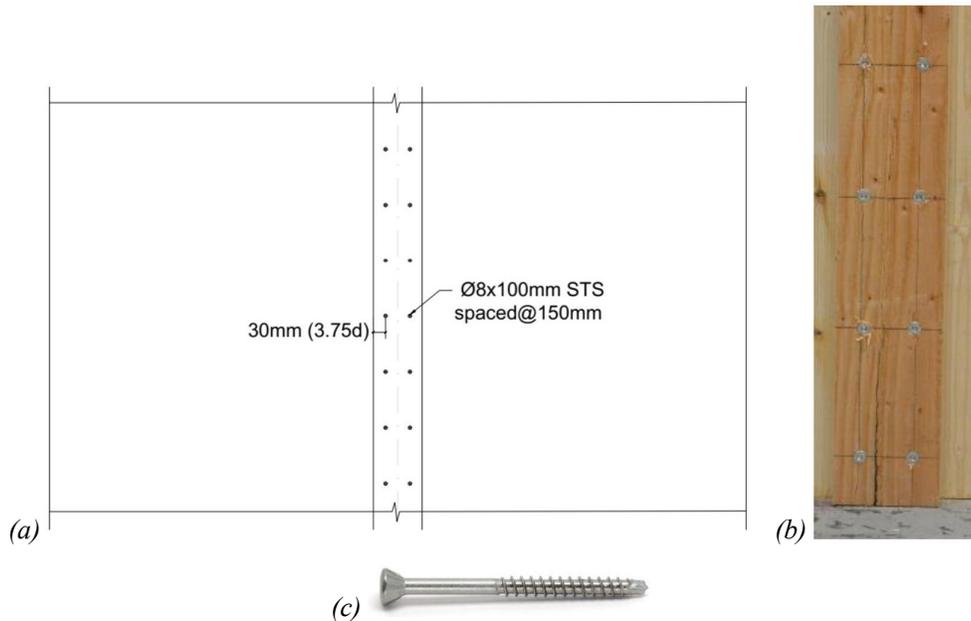
Figure 3.3. Spline joint in CLT shear walls a) sketch, b) photo, c) ASSY ECO screw

The panel-to-panel vertical connections were surface mounted 25 mm × 140 mm × 2500 mm D-Fir plywood splines attached to the panel with partially threaded  $\varnothing 8 \times 100$  mm STSs as shown in Figure 3.3 [20]; the edge distance of the screws and the spacing between the screws were 30 mm and 150 mm, respectively. The splines were attached to the panels with 16 and 11 STSs in the first and 2<sup>nd</sup> floor, respectively, per panel edge side (total per spline 22 and 32, respectively).

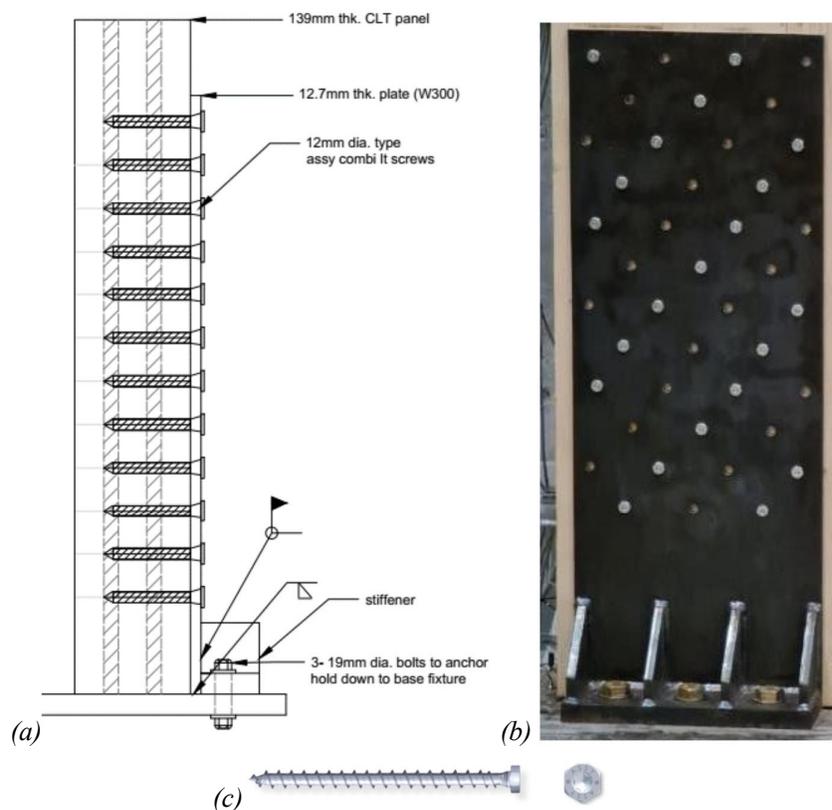
Figure 3.4. HD: a) side view, b) photo c) ASSY Kombi LT STS [3]

HD were made of custom steel plates of grade 44W/300W. The HD were 212 mm wide, 719 mm high, with a 70 mm long base plate, thickness equal to 12.7 mm (vertical part) and 25 mm (base plate). 42  $\varnothing$  13 mm holes were prepared in the vertical part for installing STSs while 21 fully-threaded STSs  $\varnothing$  12  $\times$  120 mm [20] were installed; the base plate had 3  $\varnothing$  19 mm holes for installing bolts to the foundation, see Figure 3.4.

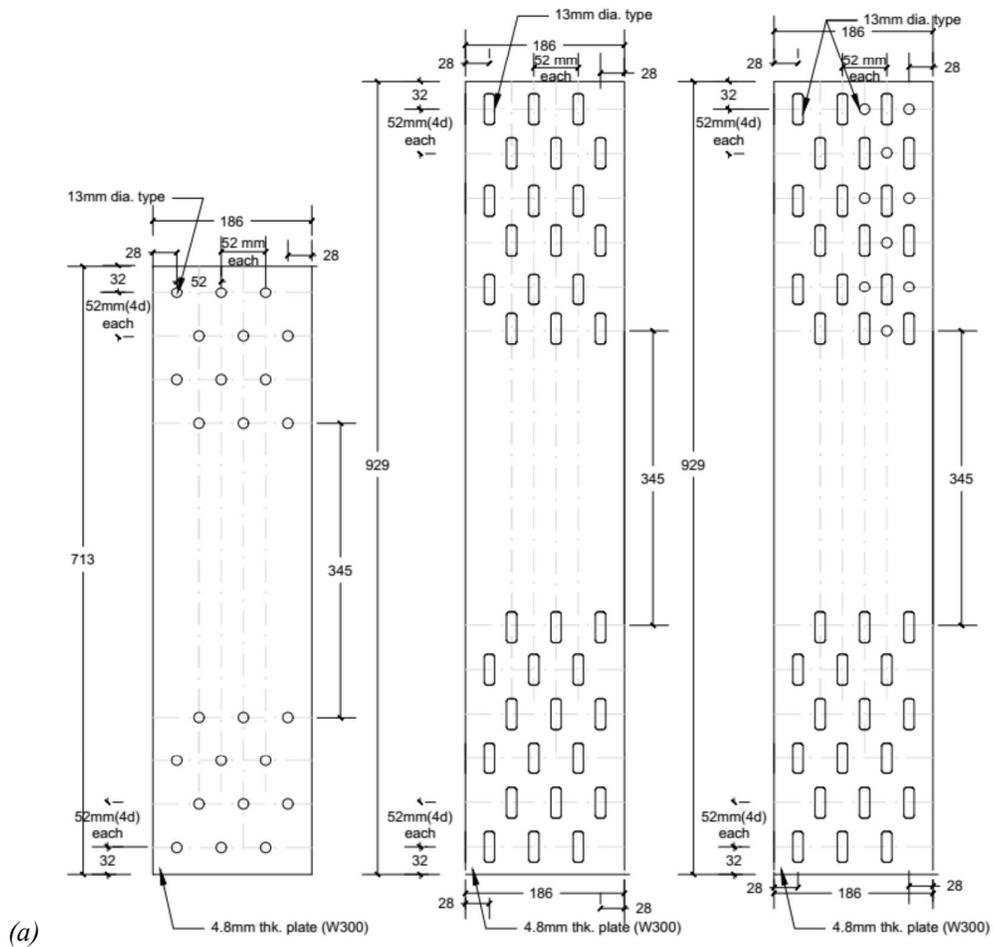
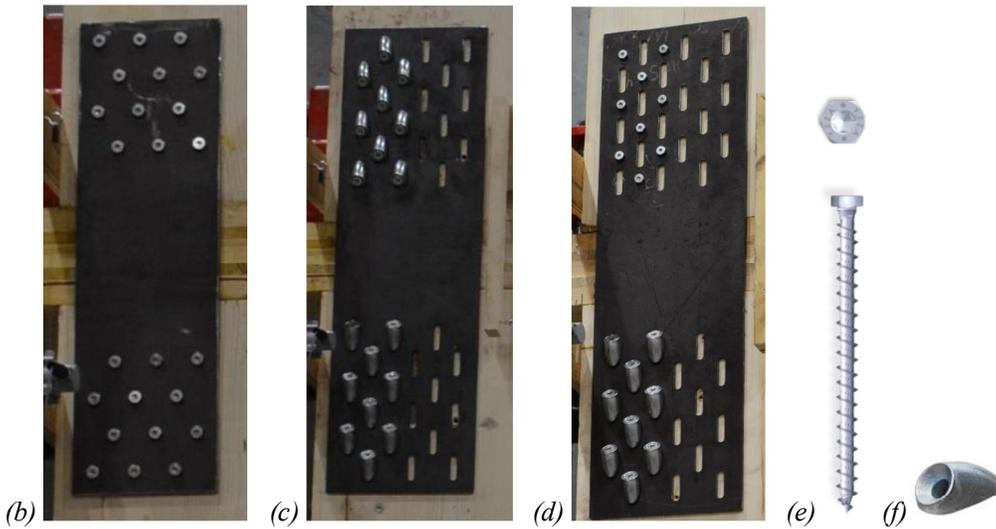
Figure 3.5. Tension strap: a) sketch; b) photo type 1, c) photo type 2; d) photo type 3, e) ASSY Kombi LT STS used in tension strap, f) 45° washer [3]

Tension straps vertically connected the shear walls over the two stories; these were made of custom steel plates of grade 44W/300W. The tension straps were 186 mm wide, 713 mm or 929 mm high, thickness equal to 4.8 mm.

According to the literature in CLT connections the most ductility was observed in STS inclination angle of  $90^\circ$  compared to inclined STS with  $45^\circ$ . [22] In order to observe the effect of ductility two inclination angles of  $45^\circ$  and  $90^\circ$  for fasteners in tension strap were tested. One type for installing all screws at  $90^\circ$  angle had a total of 24  $\varnothing 13$  mm holes; in these 8, 9 or 12  $\varnothing 12$  mm  $\times$  120 mm fully-threaded ASSY Kombi LT STSs [20] were installed at each end (Figure 3.5 a, b). The second type for installing all screws at  $45^\circ$  had a total of 36  $\varnothing 13$  mm slots where 9  $\varnothing 12 \times 160$  mm ASSY VG STSs [20] were installed at each combined with  $45^\circ$  washers (Figure 3.5c). A third type consisted of a combination of both inclination angles, where a total of 36  $\varnothing 13$  mm slots and 9  $\varnothing 13$  mm holes were prepared and 9  $\varnothing 12 \times 160$  mm ASSY VG STSs [3] with the angle of  $45^\circ$  were installed in the bottom of tension strap while 9  $\varnothing 12 \times 120$  mm ASSY Kombi LT STSs with  $90^\circ$  angle were on the top of tension strap (Figure 3.5d).

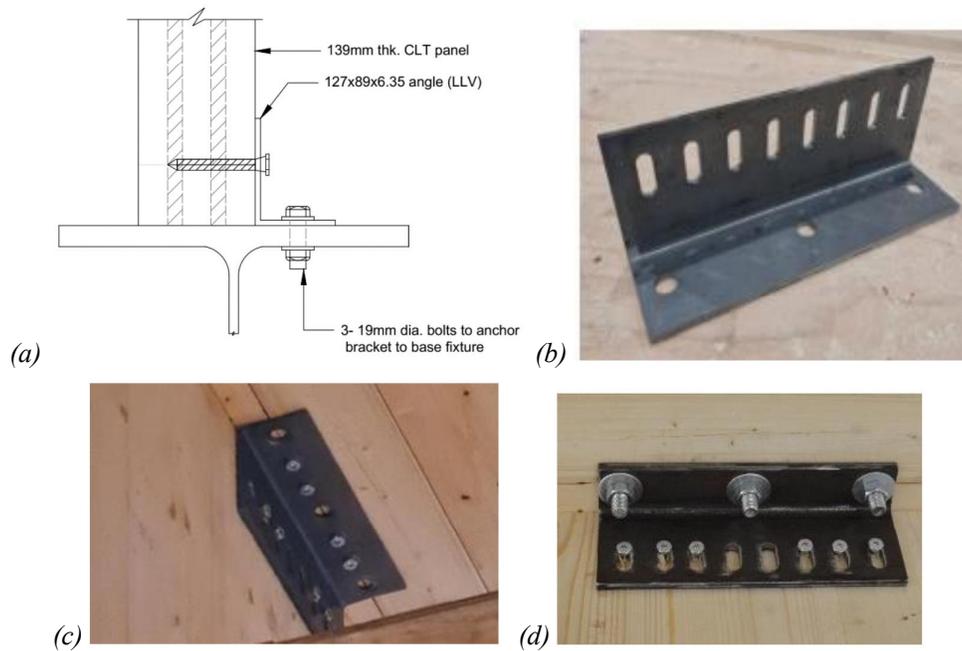
Figure 3.6. Custom SB: a) side view; b) photo; c) type 1, attached by STSs on both sides; d) type 2, attached by bolts and STSs

SB were made of custom steel plates of grade 44W/300W. The SB was 340 mm wide with a length of the vertical and horizontal plate equal to 127 mm and 89 mm, respectively, and a constant thickness of 6.35 mm.

It had 8 vertical slots, 11 mm wide for installing the STSs to eliminate any uplift resistance so that only shear is resisted. ASSY Kombi LT screw  $\varnothing 12 \times 120$  mm was used as fastener for SB, see Figure 3.6 a and b. Two types of connectors were used in the SB, either 3 STSs were used in each sides of the SB as shown in Figure 3.6 c and d; or the SB was attached by 4, 6 or 8 STSs on the vertical leg while, while 3 bolts were installed on the horizontal leg (Figure 3.6d).

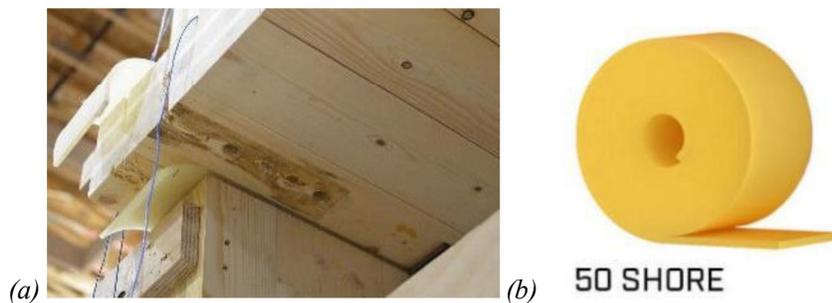
Figure 3.7. Acoustic separation layer Xylofon type 50 SHORE: a) photo; b) sketch[61]

The material that was used as an acoustic separation layer was Xylofon [61]. It is a high-performance resilient profile that is designed to reduce flanking sound transmission in platform CLT building. Made of a polyurethane compound, it is available in from 35 to 90 shore (hardness measurement scale used for the Xylofon material) depending on the bearing load. In this study 50 shore was selected. The width of the layer is 140 mm with the thickness of 6 mm, see Figure 3.7.

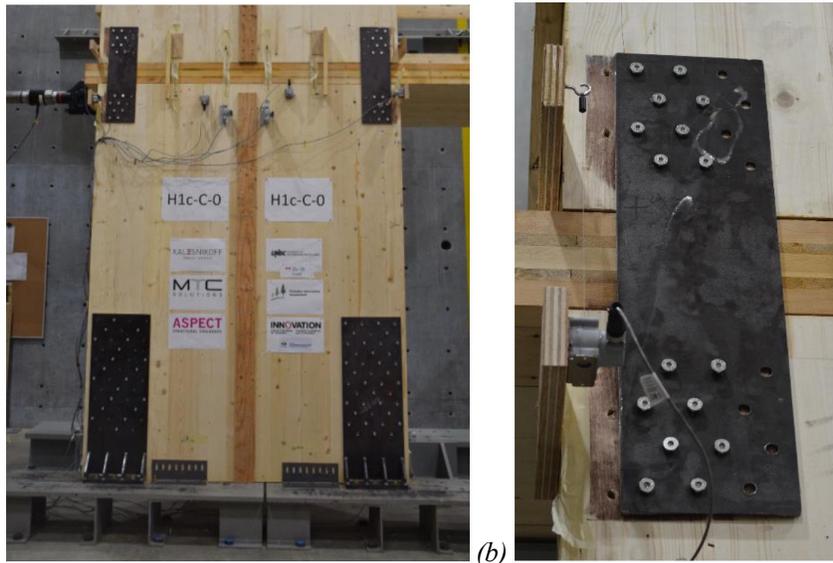
Figure 3.8. Structure #1c: a) full view, b) TS with perp. screws

**In structure #1** three tests were conducted on this structure: **#H1a** and **#H1b** were subjected to monotonic loading and **#H1c** reversed cyclic loading. the top SBs of the first level floor had 3 bolts + 6 STSs, while bottom and top SBs of the 2<sup>nd</sup> level floor had 3 bolts + 4 STSs. Notably, in the structures **#H1a** and **#H1b** there were no SBs on the top of the 2<sup>nd</sup> level, and the floor panel was attached to the underlying shear walls using STSs applied perpendicular to the roof panel. Tension straps were attached with 8 STSs installed at 90° (Figure 3.8b). No additional dead load was applied.

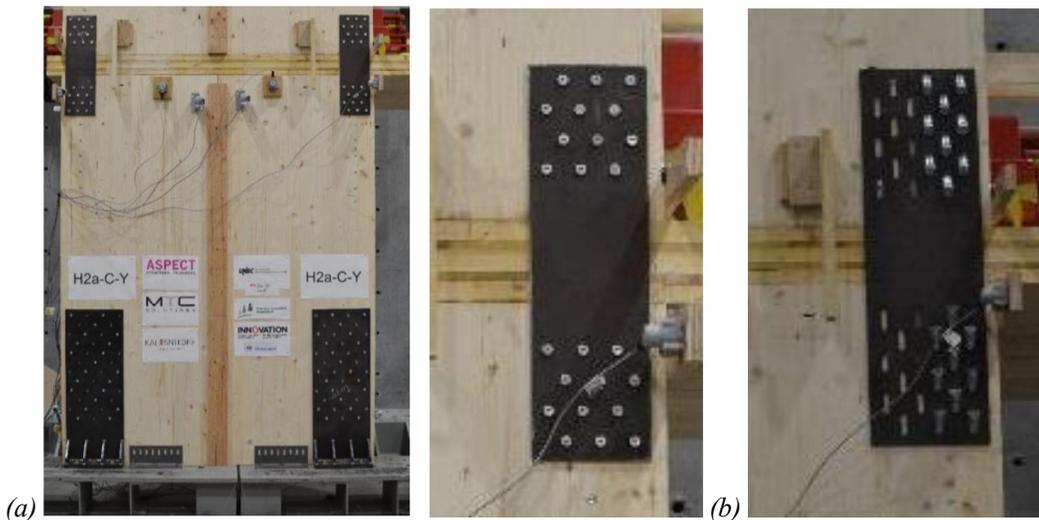
*Figure 3.9. Structure #2: a) test H2a with perp. screws; b) test H2b with 45° inclined screws*

**In structure #2**, the top SB of the first storey had 3 bolts + 6 STSs, the bottom SB of the 2<sup>nd</sup> storey had 3 bolts + 4 STSs, while the 2<sup>nd</sup> level floor SB had 3 bolts + 8 STSs. A dead load of 2 tons was applied to each floor, and both tests were conducted under reversed cyclic loading tests. Two tension strap STS installation angles were compared: **#H2a** 12  $\phi$  12 mm x 120 mm STSs were installed at 90° (Figure 3.9a); and **#H2b** 9  $\phi$  12 mm x 160 mm STSs were installed at 45° as shown in Figure 3.9b.

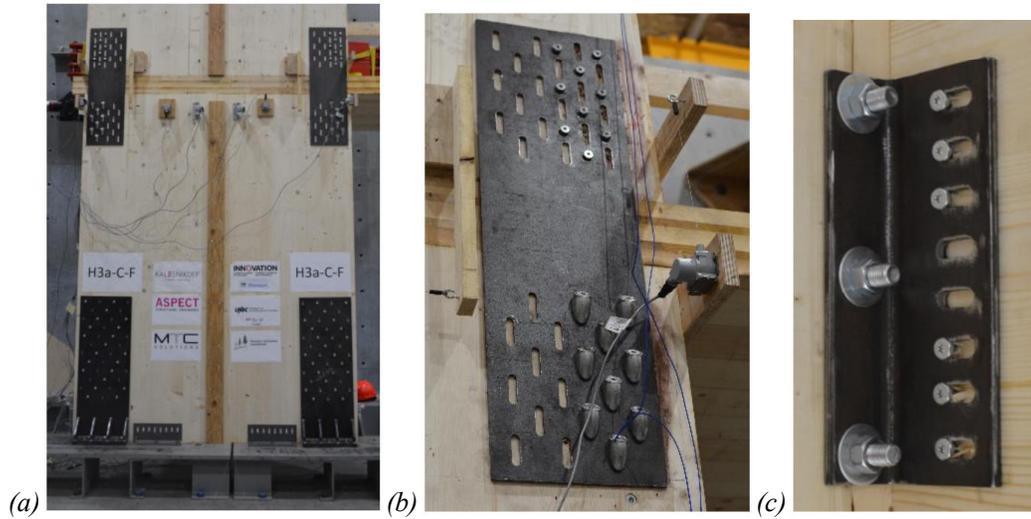
Figure 3.10. Structure #3a: a) full view, b) tension strap with perp. and 45° inclined screws; c) SB with bolts and STSs

**In structure #3**, the tension straps were connected by 9  $\phi$  12 mm x 160 mm STSs installed at 45° on the lower level, while it had 9  $\phi$  12 mm x 120 mm STS installed at 90° on the upper shear wall, as shown in Figure 3.10b. The bottom SB of the 2<sup>nd</sup> storey had 3 bolts + 6 STSs; the 2<sup>nd</sup> level floor SB had 3 bolts + 8 STSs. A dead load of 2 tons was applied to each floor, and both tests were conducted under reversed cyclic loading tests. The effect of different shear connections between floors was investigated: **#H3a** had 3 bolts + 6 STSs in the top SB of the first storey as shown in Figure 3.10c; and **#H3b** had 6 STSs on each side of the SB, see Figure 3.11c.

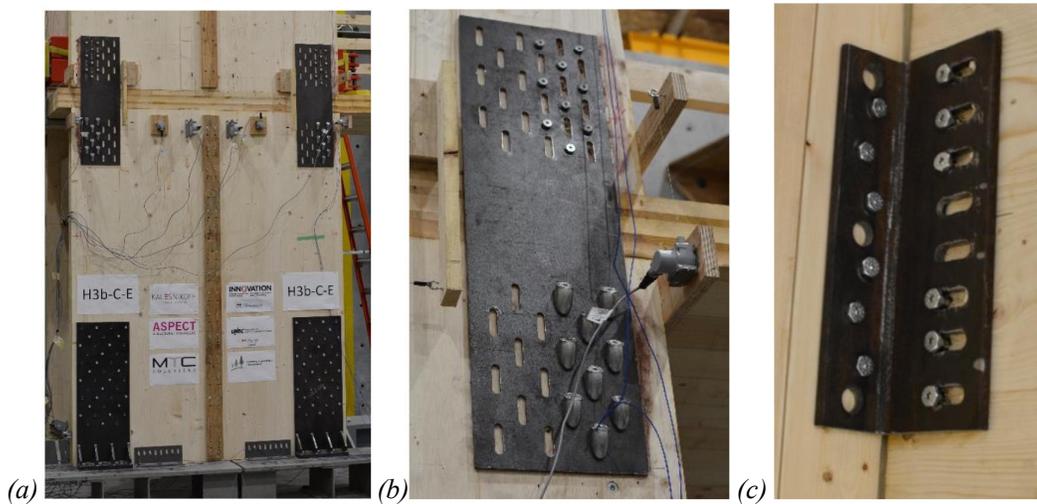
Figure 3.11. Structure #3b: a) full view, b) tension strap with perp. and 45° inclined screws; c) SB with STS on both legs

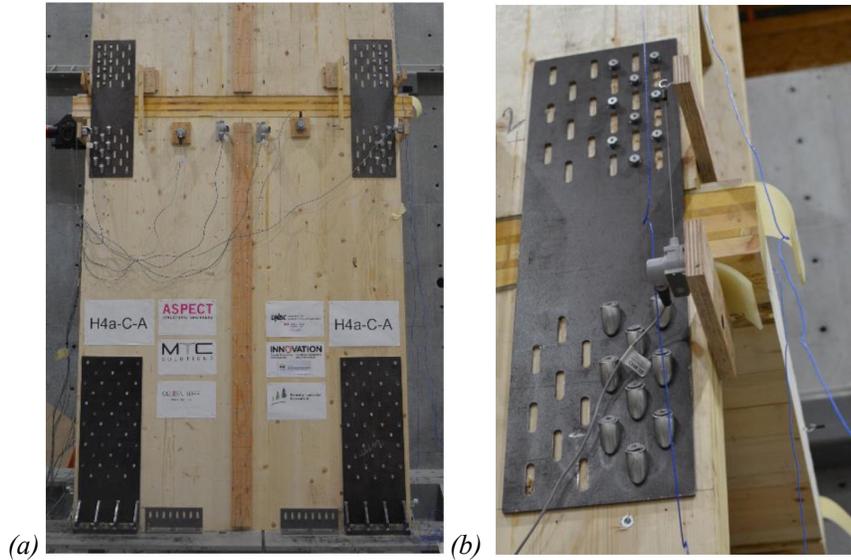
Figure 3.12. Structure #4a: a) full view, b) test H4a with acoustic layer

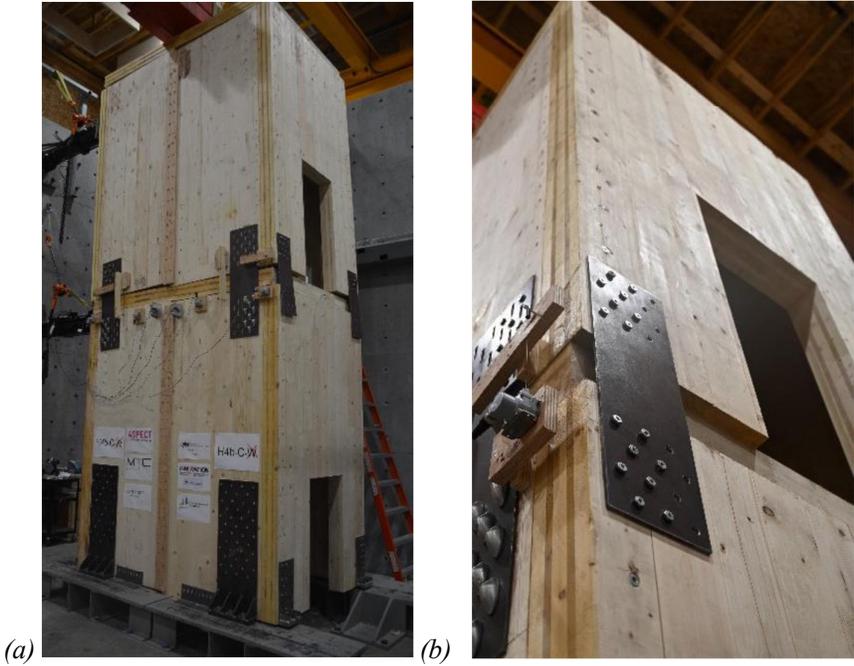
Figure 3.13. Structure #4b: a) full view; b) test H4b perpendicular shear walls

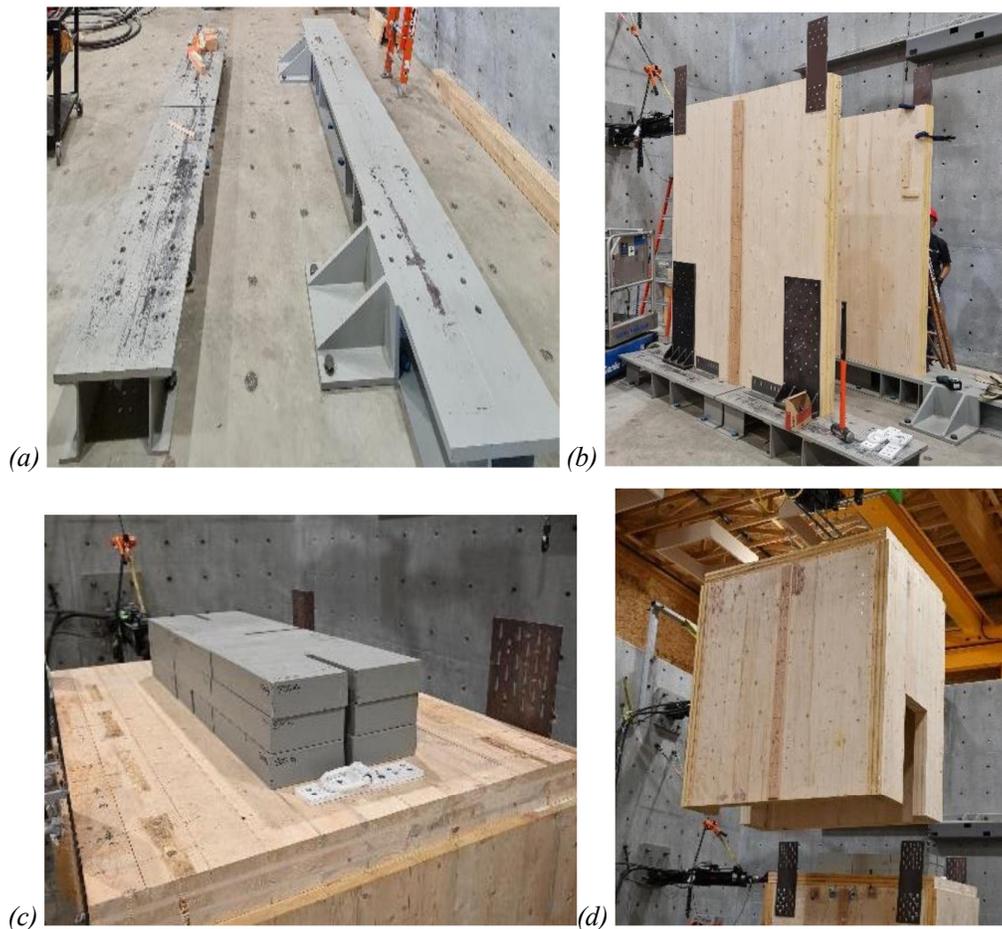
*Figure 3.14. Assembly of structure: a) steel base fixture, b) installation of walls on base, c) installing 1<sup>st</sup> level floor panel and weights, d) adding pre-assembled 2<sup>nd</sup> storey*

The structures were constructed on a steel base fixture that was bolted down to a reaction floor (Figure 3.14a) by using a crane CLT walls were lifted and put on the base fixture (Figure 3.14b). The CLT panels were connected to the base fixture using SB and HD.

The structures were built in a platform style that means first storey ceiling panels were the base for the 2<sup>nd</sup> storey walls. To simulate the dead loads, additional masses of 2 ton on each floor slab were applied on the floor, (Figure 3.14c) and finally the pre-assembled

2<sup>nd</sup> storey consisted of walls and 2<sup>nd</sup> level floor panel rests on the top of the first storey panel as shown in Figure 3.14d. In the first structure tests no additional weight was applied while weights of 2 tons on each floor slab were applied in the other tests.

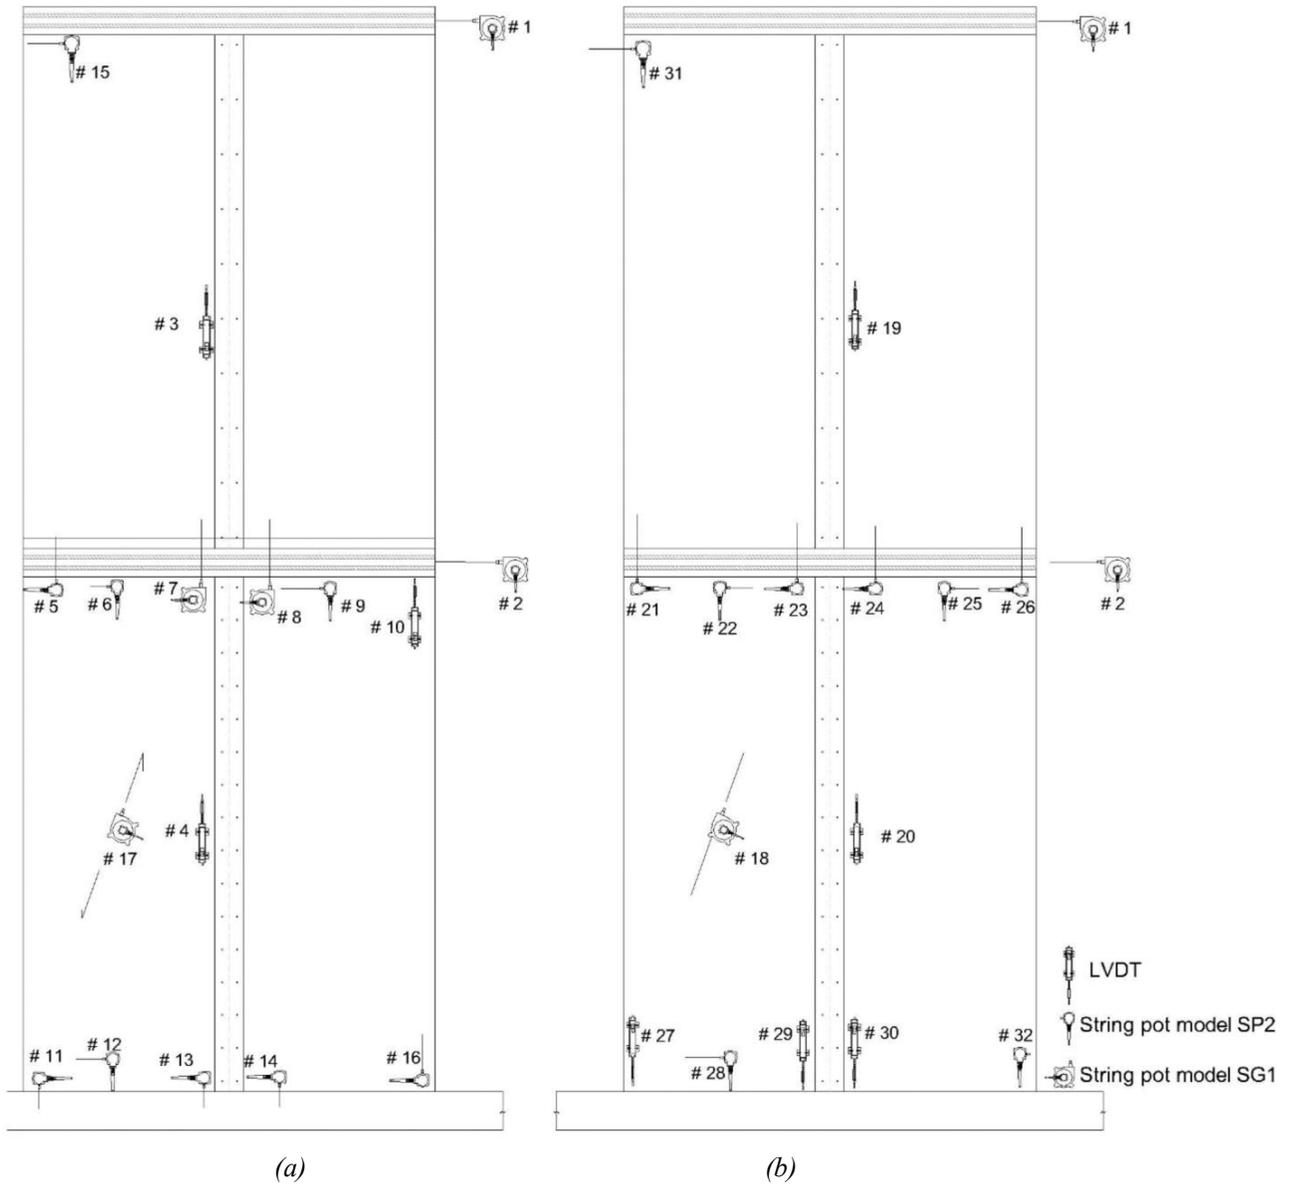
Figure 3.15. The location of sensors: a) south face b) north face

Three types of measurement instruments were used in the tests: two types of string pots, and one type of a Linear Variable Differential Transducer (LVDT). Half of the sensors were installed on the North side and half of them on the South side shear walls. The sensor locations are illustrated in Figure 3.15 and selected sensors are shown in Figure 3.16.

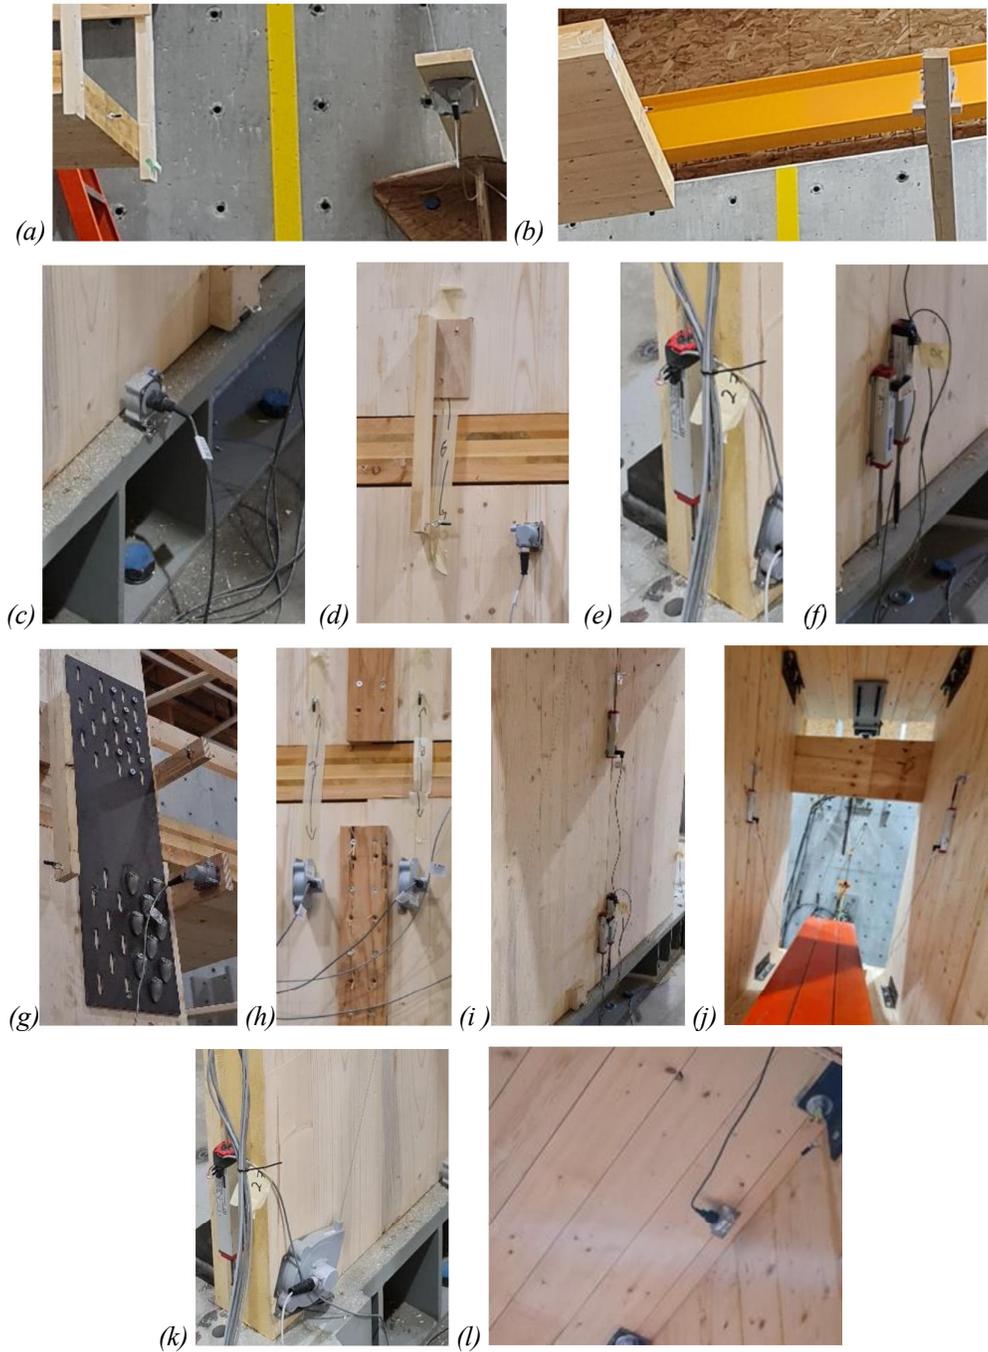
Figure 3.16. Sensors: a) 1<sup>st</sup> storey displacement free end, b) 2<sup>nd</sup> storey displacement free end, c) 1<sup>st</sup> storey sliding, d) 2<sup>nd</sup> storey sliding, e) HD uplift, f) 1<sup>st</sup> storey inner corner uplift, g) tension strap uplift, h) 2<sup>nd</sup> storey inner corner uplift, i) 1<sup>st</sup> storey panel-panel slip, j) 2<sup>nd</sup> storey panel-panel slip, (k) panel distortion, (l) 2<sup>nd</sup> floor sliding

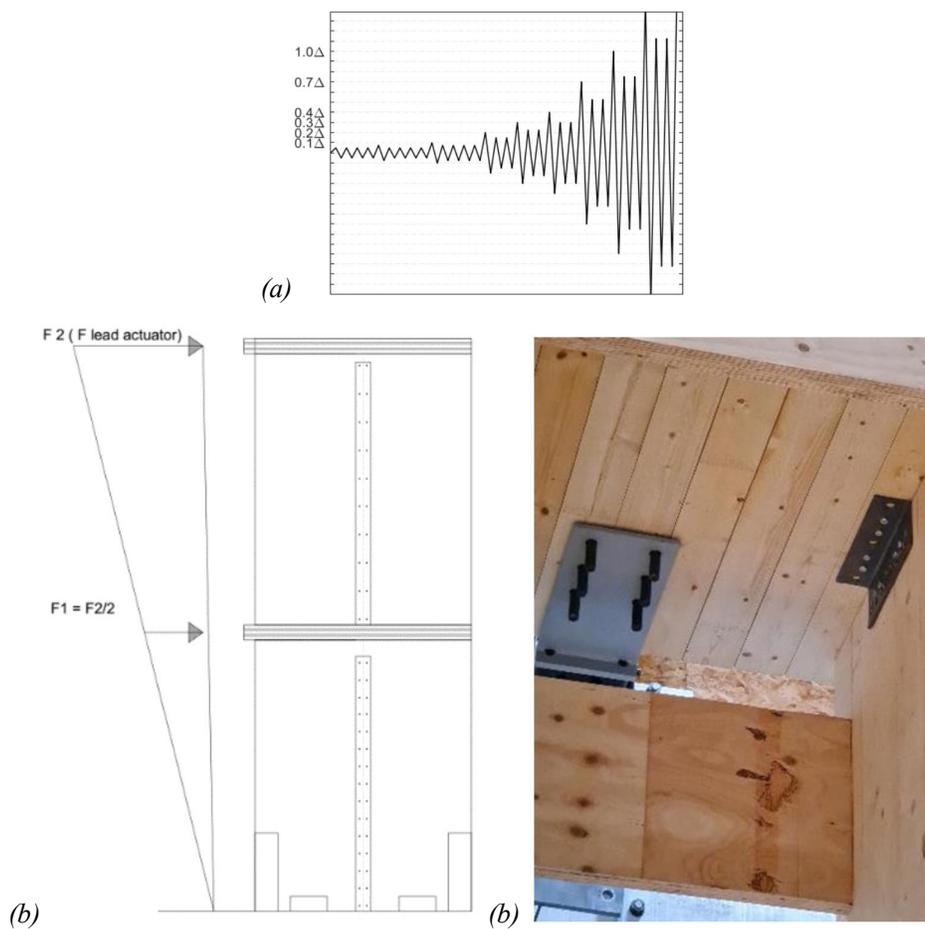
Figure 3.17. Load application (a) protocol, (b) schematic, (c) photo of fixture

Two monotonic tests, one pulling and one pushing, were conducted because the symmetrical configuration enabled the execution of two tests with minimal connection repairs required in between, in addition, the second test was done to assess if there is any asymmetrical response between pull and push loads. The monotonic pushover tests were conducted at a rate of loading of 15 mm/min until reaching the target displacement of 3% (150 mm) inter storey drift (ISD). The reversed cyclic tests followed the Consortium of Universities for Research in Earthquake Engineering (CUREE) loading history [62] as illustrated in Figure 3.17a, with a 100% target displacement of 150 mm, and continued with further cycles of 130%, and 160% of target displacement.

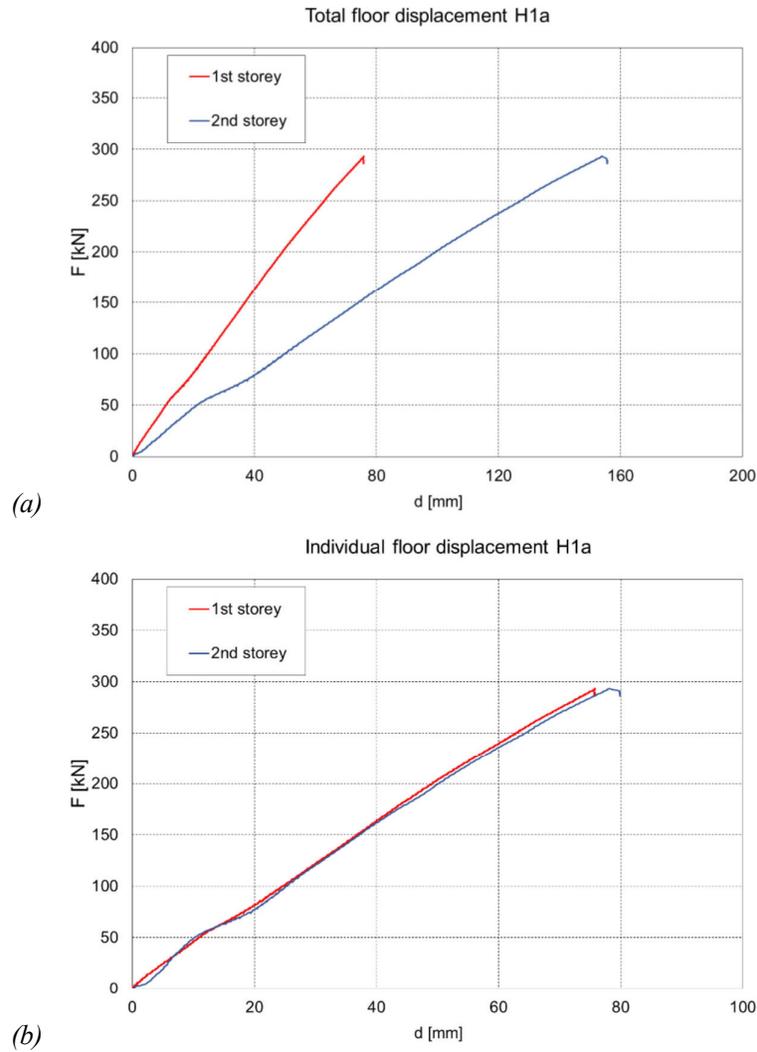
Figure 3.18. H1a (a) total storey displacements, (b) individual storey displacements

The horizontal storey displacements are depicted in Figure 3.18. In this test, the structure was subjected to a displacement of -157 mm (pulling forces) before the test was stopped. The load-displacement graph displayed a nearly linear relationship up to a 20 mm displacement, characterized by a steeper slope. Beyond this point, the slope decreased, indicating a failure in the structure connections and the graph continued to rise until reaching the -100% target displacement, with the total load  $F_{@-100\%}$  reaching 283 kN. Given that the objective was not to induce a total structural failure of the structure, the displacement was not extended beyond this limit. Importantly, it is worth noting that the capacity of the structure did not exhibit any discernible decrease.

At -100% target displacement, the lateral displacements of the 1<sup>st</sup> and 2<sup>nd</sup> stories were both 75 mm, and the graphs for these displacements were almost identical. Since there were no intention for general failure of the structure, it was not pulled more than this, it did not show any capacity decrease though.
