**EXPERIMENTAL INVESTIGATION ON THE STRUCTURAL PERFORMANCE  
OF TWO-STOREY CROSS-LAMINATED TIMBER SHEAR WALLS**

**Sedigheh Gheisari**

THESIS SUBMITTED IN PARTIAL FULFILLMENT OF  
THE REQUIREMENTS FOR THE DEGREE OF  
ENTER DEGREE NAME  
IN  
ENGINEERING

UNIVERSITY OF NORTHERN BRITISH COLUMBIA

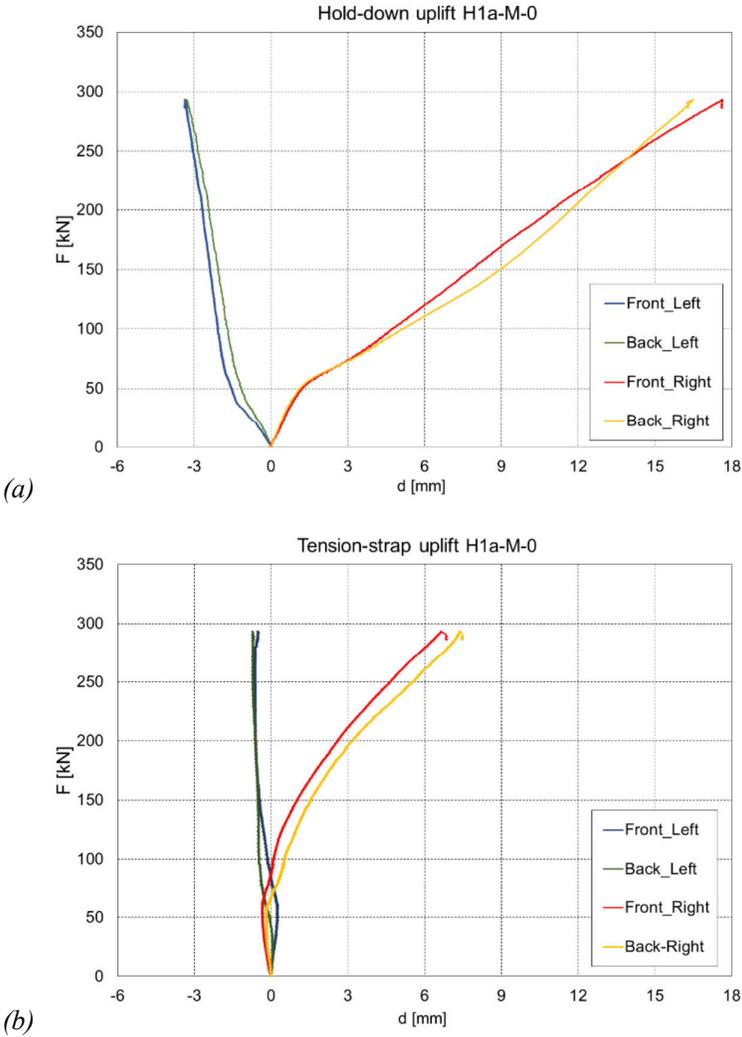
Figure 3.19. H1a uplift at: (a) hold downs (b) tension straps

The vertical uplift experienced in the four HD and tension straps (two on the front and back shear walls each) are illustrated in Figure 3.19. The graph of the load-displacement curves was bi-linear. This structure was subjected to a pulling force, causing the right-side HD to undergo tension as shown in Figure 3.19a. The load increased steadily until reaching 60 kN, resulting in a 1.2 mm uplift in the HD. However, after this point, there was a significant decrease in stiffness, followed by a gradual increase with a softer slope. The load continued to rise, reaching a  $F_{@-100\%}$  of 283 kN, accompanied by a 17 mm uplift.

On the left side, the HD acted predominantly in compression. The load increased to approximately 40 kN, causing a -1.2 mm uplift. Subsequently, the slope became steeper, indicating an increase in stiffness. The load continued to rise to its maximum level, accompanied by a -3.3 mm uplift (compression).

The graph depicting the uplift of the tension straps exhibits a bilinear pattern for each HD, as shown in Figure 3.19b. The force steadily increased with minimal uplift until reaching 60 kN. Beyond this point, on the right side of the shear wall, there was a notable

decrease in stiffness, indicating the initiation of structural failure. Subsequently, there was a gradual increase with a gentler slope, ultimately resulting in an uplift of 7 mm at the -100% target displacement. Conversely, the tension straps on the left side of the shear wall were subject to slight compression forces, resulting in negative uplifts of -0.7 mm at the +100% target displacement.

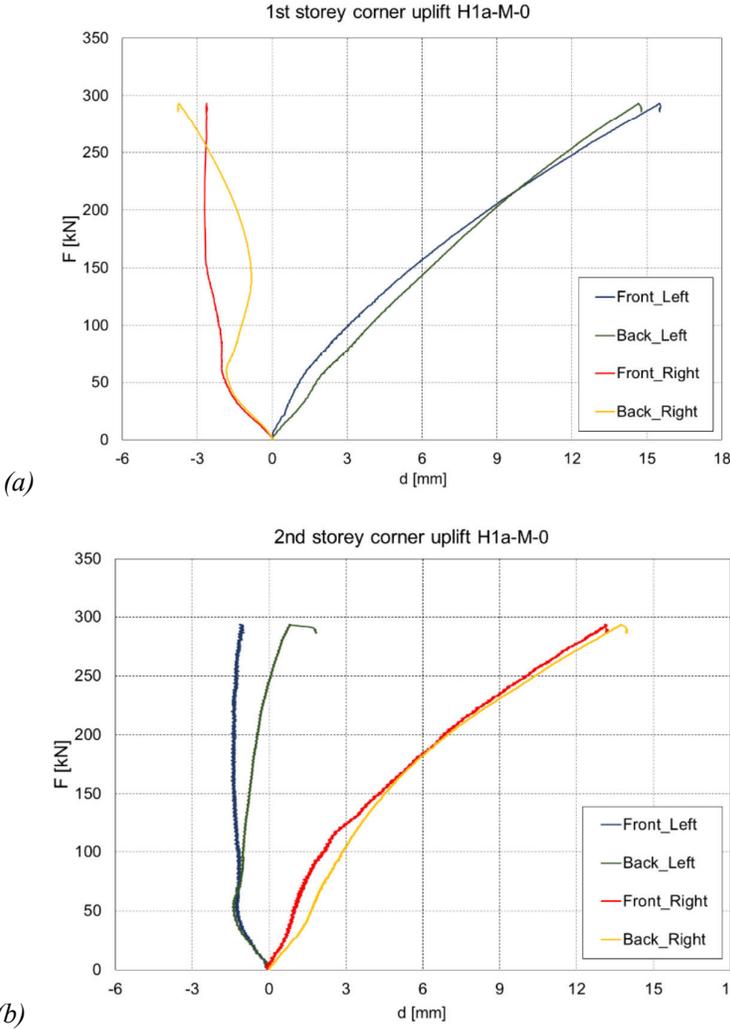
Figure 3.20. H1a inner corner uplifts at: (a) 1<sup>st</sup> storey, (b) 2<sup>nd</sup> storey

The vertical uplift experienced in the four inner corners of the coupled shear walls are illustrated in Figure 3.20.

The curve of the load-displacement was quasi-linear when the total load reached 60 kN and then with a softer slope culminated in  $F_{@-100\%}$  of 283 kN at -100% target displacement. The corresponding left side inner corner uplifts in the 1<sup>st</sup> storey shear wall (Figure 3.20a) were 14.5 mm and 15.5 mm mirroring the HD uplifts of the 1<sup>st</sup> storey. The negative uplifts correspond to compression in the panel corners. At the -100% target displacement, the uplifts on the right side of the shear wall were close to -3 mm.

The inner corner uplifts in the 2<sup>nd</sup> storey shear wall, depicted in Figure 3.20b, varied from -1 to 1 mm at the -100% target displacements in left-side panel corners and 13 mm and 14 mm in right corners. The displacements in the corners of the 1<sup>st</sup> and 2<sup>nd</sup> stories exhibit an interesting relationship where they are essentially mirror images of each other. When the corners on the 1<sup>st</sup> storey were subjected to compression, the corresponding corners on the 2<sup>nd</sup> storey underwent uplift, and conversely, when the 1<sup>st</sup> storey corners experienced uplift, the corresponding 2<sup>nd</sup> storey corners were subjected to compression.

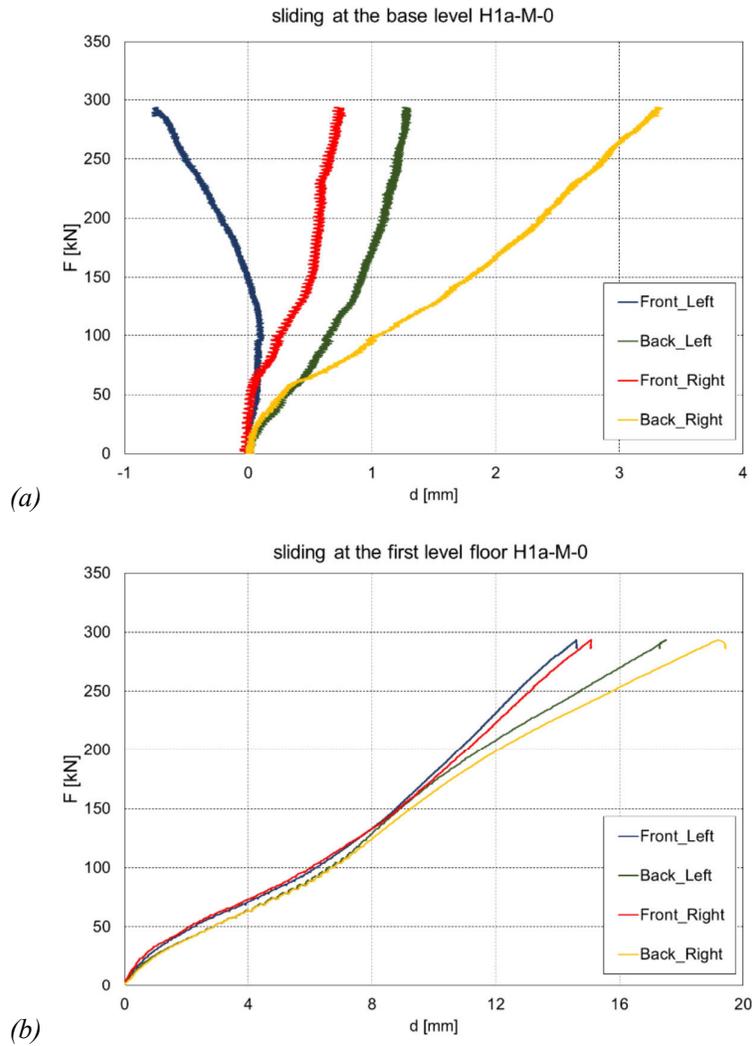
Figure 3.21. H1a sliding of shear wall at: (a) base level, (b) 1<sup>st</sup> floor

The sliding values at the base and 1<sup>st</sup> level floor are shown in Figure 3.21. There was only a small amount of sliding at the base level, with the highest values being -0.8 mm and 0.8 mm for the front and 1.3mm and 3.3 mm for back side panels, respectively, when the displacement was increased to -100% target displacement, see Figure 3.21a. The sliding at the 1<sup>st</sup> level floor, as shown in Figure 3.21b, exhibited values ranging from 14.5 mm to 15.1 mm in front and from 17.5 mm to 19.3 mm in back SB at the +100% target displacement. These sliding values contributed approximately 10% to the overall lateral displacement.

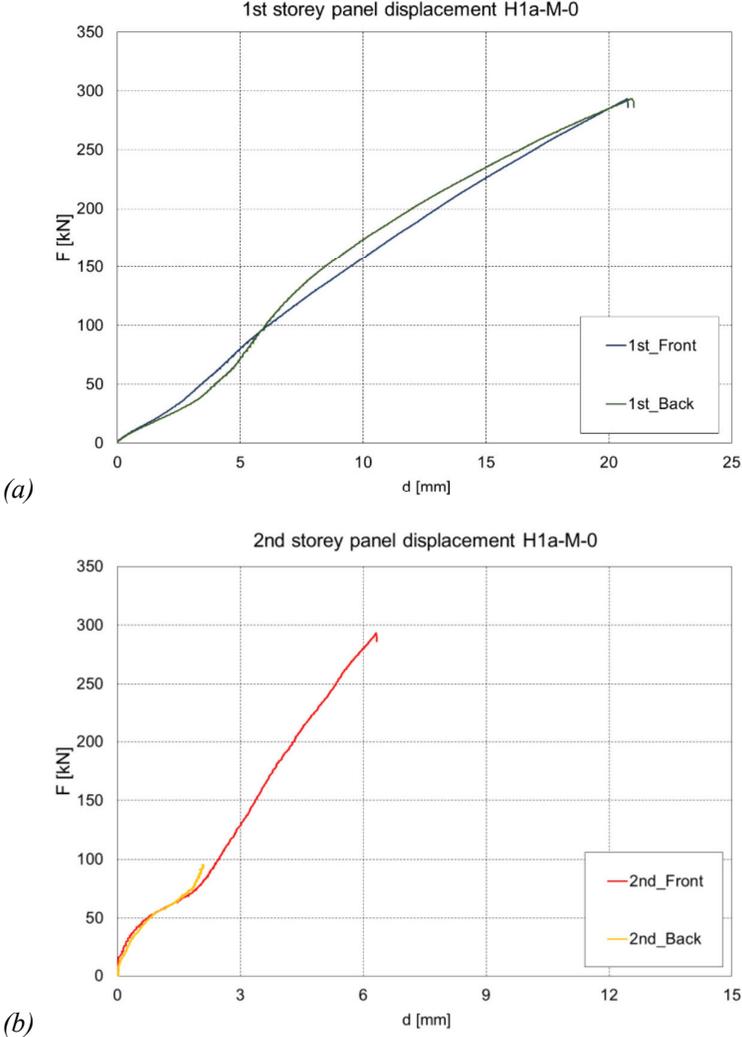
Figure 3.22. H1a Panel-to-panel slip for: (a) 1<sup>st</sup> storey, (b) 2<sup>nd</sup> storey

Herein Panel-to-panel slip are presented in Figure 3.22. The 1<sup>st</sup> storey load-displacement curve was quasi-linear up to the -100% target displacement with the total load  $F_{@-100\%}$  of 283 kN. The corresponding panel slips, as shown in Figure 3.22a, was approximately 21 mm, with minimal variation between the back and front panels.

The recorded panel slips in the 2<sup>nd</sup> storey shear wall, as shown in Figure 3.22b, exhibited an upward trend in the front panels. This trend continued until reaching 60 kN, at which point a notable reduction in stiffness was observed. Subsequently, the force increased,

reaching the -100% target displacement. At the -100% target displacement, the panel slips in the front panels measured 6.3 mm. Due to an instrumentation error, complete data for the back panel was not recorded; consequently, the graph is truncated at 93 kN.

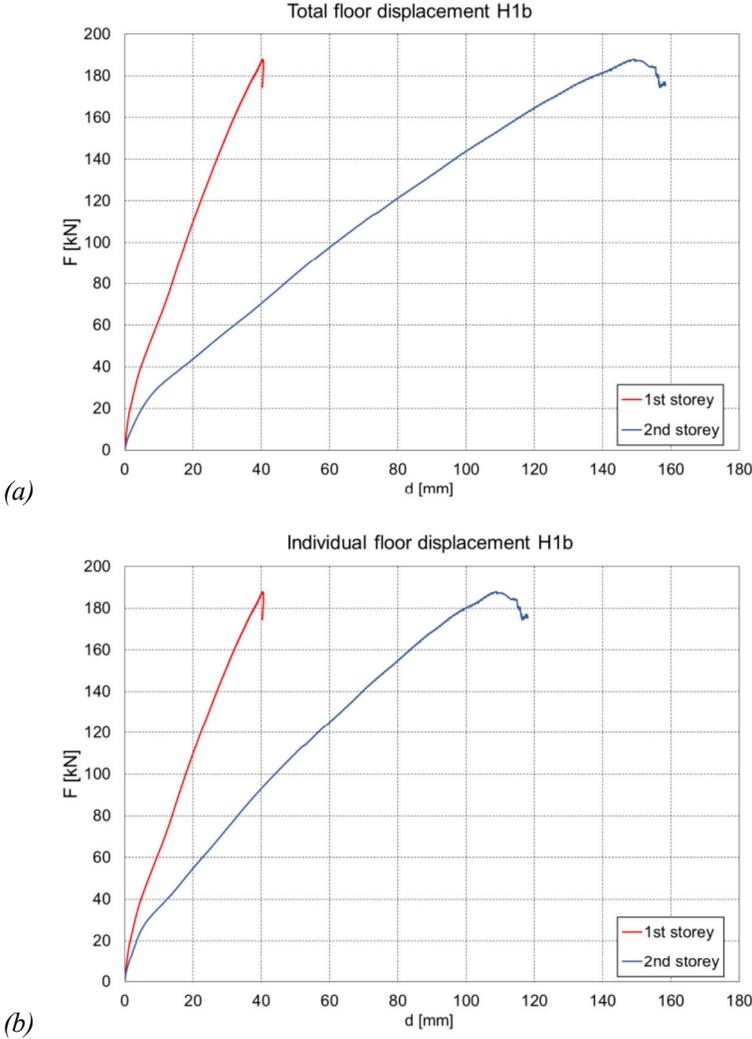
Figure 3.23. H1b (a) total storey displacements, (b) individual storey displacements

type of load they experienced. The horizontal storey displacements are shown in Figure 3.23. H1a was subjected to a monotonic pulling, whereas H1b was subjected to lateral pushing.

The load-displacement graph displayed a nearly linear relationship up to a 4.5 mm displacement with 25 kN force, characterized by a steep slope. Beyond this point, the slope decreased, indicating a failure in the structure connections and stiffness reduction. Despite this, the graph continued to ascend until it reached the 100% target displacement,

with the total load  $F_{@+100\%}$  peaking at 187 kN. Given that the intent was not to induce a complete structural failure of the structure, the displacement was not extended beyond this threshold. At +100% target displacement, the lateral displacements of the 1<sup>st</sup> and 2<sup>nd</sup> stories were 40 mm and 110 mm respectively, therefore, the 2<sup>nd</sup> storey drift was almost 275% of the 1<sup>st</sup> storey drift.

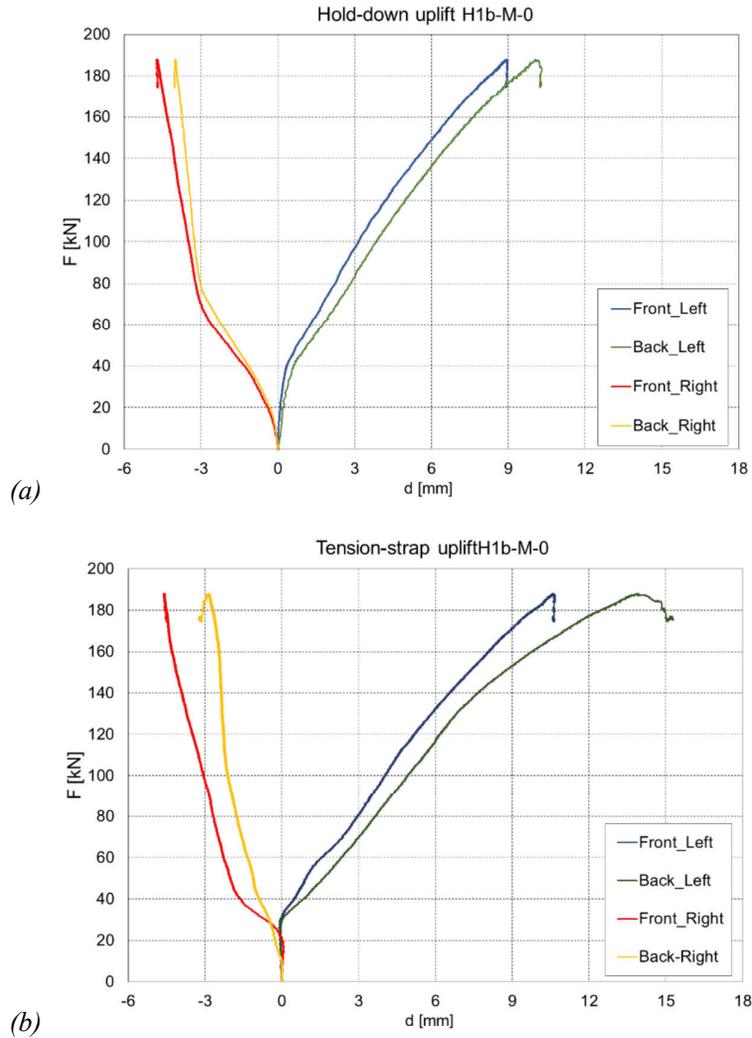
Figure 3.24. H1b uplift at: (a) hold downs (b) tension straps

The vertical uplift experienced in the four HD and tension straps are illustrated in Figure 3.24. The graphs of the load-displacement curves were bi-linear. This structure was subjected to a pushing force, causing the left-side HD to undergo tension (see Figure 3.24a). The load increased steadily until reaching 40 kN, resulting in almost zero uplift in left-side HD. However, after this point, there was a significant decrease in stiffness, followed by a gradual increase with a softer slope. The load continued to rise, reaching a  $F_{@+100\%}$  of 187 kN, accompanied by a 10 mm uplift.

The graph illustrating the uplift of the tension straps displays a bilinear pattern for each strap, as shown in Figure 3.24b. The force steadily increased with minimal uplift until it reached 30 kN. However, beyond this point, a significant decrease in stiffness became apparent on the left side of the shear wall, indicating the initial stages of tension strap screw failure. Subsequently, there was a gradual resurgence with a gentler slope, resulting in an uplift of 10 mm and 14 mm on the front and back tension straps, respectively, at the +100% target displacement. Conversely, the tension straps on the right side of the shear

wall experienced compression forces, leading to negative uplifts of -3 mm and -4.5 mm on the back and front tension straps, respectively, at the +100% target displacement.

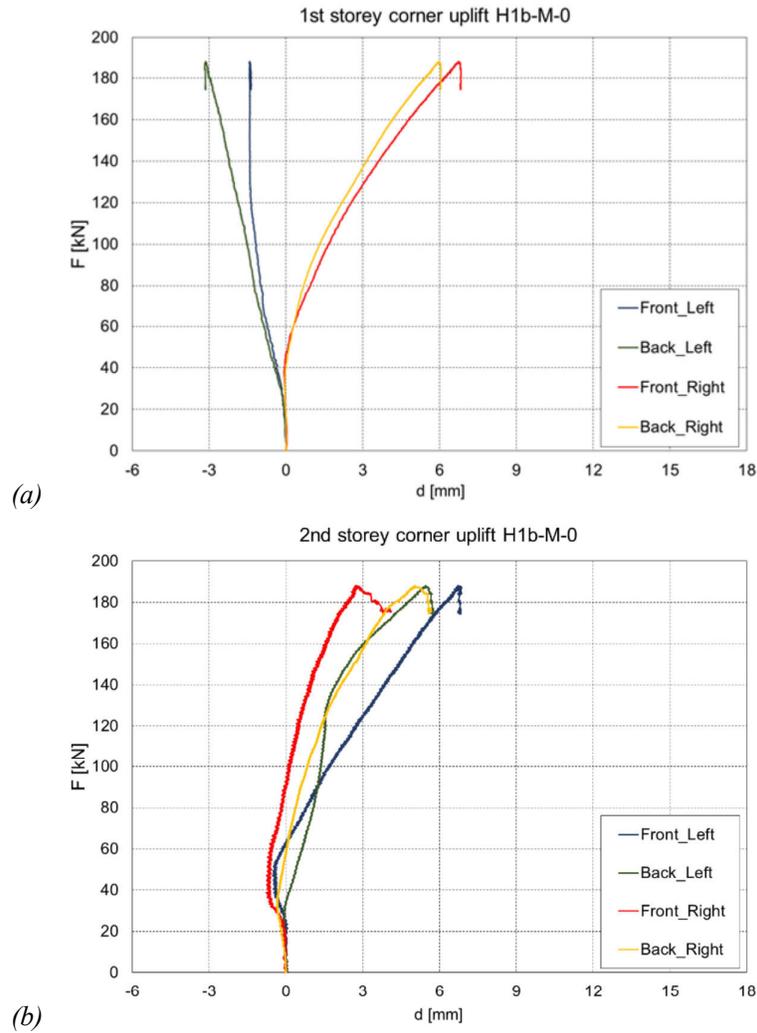
Figure 3.25. H1b inner corner uplifts at: (a) 1<sup>st</sup> storey, (b) 2<sup>nd</sup> storey

The vertical uplift experienced in the four inner corners of the coupled shear walls are illustrated in Figure 3.25. The curve of the load-displacement shows zero uplift till the point that total load reached to 30 kN and then almost linearly increased to  $F_{@+100\%}$  of 187 kN at +100% target displacement.

The corresponding right side inner corner uplifts in the 1<sup>st</sup> storey shear wall (Figure 3.25a) were 6 mm and 6.7 mm mirroring the HD uplifts of the 1<sup>st</sup> storey. The negative uplifts correspond to compression in the panel corners. At the +100% target displacement, the uplifts on the left side of the shear wall were -1.4 mm to -3 mm on front and back panels. The inner corner uplifts in the 2<sup>nd</sup> storey shear walls, depicted in Figure 3.25b, varied from 3 mm to 6.5 mm at the +100% target displacements. Notably, there were no instances of compression observed in the panel corners.

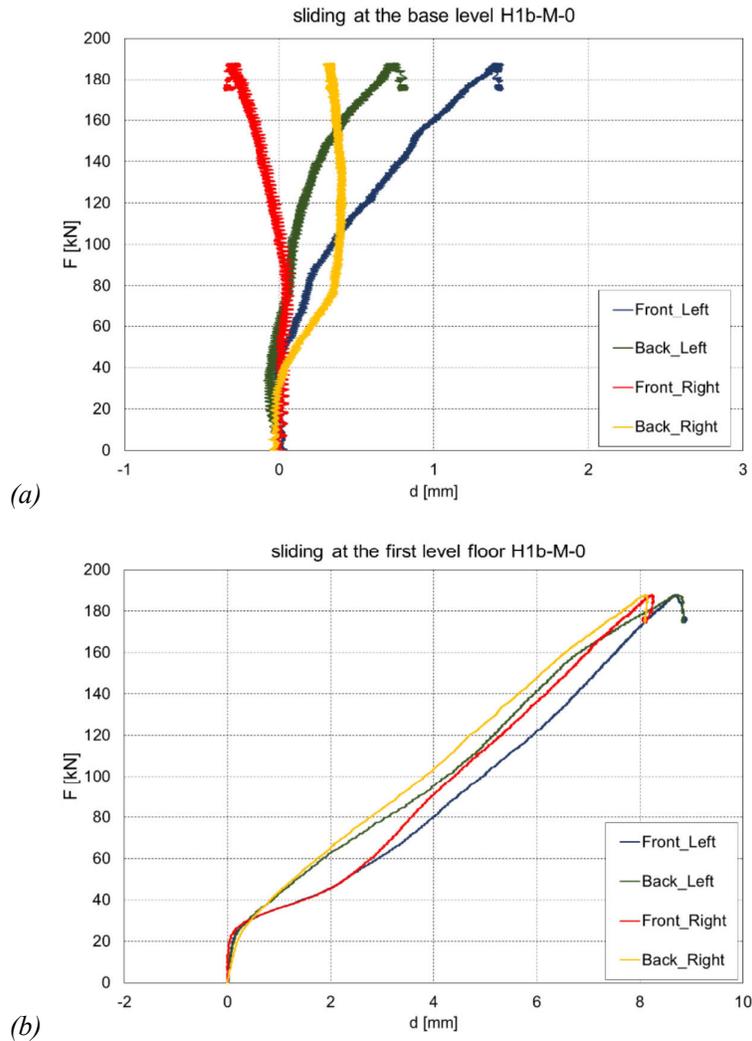
Figure 3.26. H1b sliding of shear wall at: (a) base level, (b) 1<sup>st</sup> level

The sliding values at the base and 1<sup>st</sup> level floor are shown in Figure 3.26.

There was only a small amount of sliding at the base level, with the highest values being 0.3 mm and 1.3 mm for the right and back side panels, respectively, when the displacement was increased to -100% target displacement, see Figure 3.26a. The sliding at the 1<sup>st</sup> level floor, as shown in Figure 3.26b, exhibited values ranging from 8 mm to 9

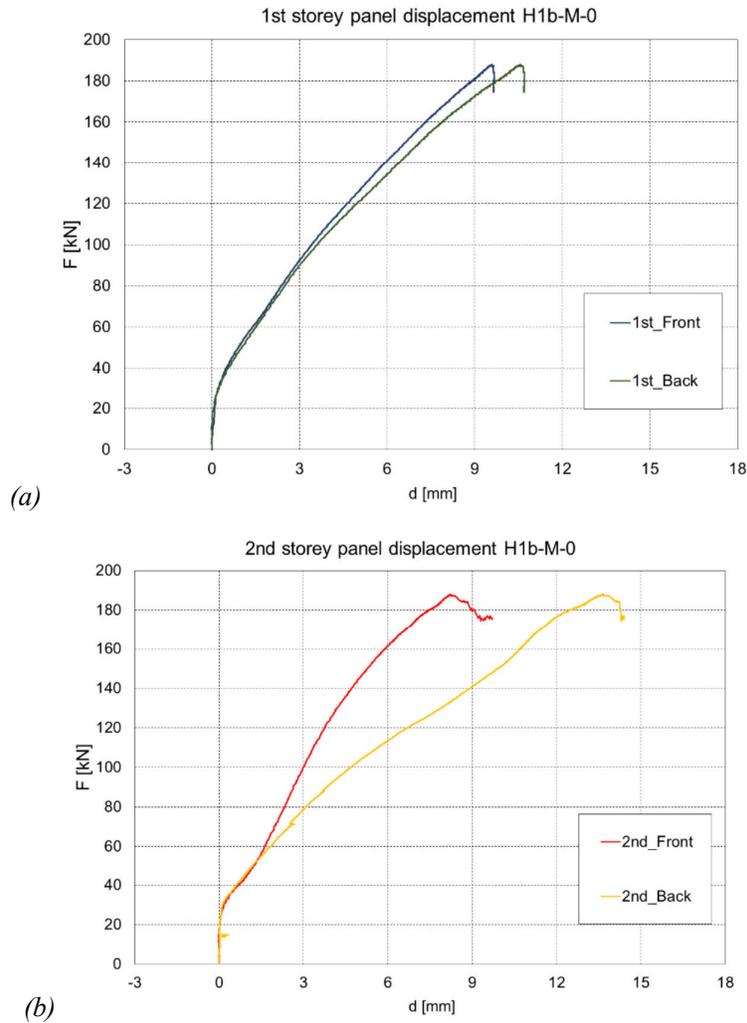
Figure 3.27. H1b Panel-to-panel slip for: (a) 1<sup>st</sup> storey, (b) 2<sup>nd</sup> storey

The Panel-to-panel slips are presented in Figure 3.27.

The 1<sup>st</sup> storey load-displacement curve was quasi-linear up to the +100% target displacement with the total load  $F_{@+100\%}$  of 187 kN. The corresponding panel slips, as

shown in Figure 3.27a, was approximately 10.2 mm, with minimal variation between the back and front panels.

The panel slips recorded in the 2<sup>nd</sup> storey shear wall, as depicted in Figure 3.27b, remained stable with no noticeable slip until they reached 30 kN. Afterward, a linear upward trend in the back panels emerged. This trend persisted until it reached a total load  $F_{@+100\%}$  of 187 kN. However, the behavior of the front panel differed from this linear trend. Instead, an increase in stiffness was observed at 50 kN, and this continued until it reached 8.3 mm of slip at the +100% target displacement.

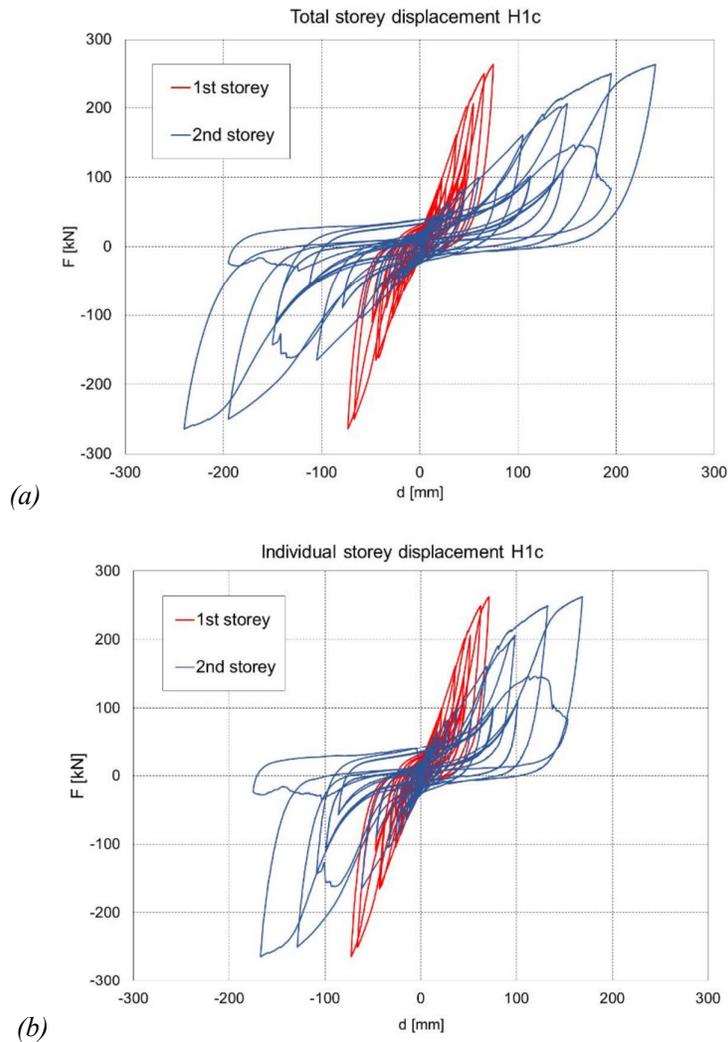
Figure 3.28, H1c (a) total storey displacements, (b) individual storey displacements

The horizontal storey displacements are illustrated in Figure 3.28. The envelope of the load-displacement curve was quasi-linear to 100% of the target displacement (equal to 150 mm) with the total load  $F_{@+100\%}$  reaching 205 kN. During the subsequent displacement cycle (195 mm), the total load increased to 249 kN.

The positive and negative envelopes were similar, with the negative force  $F_{@-100\%}$  reaching approximately -143 kN and  $F_{@-130\%} = -250$  kN. The lateral displacements (1<sup>st</sup> storey drift) of the first floor were 55 mm and -42 mm for the positive and negative 100% target displacement respectively. The 2<sup>nd</sup> storey drifts were 95 mm and -109 mm and therefore roughly 220% of the 1<sup>st</sup> floor drifts.

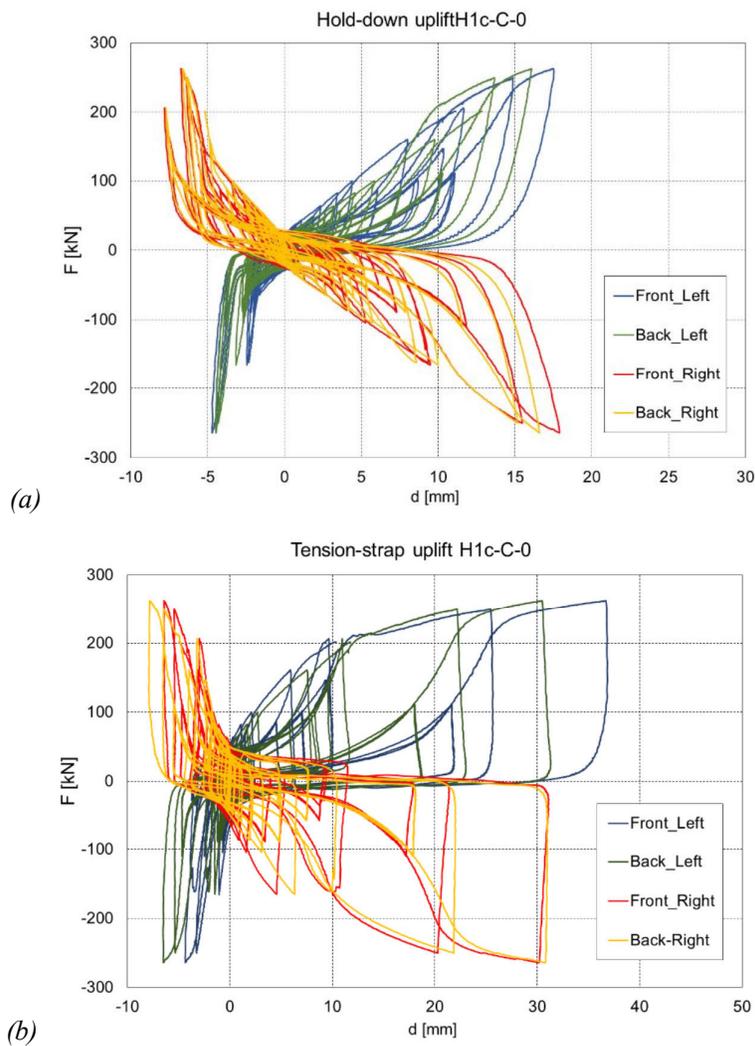
Figure 3.29. H1c uplifts at (a) the HDs, (b) tension straps

The uplift forces resulted from lateral loads are resisted by HD that connect the first storey to the base fixture and tension straps that connect first storey to the second storey. The vertical uplift experienced in the four HD and tension straps (two on the front and back shear walls each) are illustrated in Figure 3.29. The envelopes of the load-displacement curves were all quasi-linear up to the +130% target displacement when the total load  $F_{@+130\%}$  reached 249 kN. The corresponding HD uplifts (Figure 3.29a) on the left side of the shear wall were 14.5 mm and 14 mm. At the -130% target displacement, the uplifts

on the right side of the shear wall were 15.2 mm and 15.5 mm. The negative HD uplifts correspond to compression in the panel corners. The maximum compressions at the +/- 130% target displacements ranged from 4.4 mm to 6.4 mm.

The tension strap uplifts (Figure 3.29b) on the left side of the shear wall were 25 mm and 22.2 mm at the +/-130% target displacement indicating onset of failure which in the next cycle, reached 36.7 mm and 30.5 mm during the +160% target displacement. The tension strap uplifts on the right side of the shear wall were 20.3 and 21.9 mm indicating onset of failure which in the next cycle with uplifts exceeding 30 mm.

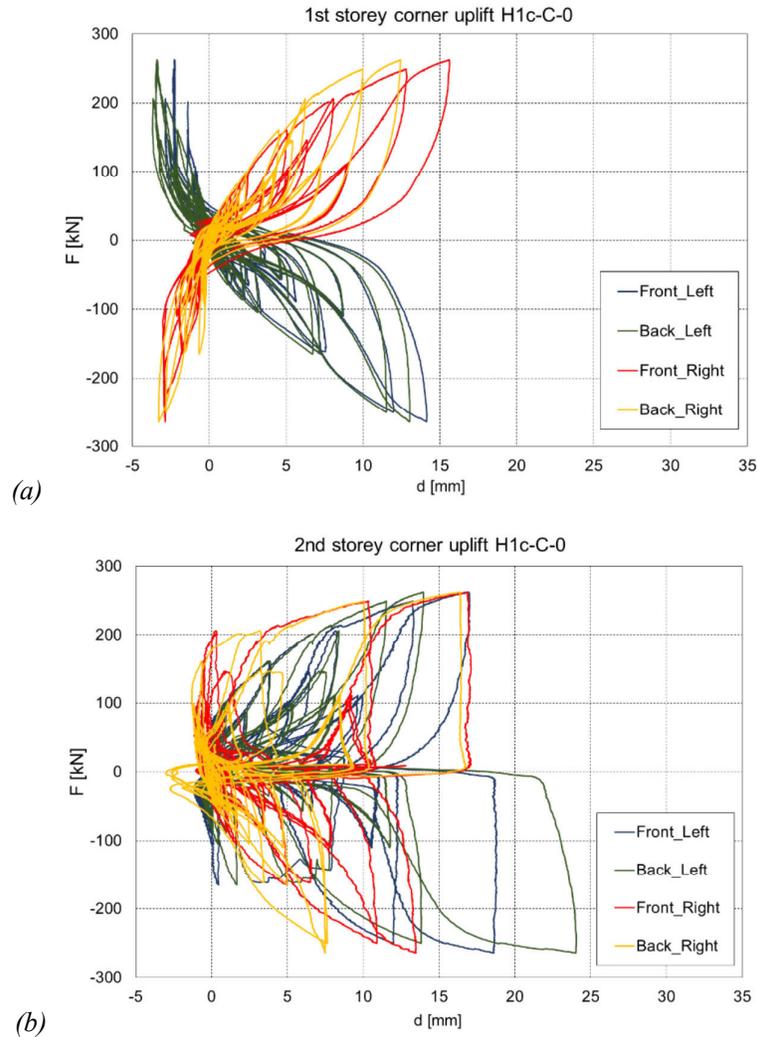
Figure 3.30. H1c inner corner uplifts at (a) 1<sup>st</sup> storey, (b) 2<sup>nd</sup> storey

The vertical uplift experienced in the four inner corners of the coupled shear walls are illustrated in Figure 3.30. The envelopes of the load-displacement curves were all quasi-linear up to the +100% target displacement when the total load  $F_{@+100\%}$  reached 205 kN.

The corresponding right side inner corner uplifts in the 1<sup>st</sup> storey shear wall (Figure 3.30a) were 7.9 mm and 6.4 mm. At the -100% target displacement, the uplifts on the left side of the shear wall ranged from 7.1 mm to 7.4 mm, closely mirroring the HD uplifts of the

The inner corner uplifts in the 2<sup>nd</sup> storey shear wall, depicted in Figure 3.30b, varied from 0.3 mm to 8.3 mm at the +/-100% target displacements. These uplift values increased in the subsequent cycle, ranging between 7.6 mm and 13.8 mm. Notably, there was almost no compression observed in the three inner corners since they were consistently slightly lifted by the opposite side panel during uplift, but the back right corner experienced a compression of -2 mm, indicating a slight downward displacement in that specific corner.

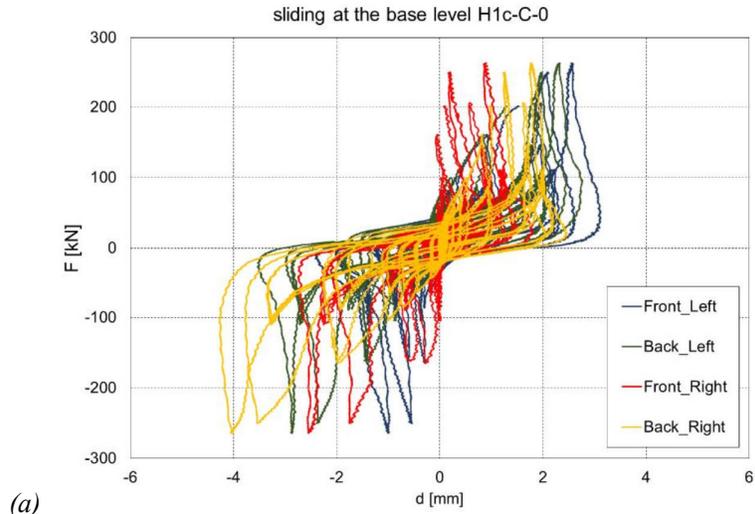
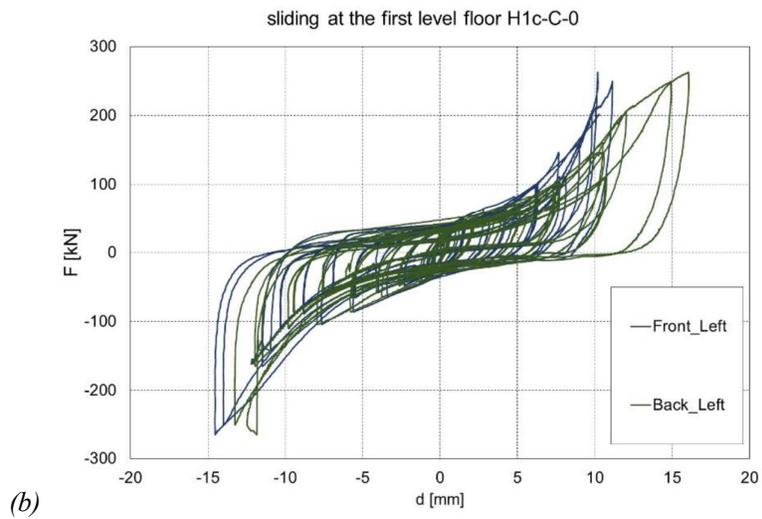
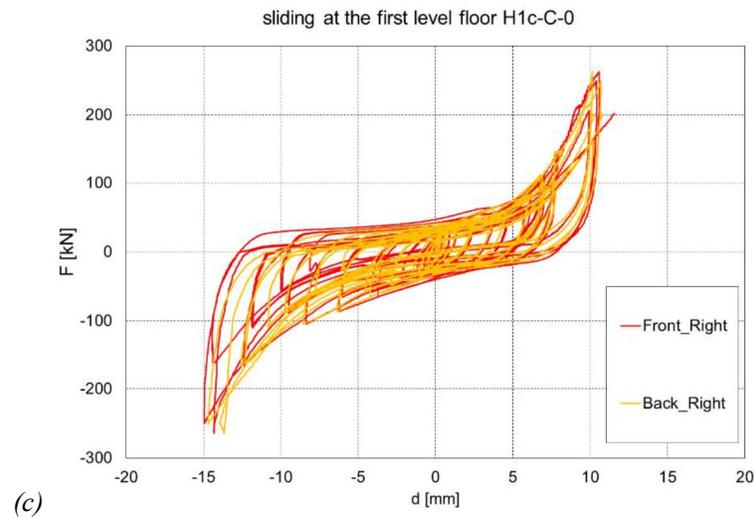
Figure 3.31. H1c panel sliding at: a) base level, b) 1<sup>st</sup> level left, c) 1<sup>st</sup> level right

Shear wall panel sliding is resisted by SB; the sliding values at each level are shown in Figure 3.31. It must be noted that the sliding at the 1<sup>st</sup> level floor is the total relative displacement between the shear walls of the 1<sup>st</sup> and 2<sup>nd</sup> stories; given the sensor installation, the recorded values also include the cumulative overturning effect of the 2<sup>nd</sup> storey. Further analyses, beyond the scope of this thesis are required to evaluate the actual sliding behavior as a function of the acting lateral load at this level.

The displacement caused by sliding at the base level (depicted in Figure 3.31a) observed at the +100% target displacement, were 2.0 mm for the front side panel and 1.9 mm for the back side panel. Based on these observations, it can be concluded that although sliding was not entirely prevented, its overall contribution at the base level was less than 5% of the storey drift. The sliding at the 1<sup>st</sup> level floor, as shown in Figure 3.31b, exhibited values ranging from 9.9 mm to 12 mm at the +100% target displacement, and from 11 mm to 14.5 mm at the -100% target displacement. These sliding values contributed approximately 10% to the overall lateral displacement.

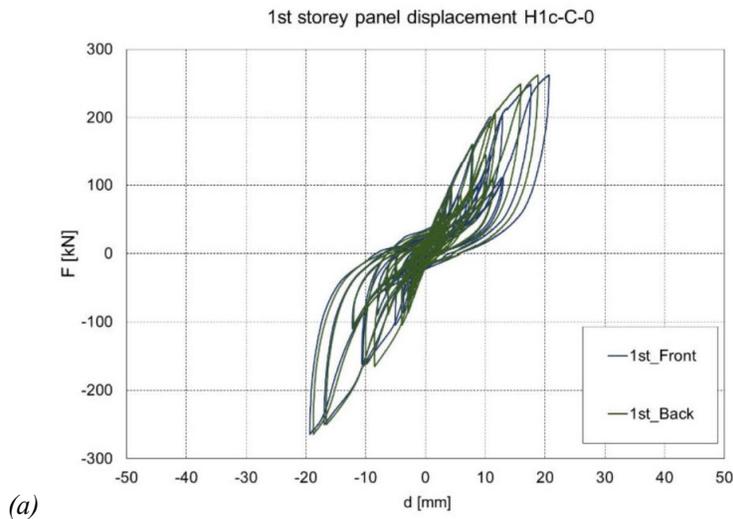
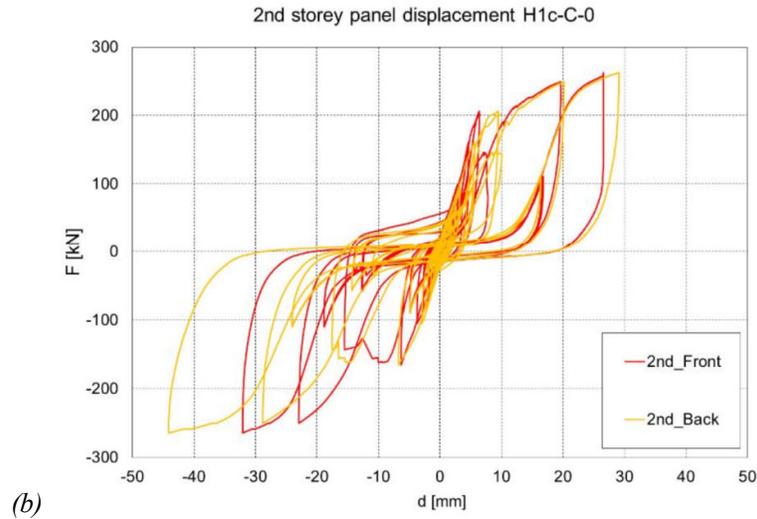
Figure 3.32. H1c Panel-to-panel slip for: (a) 1<sup>st</sup> storey, (b) 2<sup>nd</sup> storey

In coupled panel shear wall kinematics, the individual panels are expected to displace relative to each other, herein referred to as Panel-to-panel slip, as presented in Figure 3.32. This displacement in the spline joints acts as one major energy dissipation mechanism. The envelopes of the 1<sup>st</sup> storey load-displacement curves were all quasi-linear up to the +100% target displacement. The corresponding panel slips, as shown in Figure 3.32a, were approximately 12.3 mm, with minimal variation between the back and front panels or positive and negative cycles. The panel slips observed in the 2<sup>nd</sup> storey shear wall, as depicted in Figure 3.32b, formed a linear envelope up to the 100% target displacement, with the total load  $F_{@+100\%}$  reaching 205 kN. At the +100% target displacement, the panel slips were measured as 6.4 mm (front) and 9.5 mm (back). Conversely, at the -100% target displacement, the panel slips increased to 15.5 mm (front) and 17.5 mm (back).

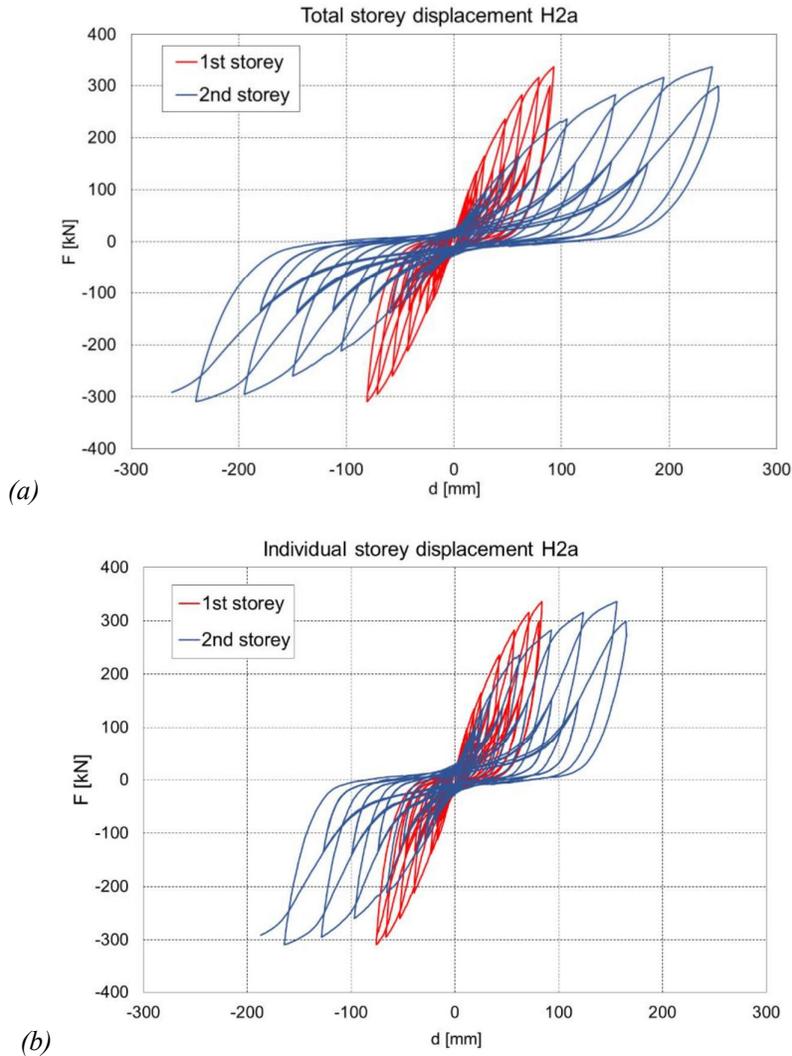
Figure 3.33. H2a (a) total storey displacements, (b) individual storey displacements

The horizontal storey displacements are illustrated in Figure 3.33. The load-displacement curve displayed a quasi-linear pattern up to 130% of the target displacement (equivalent to 195 mm), with the total load  $F_{@+130\%}$  reaching 316 kN. However, in the subsequent displacement cycle (top actuator displacement 240 mm), the total load only reached 336 kN, and certain components of the load resisting system experienced failure.

Both the positive and negative envelopes exhibited similar characteristics, with the maximum negative force at -130% of the target displacement  $F_{@-130\%}$  reaching approximately -295 kN. The lateral displacements of the first floor were 79 mm for the positive 130% target displacement and -71 mm for the negative 130% target displacement. Comparatively, the 2<sup>nd</sup> storey drifts were larger, measuring 116 mm and -124 mm, respectively, which is approximately 60% greater than the 1<sup>st</sup> storey drifts.

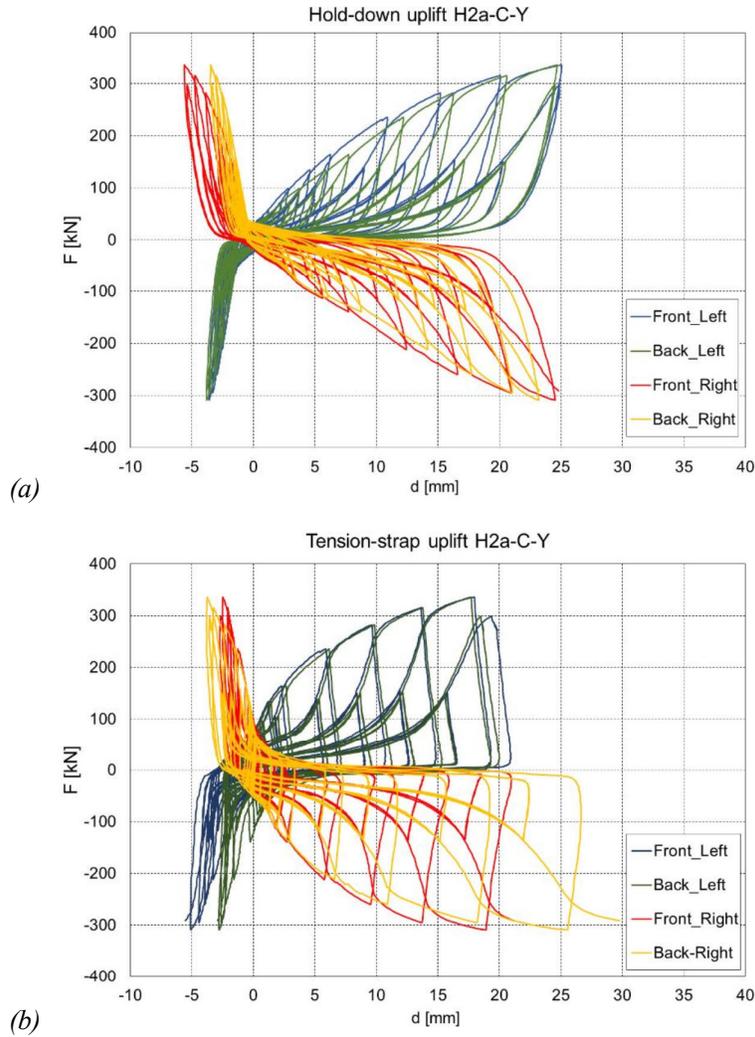
Figure 3.34. H2a uplifts at (a) the HDs, (b) tension straps

The load-displacement curves exhibited quasi-linear envelopes until the +130% target displacement, where the total load ( $F_{@+130\%}$ ) reached 316 kN. Figure 3.34 illustrates that the corresponding uplifts in the HD on the left side of the shear wall were 20 mm. Conversely, at the -130% target displacement, the uplifts on the right side of the shear wall measured 21 mm. When the uplifts in the HD are negative, the panel corners undergo compression. At the 130% target displacement, the maximum compression observed at these corners ranged from 3 mm to 4.8 mm.

The tension strap uplifts (Figure 3.34b) on the left side of the shear wall were 13.7 mm at the +130% target displacement, while they reached 17.8 mm during the +160% target displacement. The tension strap uplifts on the right side of the shear wall were 13.7 and 18.2 mm at the -130% target displacement that increased to 18.9 mm and 25.6 mm in the next cycle. At 160% target displacements, the maximum compression at tension straps ranged from 2.3 mm to 5 mm.

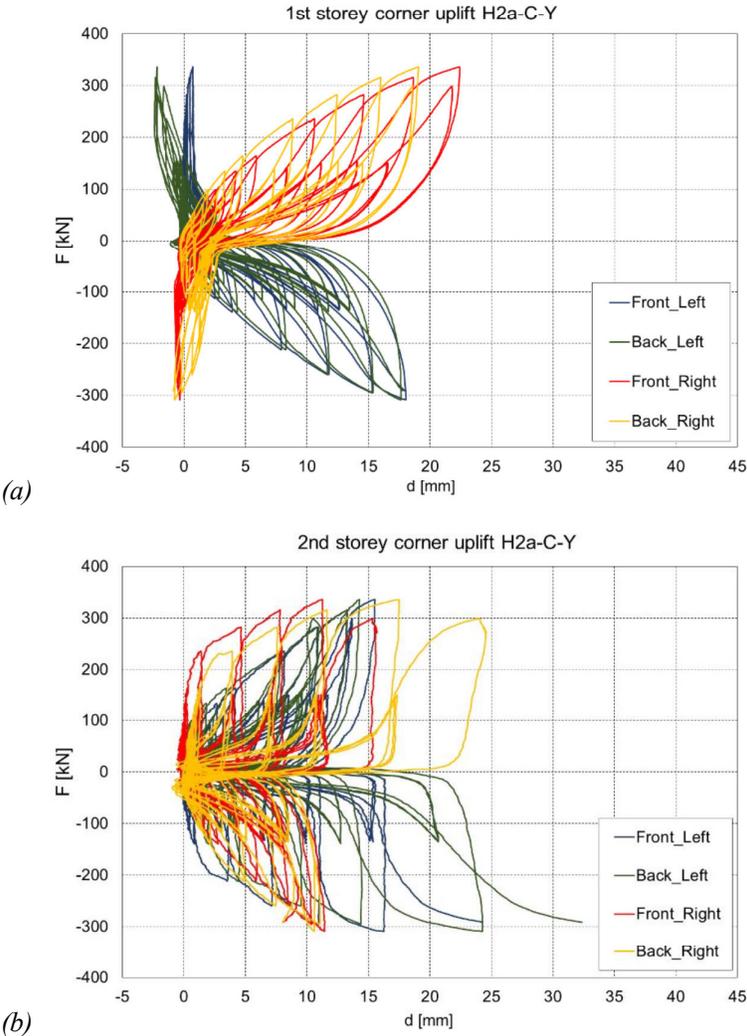
Figure 3.35. H2a inner corner uplifts at (a) 1<sup>st</sup> storey, (b) 2<sup>nd</sup> storey

Figure 3.35 shows the vertical uplift at the four inner corners of the coupled shear walls. The load-displacement curves' envelopes were mostly quasi-linear until the load  $F_{@+130\%}$  reached 316 kN at the +130% target displacement. In the 1<sup>st</sup> storey shear wall (Figure 3.35a), the corresponding uplifts at the inner corners were 16 mm and 18.6 mm on the right side of the shear wall. At the -130% target displacement, the uplifts on the left side of the shear wall varied from 15.3 mm, which closely resembled the HD uplifts of the 1<sup>st</sup> storey. The differences between the positive and negative uplifts were minimal.

The negative uplifts are linked to the compression at the corners of the panel. The front panels and the back right panel had almost no compression, while the back left panel had 2.2 mm of compression. In the 2<sup>nd</sup> storey shear wall (as shown in Figure 3.35b), the inner corners were lifted by 11.3 mm to 17.4 mm when the target displacement was +/-130%. During the following cycle, these values increased to between 15.4 mm and 24.3 mm. There was no compression observed in the inner corners, as they were always slightly lifted by the panel on the opposite side.

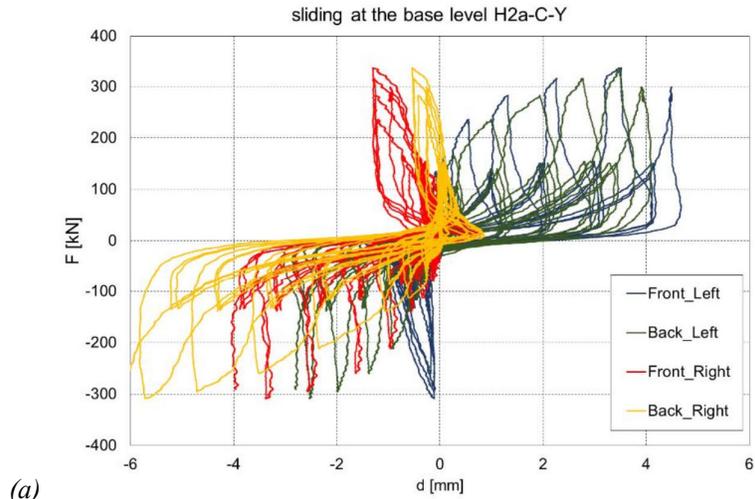
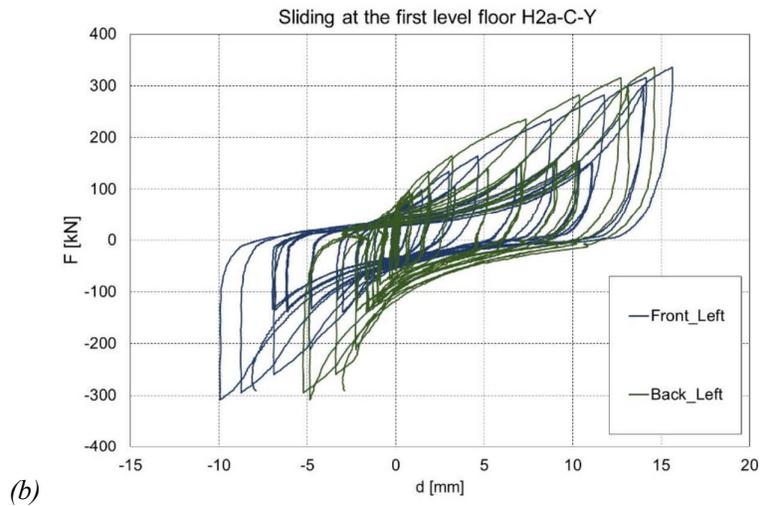
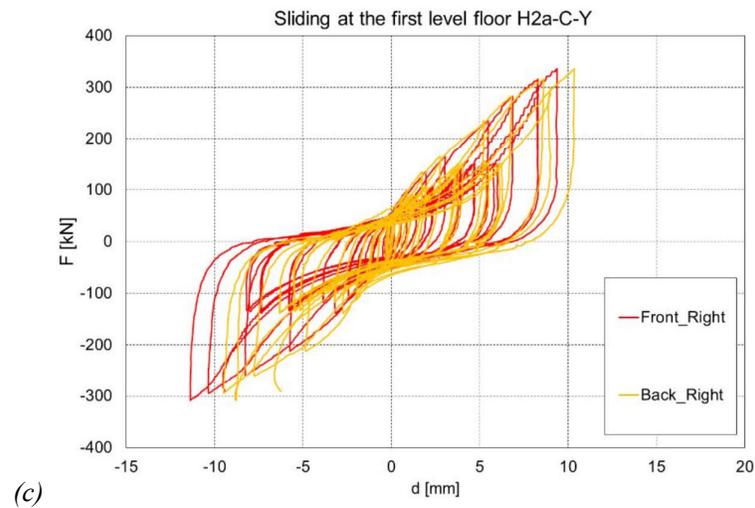
Figure 3.36. H2a panel sliding at a) base level, b) 1<sup>st</sup> level left, c) 1<sup>st</sup> level right

The sliding values at the base and 1<sup>st</sup> level floor are shown in Figure 3.36. There was only a small amount of sliding at the base level, with the highest values being 2.3 mm and 2.8 mm for the front and back side panels, respectively, when the displacement was increased to +130% target displacement, see Figure 3.36a.

At the 1<sup>st</sup> level floor, the sliding values were higher, ranging from 8.3 mm to 12.7 mm when the displacement was reached to +130% target displacement and from 5.2 mm to 10.3 mm when the displacement was reached to -130% target displacement, as shown in Figure 3.36b. These values contribute around 10% of the total lateral displacement of the two-storey shear wall and should not be ignored in design. Despite this, there was no reduction in strength, and the stiffness even seemed to be increasing. Additionally, there was no damage observed in the actual SB.

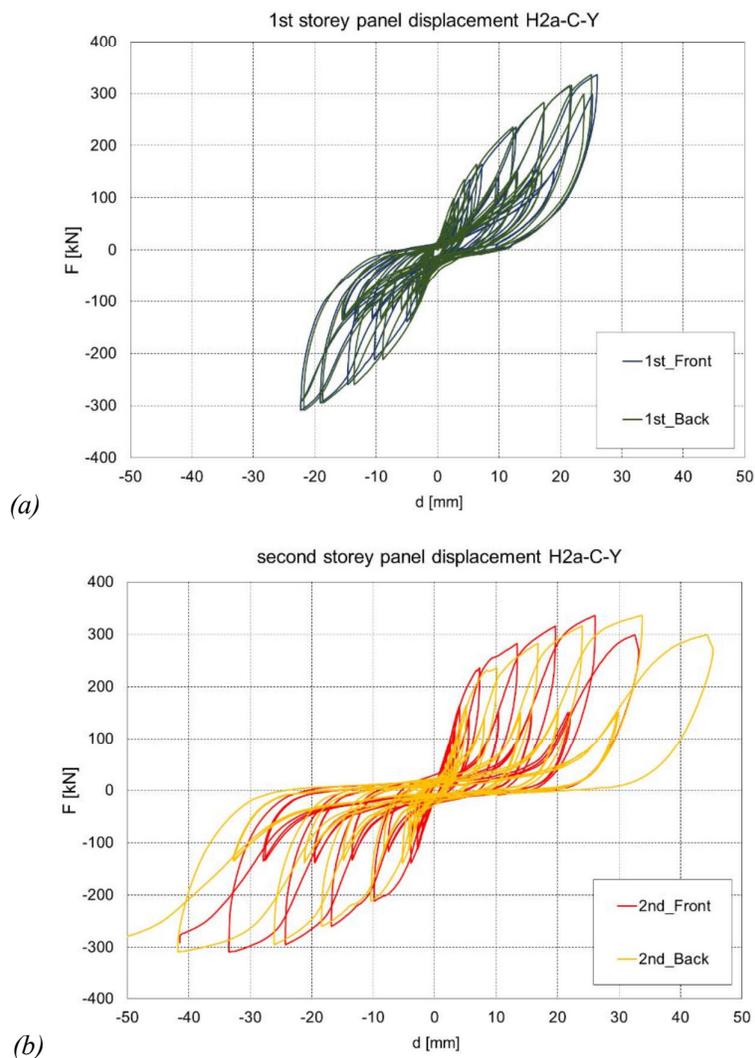
Figure 3.37. H2a panel displacements in test, a) 1<sup>st</sup> storey, b) 2<sup>nd</sup> storey

The Panel-to-panel slip is presented in Figure 3.37. The load-displacement curves exhibited nearly linear behavior up to a displacement of +130%, at which point the total load  $F_{@+130\%}$  reached 316 kN. Concurrently, the corresponding panel slips, as shown in Figure 3.37a, were approximately 22 mm and did not significantly differ between the front and back panels or between positive and negative cycles.

Figure 3.37b depicts that the panel slips in 2<sup>nd</sup> storey shear wall create a linear envelope until the +130% target displacement. At this displacement level, sliding measured approximately 19.7 mm at the front and 24 mm at the back, and 24.3 mm at the front and 26.1 mm at the back when at the -130% target displacement. Throughout the testing, there was no observed compression.

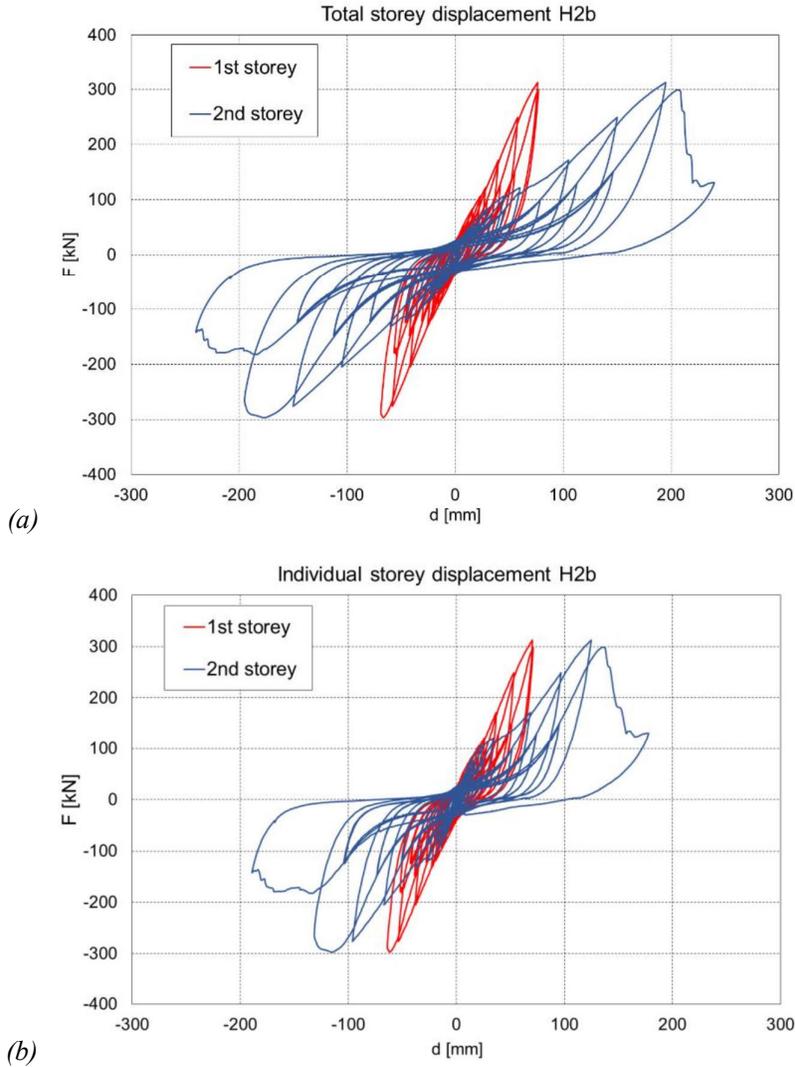
Figure 3.38. H2b (a) total storey displacements, (b) individual storey displacements

The horizontal storey displacements are illustrated in Figure 3.38. The envelope of the load-displacement curve was quasi-linear to 130% of the target displacement (equal to 195 mm in cycle 38) with the total load  $F_{@+130\%}$  reaching 311 kN. During the subsequent displacement cycle (top actuator displacement 240 mm), the total load only reached 296 kN, and parts of the load resisting system failed.

The positive and negative envelopes were very similar, with the maximum negative force at -130% of the target displacement  $F_{@-130\%}$  reaching approximately 300 kN. The lateral displacements (1<sup>st</sup> storey drift) of the first floor were 75 mm and -70 mm for the positive and negative 130% target displacement respectively. The 2<sup>nd</sup> storey drifts were 120 mm and 125 mm and therefore roughly 70% larger.
