**EXPERIMENTAL INVESTIGATION ON THE STRUCTURAL PERFORMANCE  
OF TWO-STOREY CROSS-LAMINATED TIMBER SHEAR WALLS**

**Sedigheh Gheisari**

THESIS SUBMITTED IN PARTIAL FULFILLMENT OF  
THE REQUIREMENTS FOR THE DEGREE OF  
ENTER DEGREE NAME  
IN  
ENGINEERING

UNIVERSITY OF NORTHERN BRITISH COLUMBIA

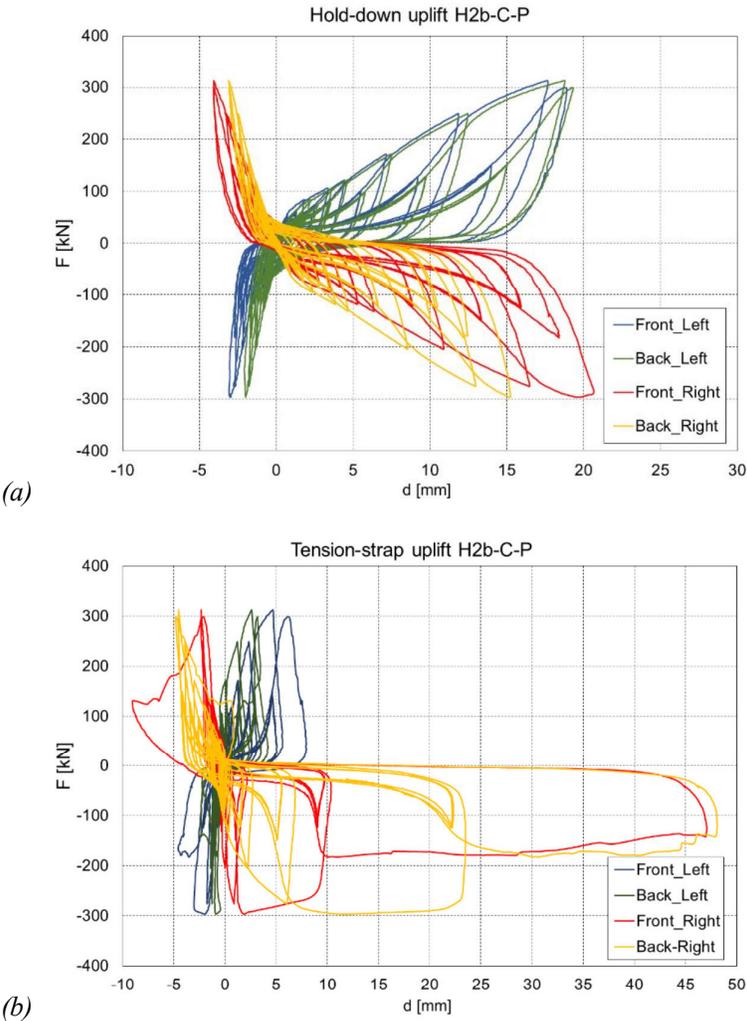
Figure 3.39. H2b uplifts at (a) the HDs, (b) tension straps

The vertical uplift experienced in the four HD and tension straps (two on the front shear back shear walls each) are illustrated in Figure 3.39. The envelopes of the load-displacement curves were all quasi-linear up to the +130% target displacement when the total load  $F_{@+130\%}$  reached 311 kN. The corresponding HD uplifts (Figure 3.39a) on the left side of the shear wall were 18 mm and 18.5 mm. At the -130% target displacement, the uplifts on the right side of the shear wall were 21 mm and 15 mm. The negative HD

uplifts correspond to compression in the panel corners. The maximum compressions at the 130% target displacements ranged from 2 mm to 4 mm. The tension strap uplifts (Figure 3.39b) on the left side of the shear wall were 2.6 mm and 4.7 mm at the +130% target displacement, while they reached 6.3 mm and 3.2 mm during the +160% target displacement. The tension strap uplifts on the right side of the shear wall were 10.4 and 23.5 mm indicating onset of failure which in the next cycle with uplifts exceeding 47 mm.

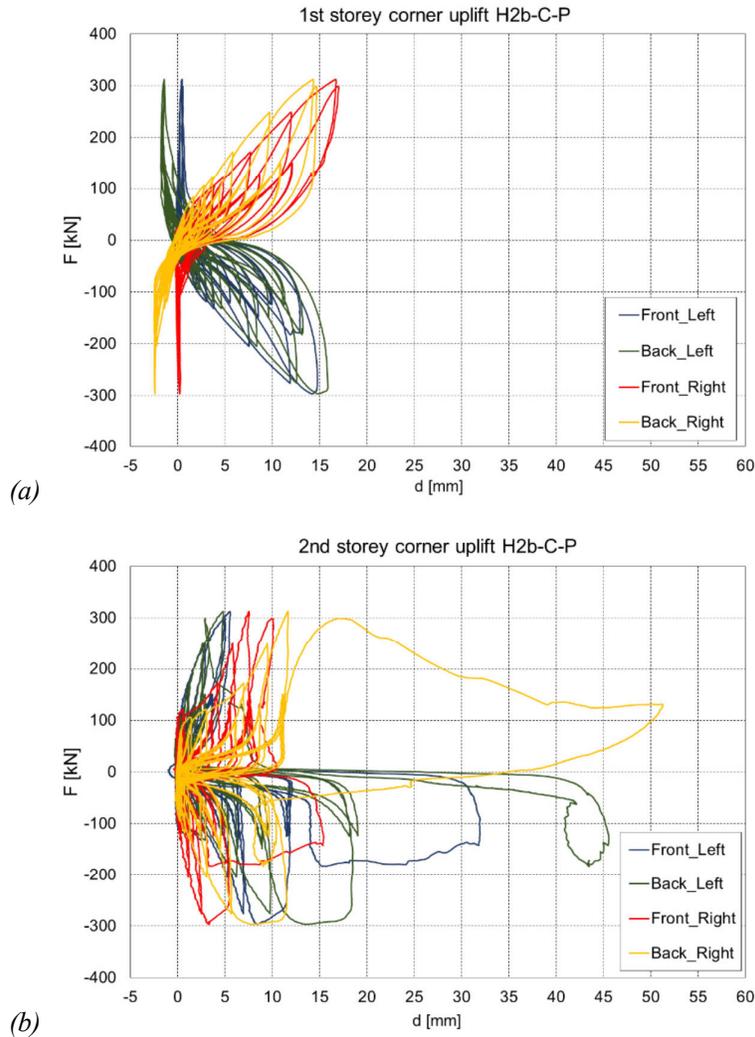
Figure 3.40. H2b inner corner uplifts at (a) 1<sup>st</sup> storey, (b) 2<sup>nd</sup> storey

The vertical uplift experienced in the four inner corners of the coupled shear walls are illustrated in Figure 3.40. The envelopes of the load-displacement curves were all quasi-linear up to the +130% target displacement when the total load  $F_{@+130\%}$  reached 311 kN.

The corresponding inner corner uplifts in the 1<sup>st</sup> storey shear wall (Figure 3.40a) were 16.7mm and 14.3 mm. At the -130% target displacement, the uplifts on the left side of the shear wall ranged from 14.8 mm to 15.8 mm, closely mirroring the HD uplifts of the

The inner corner uplifts in the 2<sup>nd</sup> storey shear wall (Figure 3.40b) ranged from 3 mm to 18 mm at the +/-130% target displacements and increased to values of up to 23 mm during the subsequent cycle when the structure exceeded its capacity. No compression was observed as the inner corners were always slightly lifted by the opposite side panel.

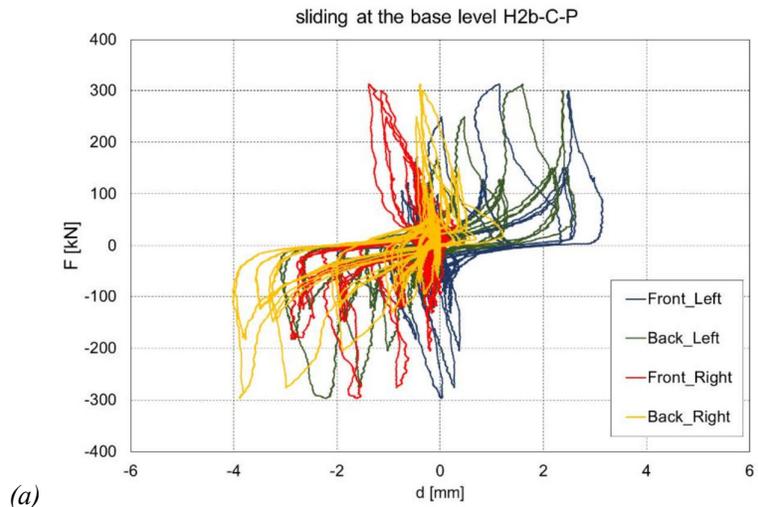
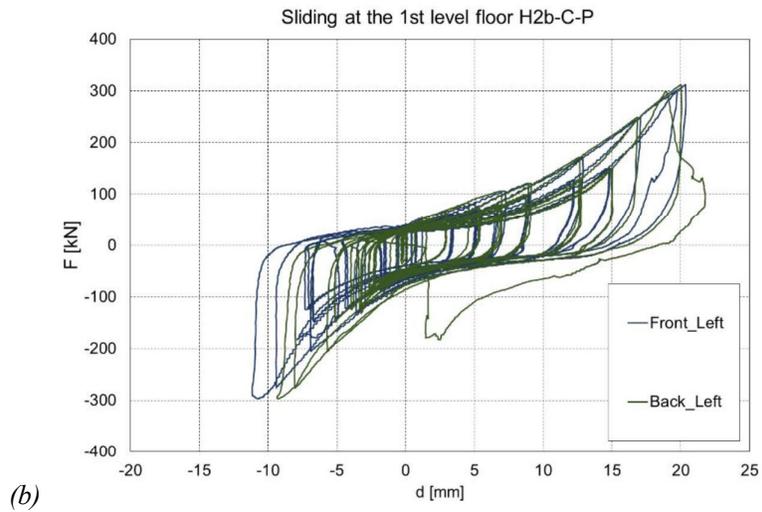
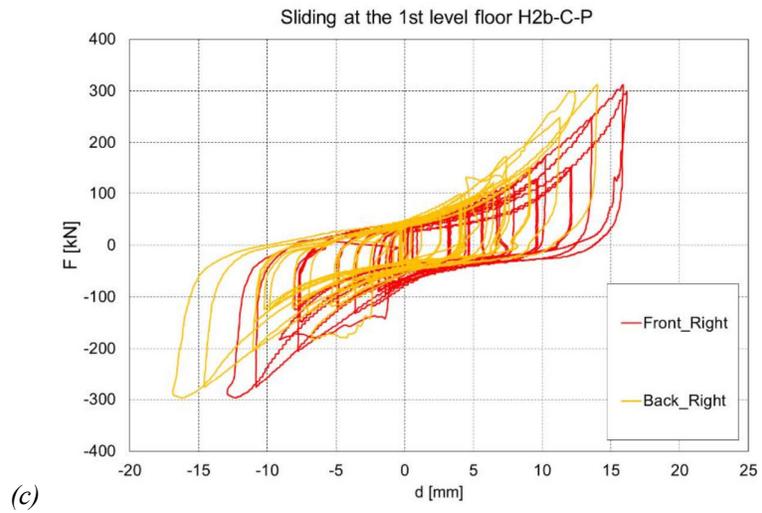
Figure 3.41. H2b panel sliding at a) base level, b) 1<sup>st</sup> level left side, c) 1<sup>st</sup> level right side

The sliding values at each level (base level, 1<sup>st</sup> level floor, and 2<sup>nd</sup> level floor) are shown in Figure 3.42. The sliding at the base level (Figure 3.42a) was very small, with maximum values at the +130% target displacement of 1.1 mm and 1.6 mm for the front and back side panels, respectively. The sliding at the 2<sup>nd</sup> level floor (Figure 3.42c) was even smaller with actually negative values at the +130% target displacement and 2 mm and 4 mm at the -130% target displacement. From these observations, it can be concluded, that while sliding was not completely prevented, the overall contributions of sliding at the base level and the 2<sup>nd</sup> level floor when measured directly between shear wall panel and floor were less than 5% of the storey displacement.

The sliding at the 1<sup>st</sup> level floor (Figure 3.42b) reached values from 14 mm to 20 mm at the +130% target displacement and from 9 mm and 16 mm at the -130% target displacement. These values therefore contribute roughly 10% of the overall lateral displacement of the 2-storey shear wall and cannot be neglected in design. However, no strength degradation was observed, rather, the stiffness seems to be increasing, and no damage in the actual SB was observed.

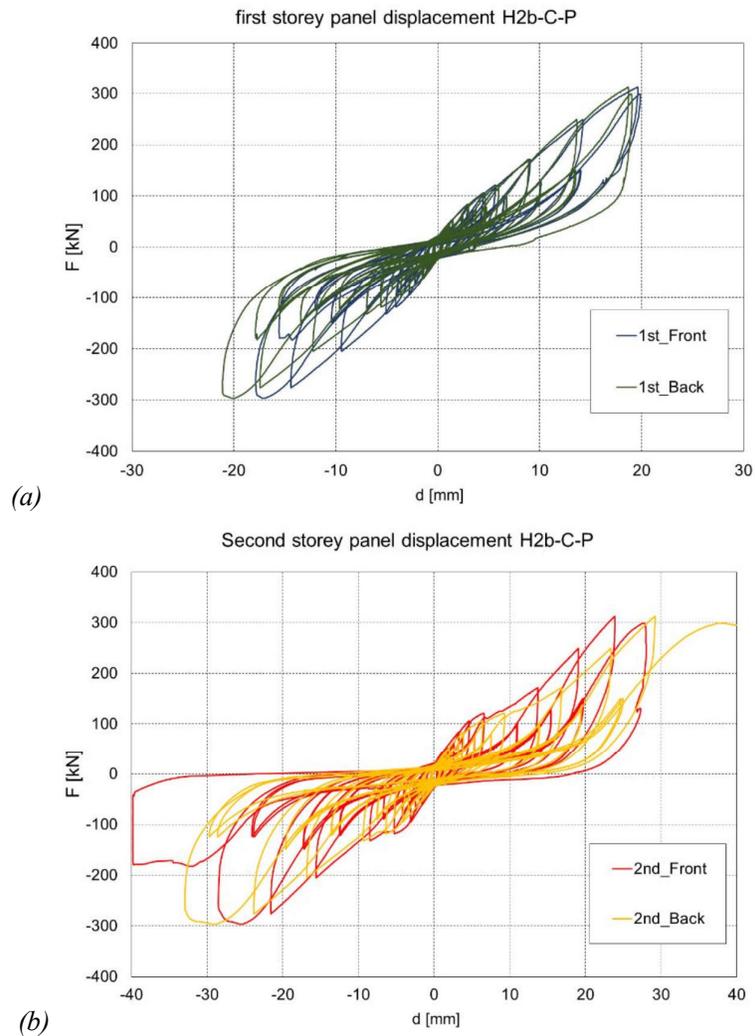
Figure 3.43. H2b panel displacements in test, a) 1<sup>st</sup> storey, b) 2<sup>nd</sup> storey

The Panel-to-panel slips are presented in Figure 3.43. The envelopes of the 1<sup>st</sup> storey load-displacement curves were all quasi-linear up to the +130% target displacement when the total load  $F_{@+130\%}$  reached 311 kN. The corresponding panel slips (Figure 3.43a) were approximate 20 mm, with almost no difference between back and front panels or positive and negative cycles.

The panel slips in the 2<sup>nd</sup> storey shear wall (Figure 3.43b) did not create a linear envelope but exhibited a small but noticeable drop in stiffness when the total load reached approximately 120 kN. At the +130% target displacement were 24 mm (front) and 29 mm (back) and 22 mm (front) and 24 mm (back) at -130% target displacement. The spline connection in the back panel failed during the subsequent cycle when pushed to the 160% target displacement. No compression was observed as the inner corners.

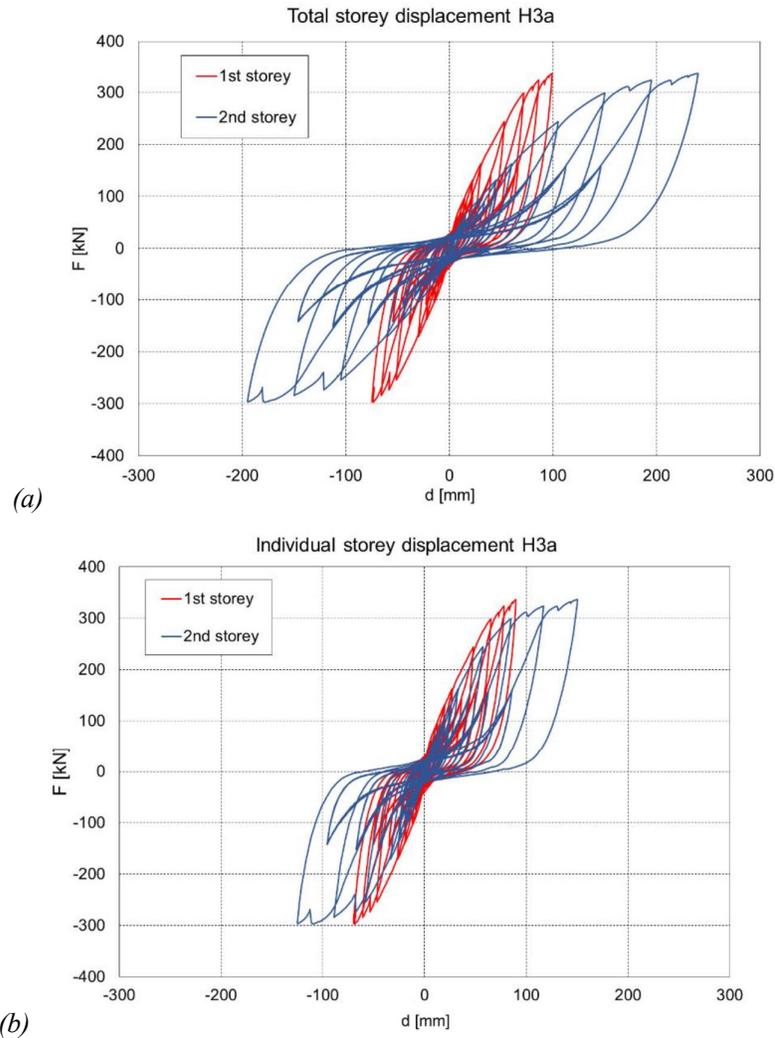
Figure 3.44. H3a (a) total storey displacements, (b) individual storey displacements

The horizontal storey displacements are illustrated in Figure 3.44. The load-displacement curve's envelope demonstrated a quasi-linear relationship up to +100% of the target displacement (equivalent to 150 mm in cycle 31), with the total load  $F_{@+100\%}$  reaching 299 kN. However, the positive and negative envelopes exhibited discrepancies. The maximum negative force at -130% of the target displacement, denoted as  $F_{@-130\%}$ , reached approximately -284 kN. Notably, due to detachment of the 2<sup>nd</sup> floor, the graph did not extend to -160% of the target displacement.

The lateral displacements, specifically the 1<sup>st</sup> storey drift, measured 72 mm and -66 mm for the +100% and -100% of the target displacement, respectively. Similarly, the 2<sup>nd</sup> storey drifts were 78 mm and -84 mm for the +100% and -100% of the target displacement, respectively, demonstrating an increase of roughly 25% compared to the 1<sup>st</sup> floor.

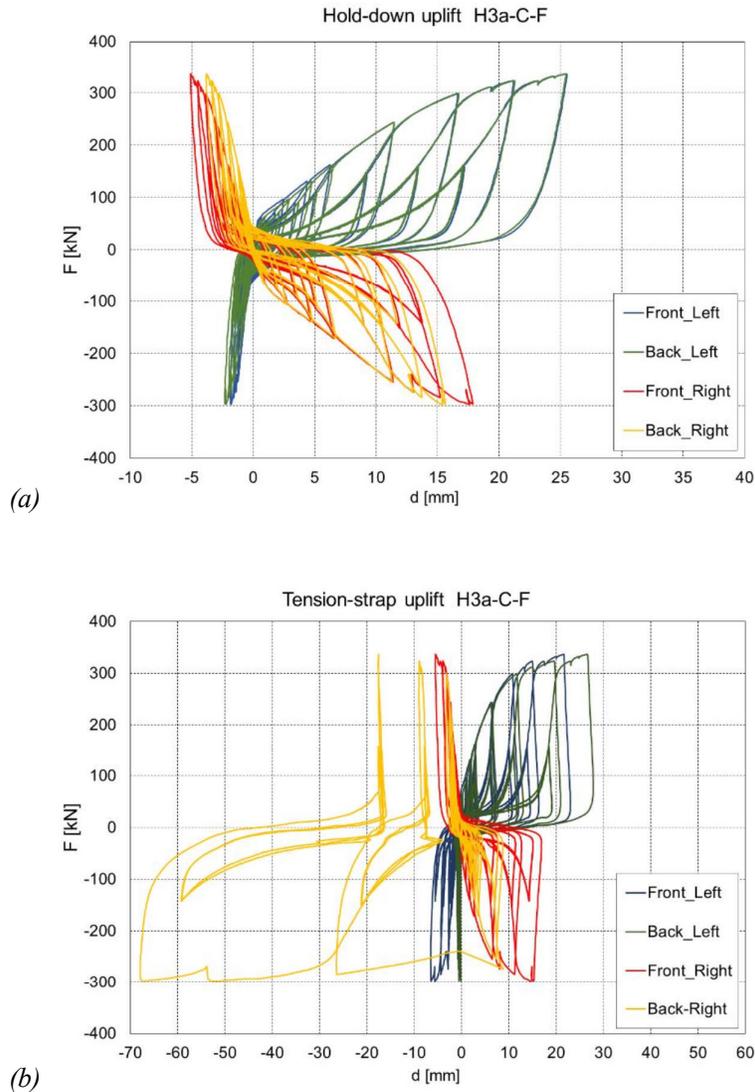
Figure 3.45. H3a uplifts at (a) the HDs, (b) tension straps

It was observed that all the load-displacement curves' envelopes were quasi-linear until the target displacement of +100%. At this point, the total load of  $F_{@+100\%}$  was found to be 336 kN, with corresponding HD uplifts of 16.6 mm on the left side of the shear wall for both HD, as shown in Figure 3.45a. On the right side of the shear wall, at the -100% target displacement, uplifts of 15.2 mm and 13.7 mm were recorded. The maximum compression values at the +100% and -100% target displacement ranged from 3.8 mm to 2 mm.

During the +100% target displacement, the tension strap uplifts on the left side of the shear wall measured 10.8 mm and 11.7 mm. As the target displacement increased to +130%, these uplifts further rose to 15 mm and 19.6 mm. On the front right side of the shear wall, the tension strap uplift was initially 11.2 mm at the -100% target displacement. It then increased to 15.3 mm at mm at a target displacement of -130%, while on the back right side, it was 26.3 mm indicating a set of failure that was followed by an increase of -68 mm at a target displacement of -130%. In the compression zone, three points tolerated

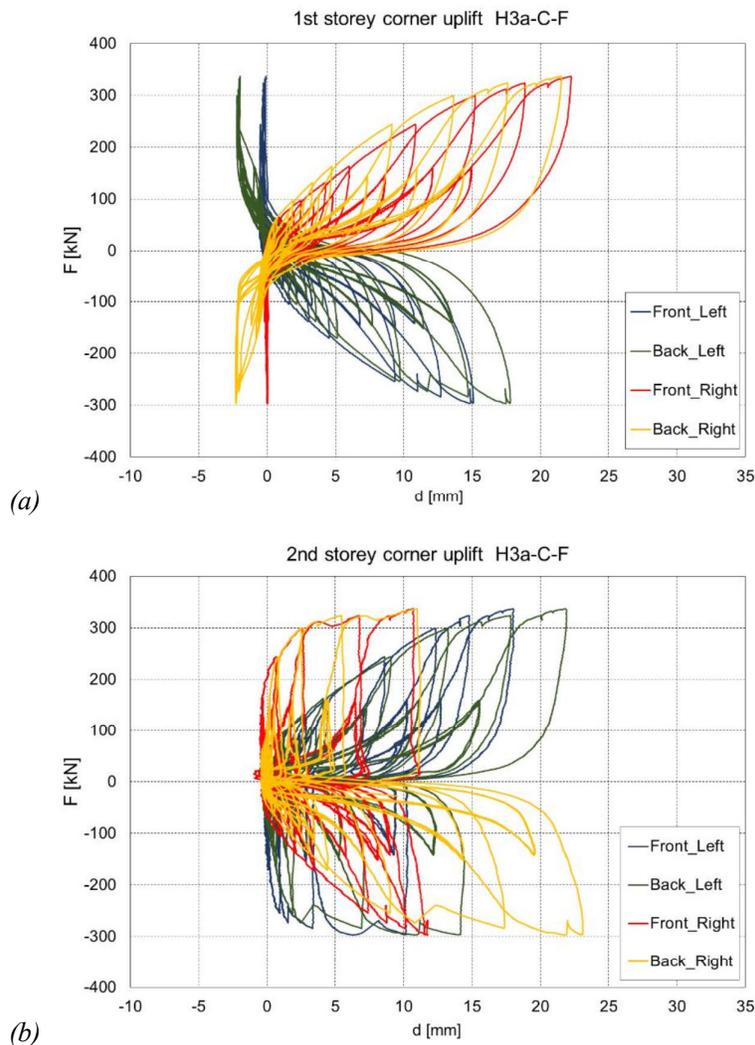
Figure 3.46. H3a inner corner uplifts at (a) 1<sup>st</sup> storey, (b) 2<sup>nd</sup> storey

Figure 3.46 demonstrates the vertical uplift observed in the four internal corners of the joined shear walls. The load-displacement curves' envelopes were almost linear until the target displacement of +100%, where the total load of  $F_{@+100\%}$  was 299 kN.

In the first-storey shear wall, the corresponding inner corner uplifts were 13.6 mm and 15.2 mm on the right side of the shear wall, see Figure 3.46a. On the left side of the shear wall, at the -100% target displacement, uplifts ranged from 12.7 mm to 14.7 mm. The uplift differences between positive and negative target displacements were minimal. The negative uplifts indicate compression in the panel corners. The front panels had almost zero compression, while the back panels had compression of 2.2 mm. In the 2<sup>nd</sup> storey shear wall (Figure 3.46b), the inner corner uplifts varied between 2.5 mm and 17.3 mm during the +/-100% target displacements. These uplifts increased to value 4.8 mm and 23.1 mm in the +/-130% target displacement. The inner corners were never compressed.

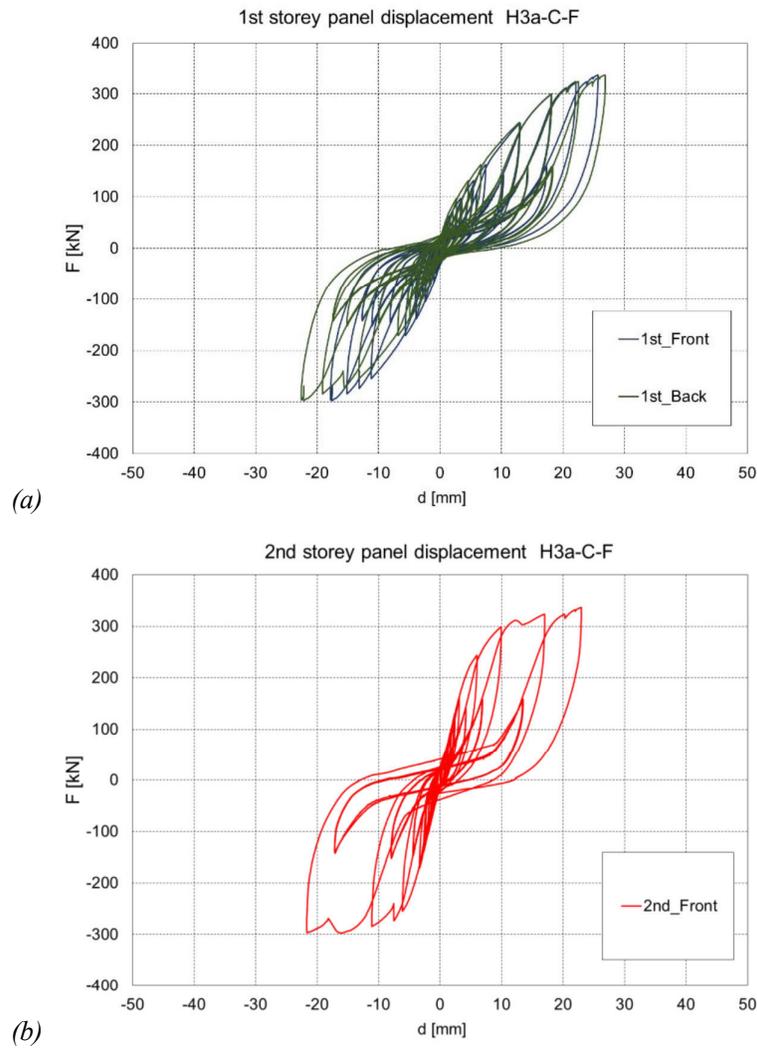
Figure 3.49. H3a Panel-to-panel slip for: (a) 1<sup>st</sup> storey, (b) 2<sup>nd</sup> storey

The Panel-to-panel slips are presented in Figure 3.49. The load-displacement curves demonstrated mostly linear behavior up to a displacement of +100% target displacement. At this point, the total load, indicated as  $F_{@+100\%}$ , reached 299 kN.

Simultaneously, the 1<sup>st</sup> storey panel slips corresponding to this displacement, as depicted in Figure 3.49a, were approximately 18 mm in positive and 17 mm in negative cycles.

Figure 3.49b demonstrates that the panel slips in the 2<sup>nd</sup> floor shear wall produce a linear envelope up to +70% target displacement. At this displacement, the front panel slid 6mm, and at the -70% target displacement, the back panel slid 6.1 mm. The maximum slip at +/160% target displacement was 22mm.

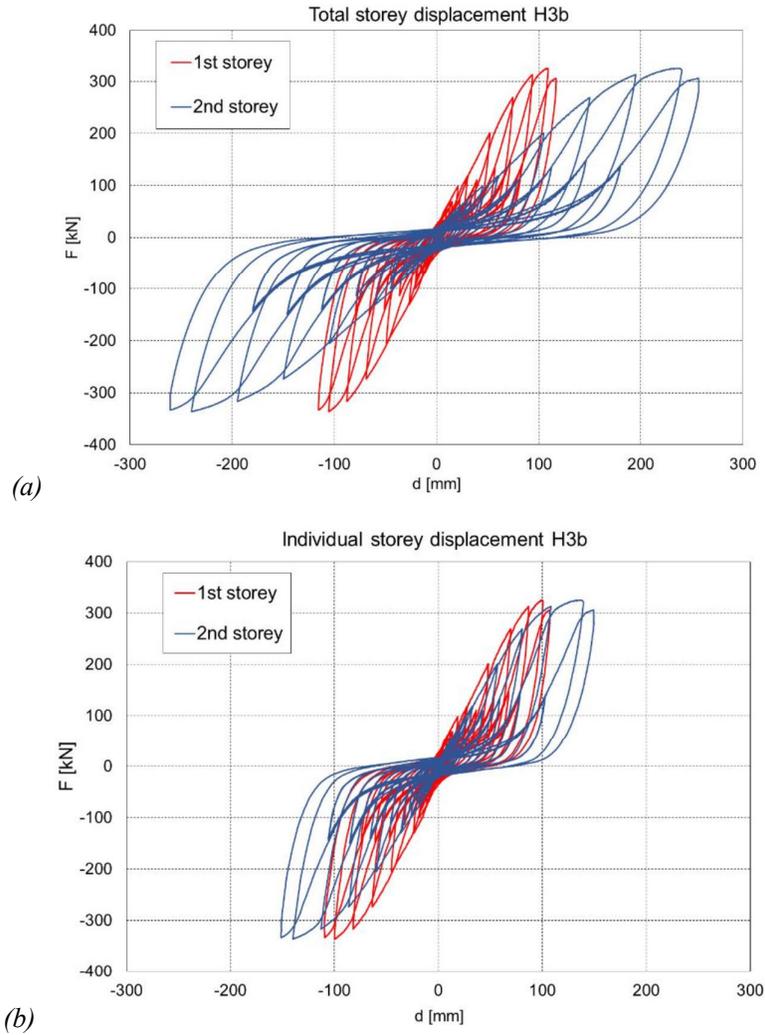
Figure 3.50. H3b (a) total storey displacements, (b) individual storey displacements

The horizontal storey displacements are illustrated in Figure 3.50. The load-displacement curve exhibited a nearly linear pattern up to 130% of the target displacement, equivalent to 195 mm, with a maximum total load of 313 kN. However, in the subsequent displacement cycle (with a top actuator displacement of 240 mm), the total load only reached 321 kN, and certain parts of the load-resisting system experienced failure. The positive and negative envelopes of the curve were quite similar, with the maximum negative force occurring at -160% of the target displacement  $F_{@-160\%}$ , reaching approximately 336 kN, followed by a slight decrease in the next cycle to 332 kN. The lateral displacements of the first floor were approximately 94 mm and -88 mm for the +/- 130% target displacements, respectively. In contrast, the 2<sup>nd</sup> storey drifts were around 101 mm and -107 mm, making them roughly 15% larger than the 1<sup>st</sup> storey displacements.

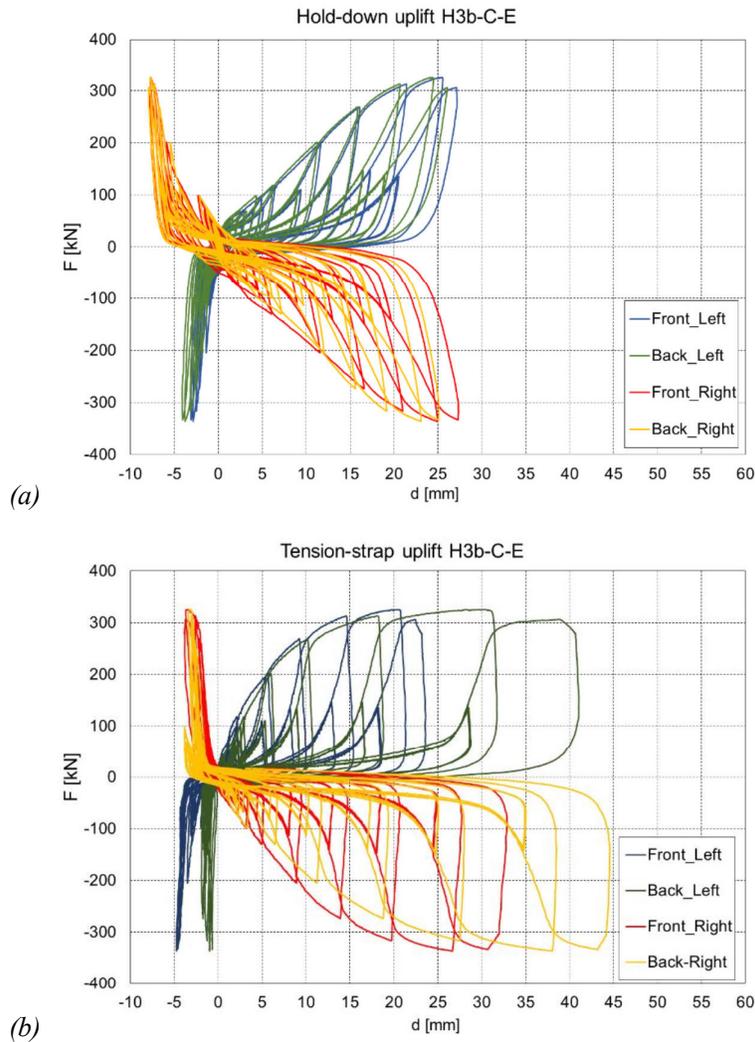
Figure 3.51. H3b uplifts at (a) the HDs, (b) tension straps

The vertical uplift experienced in the four HD and tension straps (two on the front shear back shear walls each) are illustrated in Figure 3.51. The load-displacement curves exhibited quasi-linear behavior up to the +130% target displacement, with the total load  $F_{@+130\%}$  reaching 313 kN.

On the left side of the shear wall, the corresponding uplifts (Figure 3.51a) were measured at 21.2 mm and 21.3 mm. Conversely, at the -130% target displacement, the uplifts on the right side of the shear wall were recorded at 21 mm and 19.2 mm. The negative uplifts indicate compression occurring in the panel corners. The maximum compressions observed at the +/-130% target displacements ranged from 2.5 mm to 7.3 mm.

The uplifts of the tension straps (Figure 3.51b) on the left side of the shear wall measured 14.6 mm and 18.2 mm at the +130% target displacement and increased to 20.8 mm and 31.2 mm at the +160% target displacement. On the right side of the shear wall, the tension

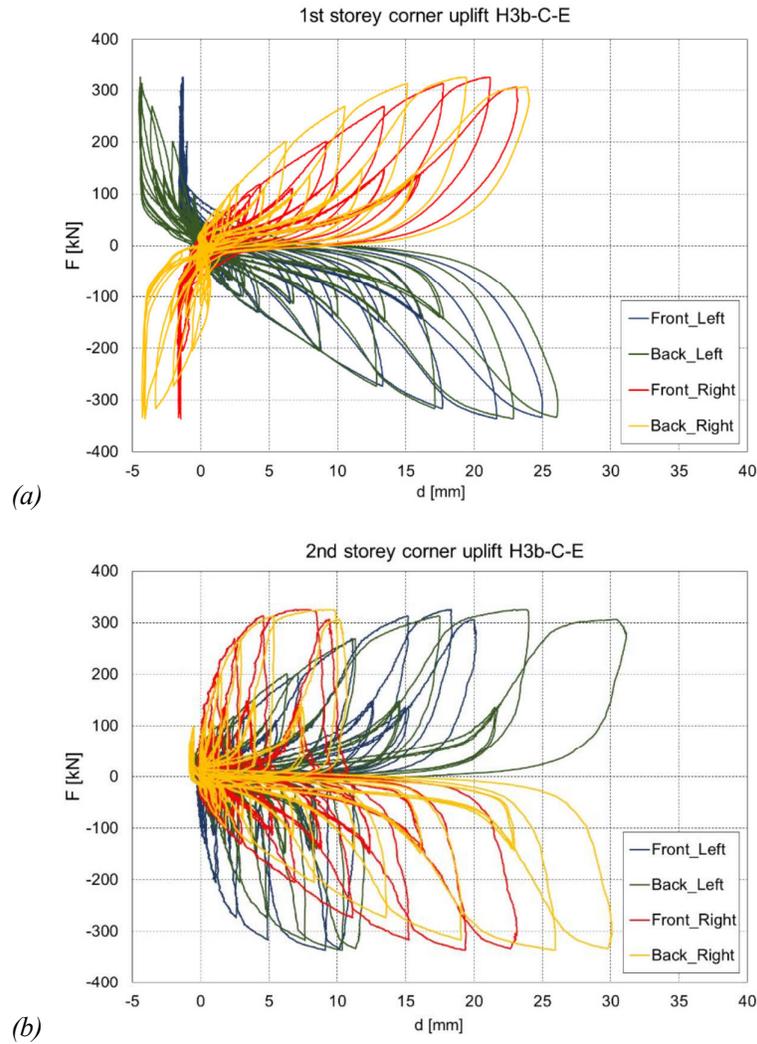
Figure 3.52. H3b inner corner uplifts at (a) 1<sup>st</sup> storey, (b) 2<sup>nd</sup> storey

Figure 3.52 illustrates the vertical uplift experienced in the four inner corners of the coupled shear walls. The load-displacement curves displayed quasi-linear behavior up to the +130% target displacement, with the total load reaching 313 kN at  $F_{@+130\%}$ . In the 1<sup>st</sup> storey shear wall on the right side (Figure 3.52a), the corresponding uplifts in the inner corners measured 15.1 mm and 17.7 mm. At the -130% target displacement, the uplifts on the left side of the shear wall ranged from 17.1 mm to 17.7 mm. The differences between positive and negative target displacements were minimal. The negative uplifts in the panel corners indicated compression, measuring around 1.4 mm on the front panels and 4.3 mm on the back panels. Figure 3.52b shows the uplifts in the inner corners of the 2<sup>nd</sup> storey shear wall. The uplift values ranged from 15.2 mm to 19 mm at the +/-130% target displacements and increased to 18.3 mm to 25.9 mm during the next cycle when the structure encountered +/-160% target displacements. There was a slight decrease in force observed in the last cycle. The inner corners of the wall were constantly uplifted by the opposite side panel, and hence no compression was observed.

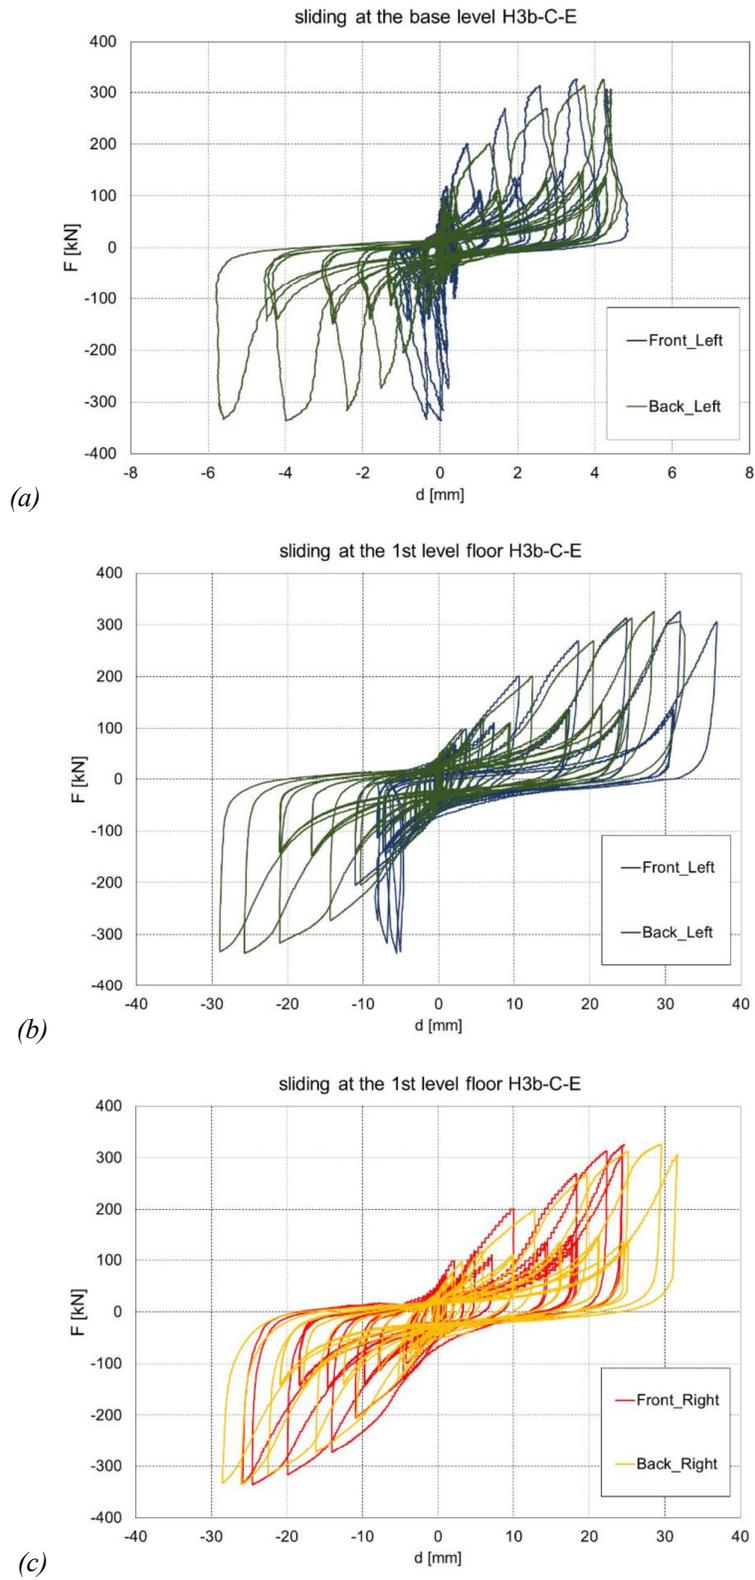
Figure 3.53. H3b panel sliding at: a) base level, b) 1<sup>st</sup> level floor left side, c) 1<sup>st</sup> level right side

The sliding at the base level (Figure 3.53a) was very small, with maximum values at the +130% target displacement of 2.6 mm and 3.7 mm for the front and back side panels, respectively. At the +130% target displacement the sliding at the 2<sup>nd</sup> level floor (Figure 3.53c) was 3 mm and 2.3 mm for the front and back side panels respectively, while in the +160% target displacement these values increased to 9.2 mm and 2.6 mm. At the -130% target displacement sliding was 1.7 and 0.8 mm for the front and back side panels respectively, while in the -160% target they were 1.2 mm and 0.7 mm.

Figure 3.53. H3b panel sliding at: a) base level, b) 1 <sup>st</sup> level floor left side, c) 1 <sup>st</sup> level right side.....	88
Figure 3.54. H3b panel sliding at 2 <sup>nd</sup> level floor .....	89
Figure 3.55. H3b panel displacements at: a) 1 <sup>st</sup> storey, b) 2 <sup>nd</sup> storey .....	90

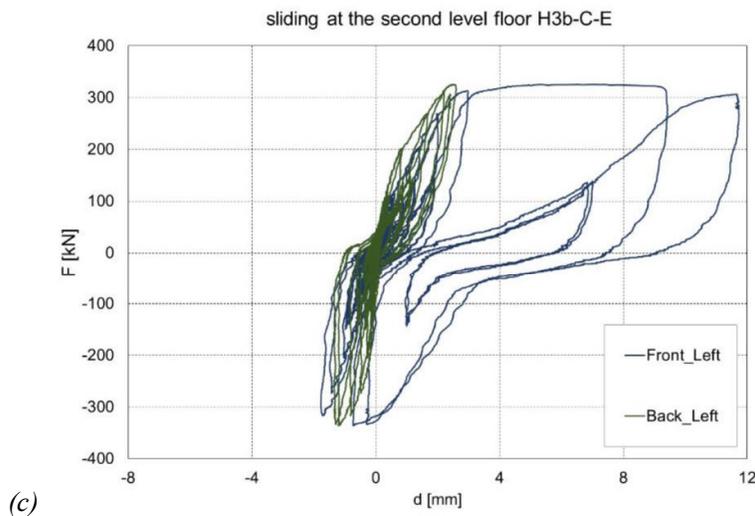
Figure 3.54. H3b panel sliding at 2<sup>nd</sup> level floor

At the +130% target displacement, sliding at the 1<sup>st</sup> level floor (Figure 3.54b) ranged from 22.3 mm to 25.6 mm, while at the -130% target displacement, it was between 6.8 mm and 22.5 mm. These values contributed approximately 10% of the total lateral displacement of the 2-storey shear wall. However, despite the significant contribution, only a minor reduction in strength was observed, and there was a slight increase in stiffness.

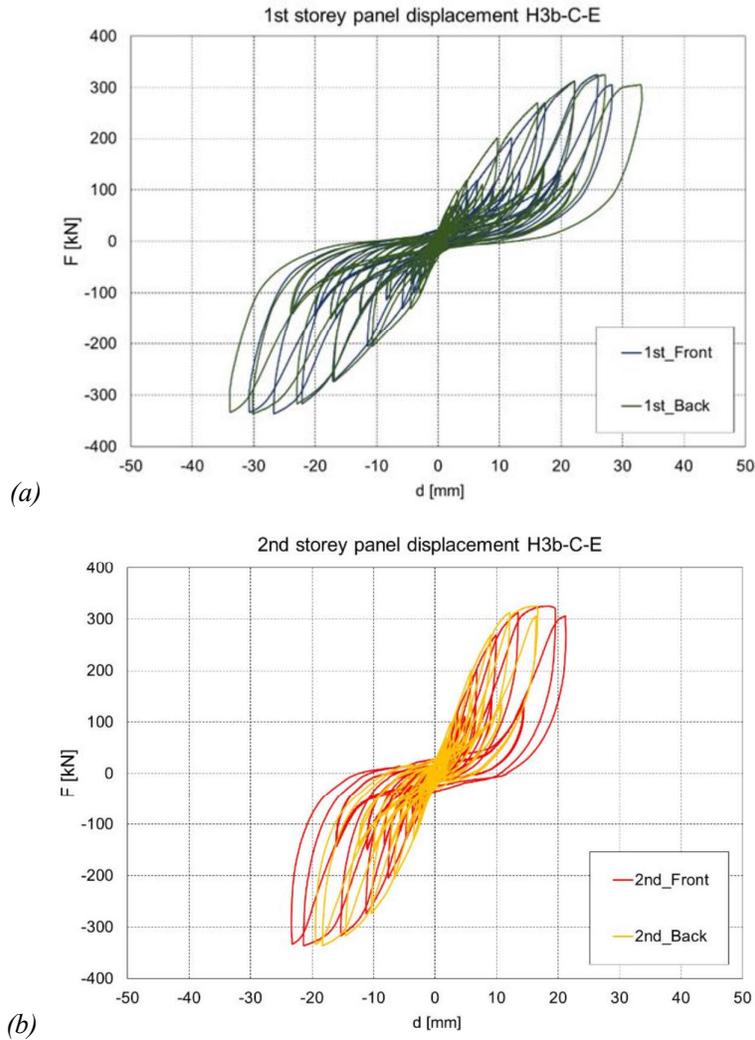
Figure 3.55. H3b panel displacements at: a) 1<sup>st</sup> storey, b) 2<sup>nd</sup> storey

The load-displacement curves of the 1<sup>st</sup> storey exhibited quasi-linear envelope patterns and remained so up to the +100% target displacement. At this displacement, the total load ( $F_{@+100\%}$ ) reached 267 kN. Panel slips at the +100% target displacement (Figure 3.55a) were approximately 25 mm, with negligible differences observed between the back and front panels or between the positive and negative cycles.

The panel slips in the 2<sup>nd</sup> storey shear wall (shown in Figure 3.55b) create a linear envelope up to the designated target displacement of +100% at this target displacement, the panel slipping measured approximately 9.5 mm. This slippage increased to 12.8 mm, when the target displacement of +130% was achieved with the same trends in back and

front panel and positive and negative cycles, also, no failures were observed in the spline connections, and there was no compression as the inner corners.

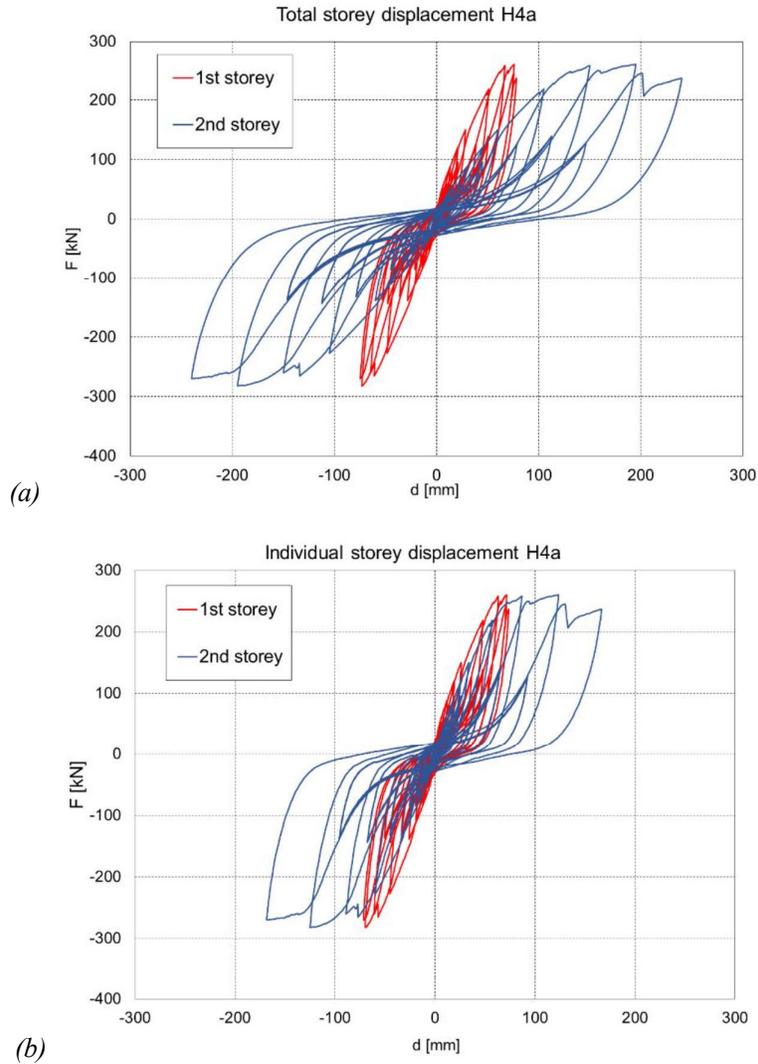
Figure 3.56. H4a (a) total storey displacements, (b) individual storey displacements

The horizontal storey displacements are illustrated in Figure 3.56. As illustrated in Figure 3.56a, the envelope of the load-displacement curve was almost linear up to the 100% target displacement of 150 mm, with a maximum load of 257 kN. In the next cycle, where the top actuator moved to 195 mm, the total load increased slightly to 259 kN. However, during the last cycle, which involved a displacement of 240 mm (160% of the target displacement), some components of the load-resisting system failed, causing the total load  $F_{@+160\%}$  to decrease to 235 kN.

Both the positive and negative load-displacement curves had a similar shape, and the maximum negative force occurred at -130% of the target displacement,  $F_{@-130\%}$ , with a value of 282 kN. At this displacement, the 1<sup>st</sup> floor lateral displacements were 76 mm and -73 mm for the positive and negative directions, respectively. Meanwhile, the 2<sup>nd</sup> storey displacements were 119 mm and -122 mm, making them approximately 60% larger than those of the 1<sup>st</sup> floor (see Figure 3.56b).

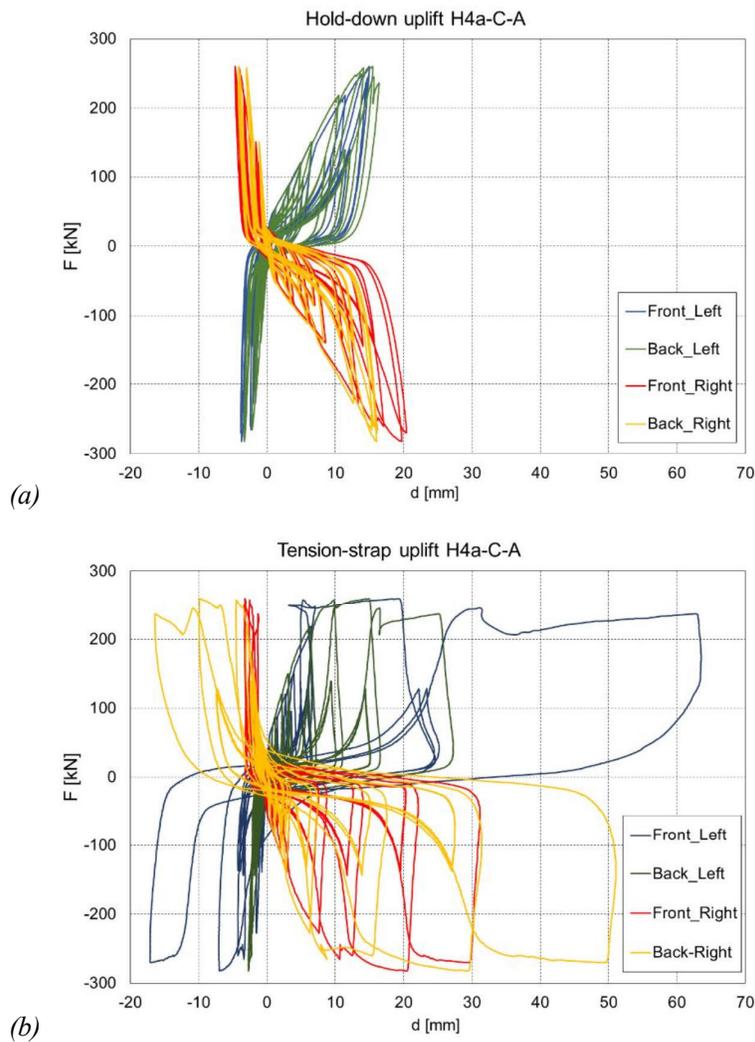
Figure 3.57. H4a uplifts at (a) the HDs, (b) tension straps

Figure 3.57 shows the vertical uplift experienced by the four HD and tension straps. The load-displacement curves for all HD were nearly linear up to the +130% target displacement, at which point the total load  $F_{@+130\%}$ , reached 259 kN. On the left side of the shear wall, the corresponding HD uplifts (Figure 3.57a) were 15.5 mm and 15 mm. At the -130% target displacement, the uplifts on the right side of the shear wall were 19.7

mm and 16 mm for the front and back HD, respectively. The negative HD uplifts indicate compression in the panel corners, with maximum compressions reaching 4.7 mm.

At the +130% target displacement, the tension strap uplifts on the left side of the shear wall measured 19.5 mm and 15 mm (Figure 3.57b). However, during the +160% target displacement, they significantly increased to 63 mm and 25.3 mm, indicating a sign of failure. On the right side of the shear wall, the tension strap uplifts were 20.5 mm and 29.5 mm, suggesting the onset of failure. In the subsequent displacement cycle, the uplifts exceeded 50 mm, further indicating the failure of the tension straps screws.

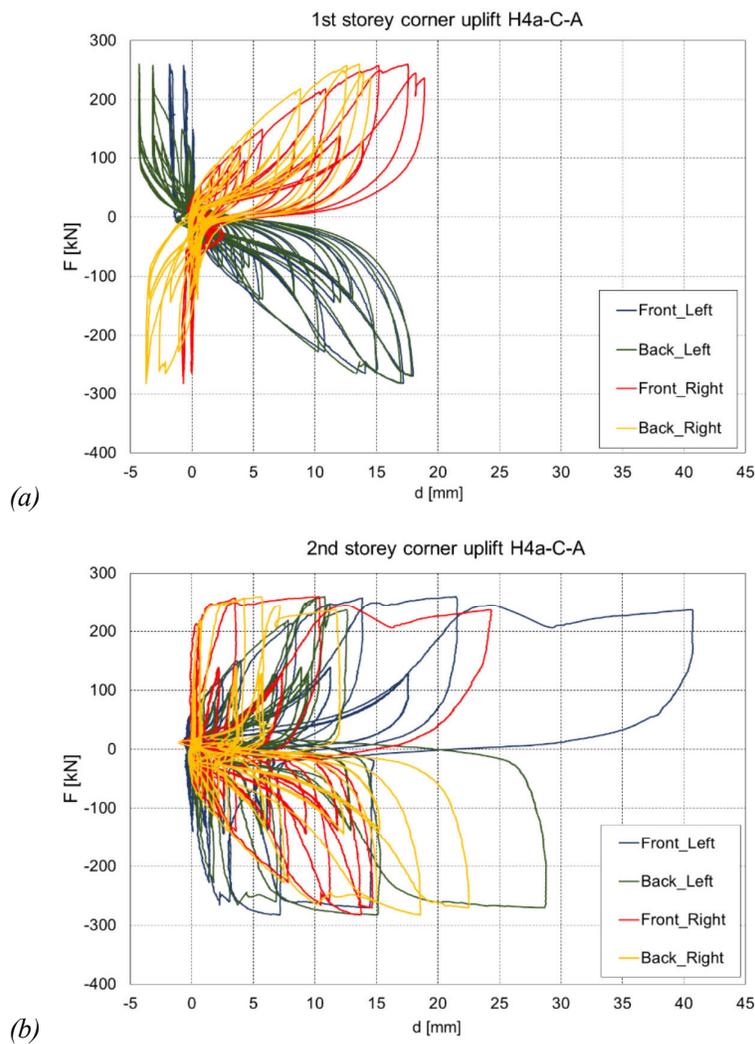
Figure 3.58. H4a inner corner uplifts at (a) 1<sup>st</sup> storey, (b) 2<sup>nd</sup> storey

The curves in Figure 3.58 illustrates the vertical uplift experienced in the four inner corners of the shear wall panels. The load-displacement curves showed quasi-linear behavior until reaching a displacement target of +70%, at which point the total load  $F_{@+70\%}$  reached 218 kN. In the 1<sup>st</sup> storey shear wall (Figure 3.58a), front and back right corners experienced uplifts of 10.8 and 8.8 mm. When the displacement target was set to -70%, uplifts on the right side of the shear wall varied from 10.2 mm to 10.8 mm, the differences between positive and negative target displacements were minimal.

Negative uplifts indicate compression in the panel corners, with the front panels experiencing uplifts close to 1 mm and the back panels ranging from 1.5 mm to 3.1 mm at +/-70% target displacement. In the 2<sup>nd</sup> storey shear wall (Figure 3.58b), uplifts in the inner corners ranged from 7.5 mm to 8.5 mm at the +/-70% target displacements. These values increased to a range of 24 mm to 41 mm at +/-160% target displacement when the structure exceeded its capacity. Compression was not observed as the inner corners.

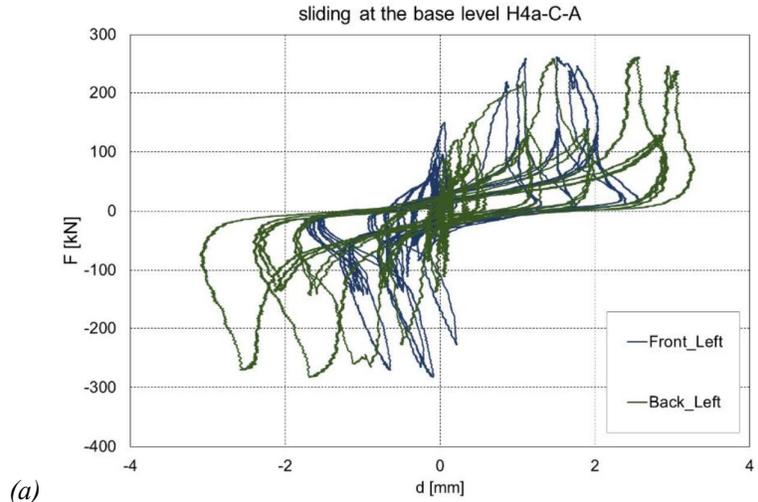
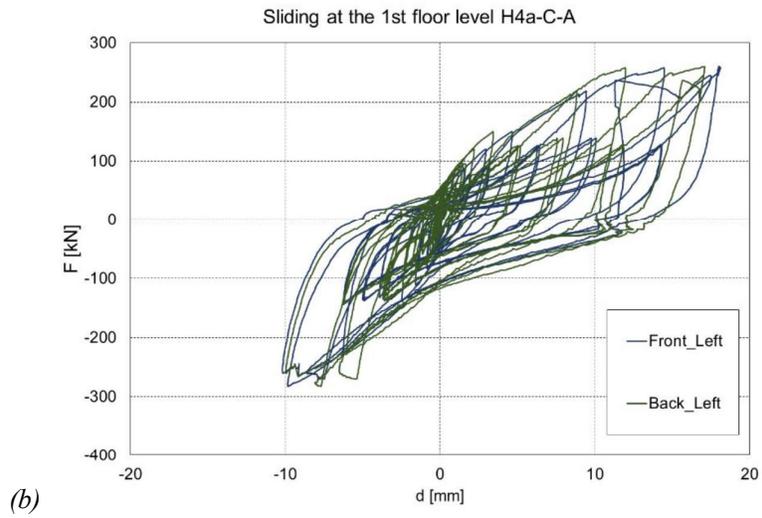
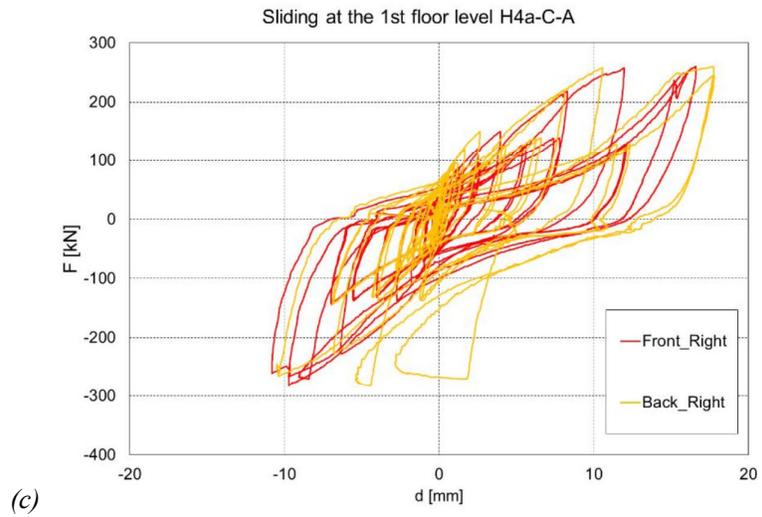
Figure 3.59. H4a panel sliding at a) base level, b) 1<sup>st</sup> level left, c) 1<sup>st</sup> level right

At the base level (Figure 3.59a), the sliding was minimal, with maximum values of 1.5 mm and 2.6 mm for the front and back side panels, respectively, at the +130% target displacement. At the 2<sup>nd</sup> level floor (Figure 3.59c), the sliding values were 3.1 mm and 10.5 mm, and 2.2 mm and 3.3 mm at the +/-130% target displacement, respectively. These values increased to 13 mm and 4.6 mm, respectively, indicating failure in the back left SB. This failure is indicated by the increased sliding. However, it should be noted that the overall contributions of sliding at the base level and the 2<sup>nd</sup> level floor accounted for less than 6% of the total storey displacement.

At the 1<sup>st</sup> level floor (Figure 3.59b), the sliding reached values ranging from 16.6 mm to 18 mm at the +130% target displacement, and from 4.4 mm to 9.8 mm at the -130% target displacement. These sliding values contribute approximately 8% of the overall lateral displacement of the 2-storey shear wall.

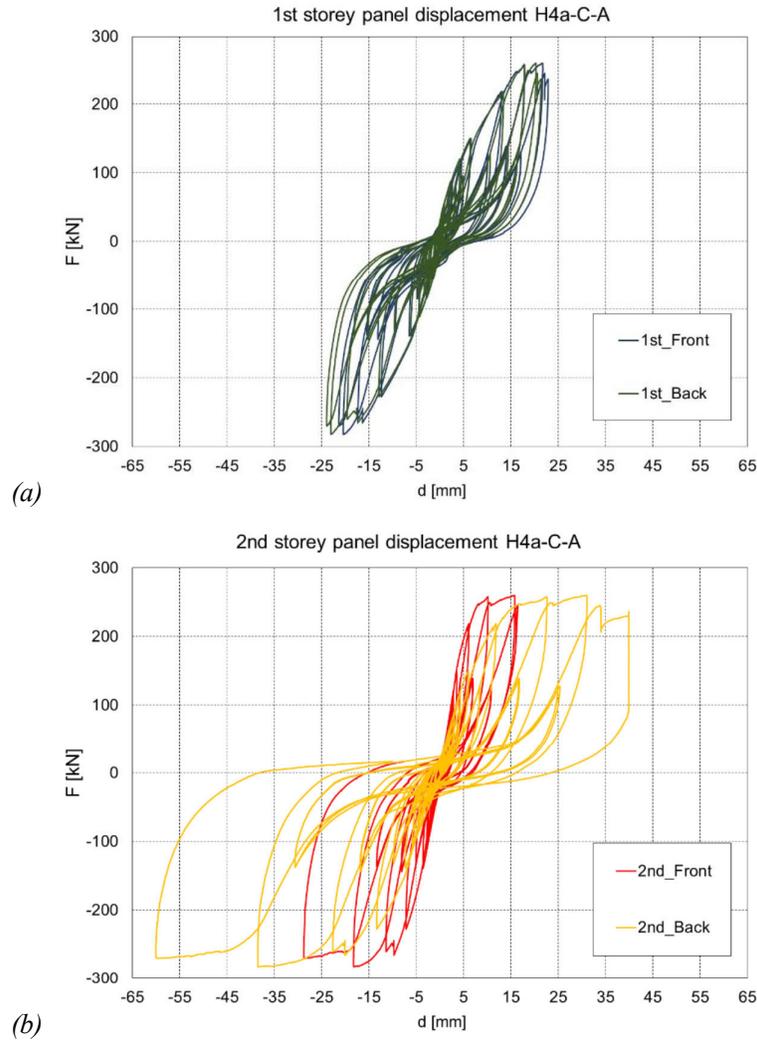
Figure 3.61. H4a panel displacements in test, a) 1<sup>st</sup> storey, b) 2<sup>nd</sup> storey

Figure 3.61 presents the Panel-to-panel slips of coupled panel shear walls. The load-displacement curves for the first floor showed quasi-linear behavior up to a +130% target displacement, corresponding to a total load  $F_{@+130\%}$  of 259 kN. The panel slips, as shown in Figure 3.61a, were approximately 21 mm, with negligible differences observed between the back and front panels or between positive and negative cycles.

In the 2<sup>nd</sup> storey shear wall (Figure 3.61b), the panel slips exhibit a linear envelope up to a +70% target displacement, corresponding to a total load of approximately 218 kN. At the +70% target displacement, the slipping values were 6.1 mm (front panel) and 11 mm (back panel), while at the -70% target displacement, they were 7.2 mm (front panel) and 13.4 mm (back panel). During the subsequent cycles, when pushed to the 130% target displacement, the spline connection in the back panel failed, resulting in a slip of 39 mm.

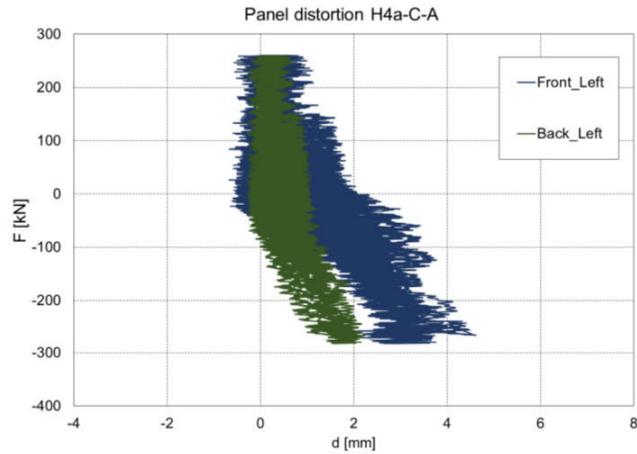
Figure 3.62. H4a panel distortion

Figure 3.62 presents measurements of distortion in two 1<sup>st</sup> storey panels. These panels primarily experienced distortion during their compression cycles, with maximum values reaching 4.6 mm and 2.2 mm in front and back panels, respectively. In contrast, the distortion during their tension cycles was considerably lower, approximately 0.1 mm for the front panel and back panel.
