**EXPERIMENTAL INVESTIGATION ON THE STRUCTURAL PERFORMANCE  
OF TWO-STOREY CROSS-LAMINATED TIMBER SHEAR WALLS**

**Sedigheh Gheisari**

THESIS SUBMITTED IN PARTIAL FULFILLMENT OF  
THE REQUIREMENTS FOR THE DEGREE OF  
ENTER DEGREE NAME  
IN  
ENGINEERING

UNIVERSITY OF NORTHERN BRITISH COLUMBIA

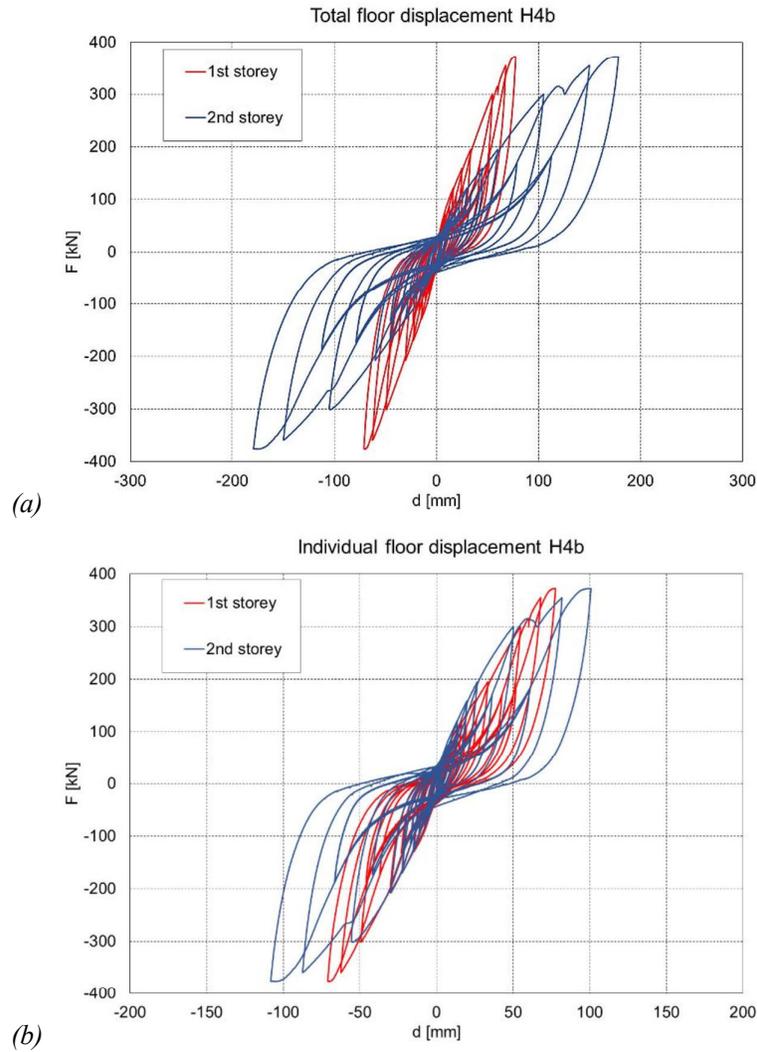
Figure 3.63. H4b (a) total storey displacements, (b) individual storey displacements

The horizontal storey displacements are illustrated in Figure 3.63. It must be noted that test #H4b was stopped at the 130% target displacement because the maximum actuator capacity was reached. The envelope of the load-displacement curve exhibited quasi-linear behavior up to 100% of the target displacement (equivalent to 150 mm) with a maximum load of 355 kN.

In the next cycle, the total load reached 373 kN at +130%, due to the actuator capacity limitation, preventing the structure from being pushed further. No signs of degradation in strength or stiffness were observed. The positive and negative envelopes were similar, with the maximum negative force occurring at -130% of the target displacement, reaching 376 kN. The lateral displacements of the 1<sup>st</sup> storey for the +/- 100% target displacements were 68 mm and -63 mm, respectively. The 2<sup>nd</sup> storey lateral displacements were approximately 30% larger, measuring 82 mm and -87 mm.

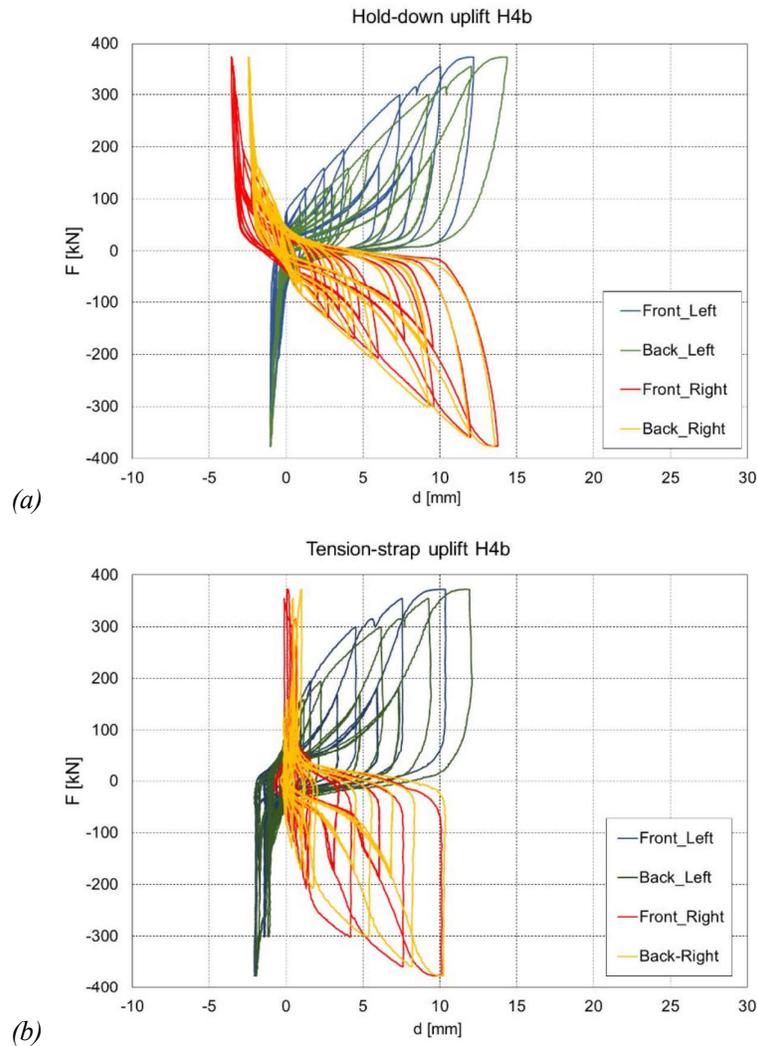
Figure 3.64. H4b uplifts at (a) the HDs, (b) tension straps

The vertical uplift experienced in the four HD and tension straps (two on the front shear and back shear walls each) are illustrated in Figure 3.64. The envelopes of the load-displacement curves were all quasi-linear up to the +100% target displacement when the total load  $F_{@+100\%}$  reached 355 kN. The corresponding HD uplifts (Figure 3.64a) on the left side of the shear wall were 10 mm and 12 mm. At the -100% target displacement, the uplifts on the right side of the shear walls were 12 mm and 12.1 mm. The maximum compressions at the +/-100% target displacements ranged from 1 mm to 3.4 mm.

At the +100% target displacement, the tension straps on the left side of the shear wall experienced uplifts of 7.6 mm and 9.3 mm (as shown in Figure 3.64b). On the right side, the uplifts for the tension straps were measured at 7.6 mm and 8.2 mm.

The negative uplifts of the tension straps indicate compression occurring in the corners of the panel. The maximum compressions observed on the left side at the +100% target displacement were 2 mm, while no compression was observed on the right side.

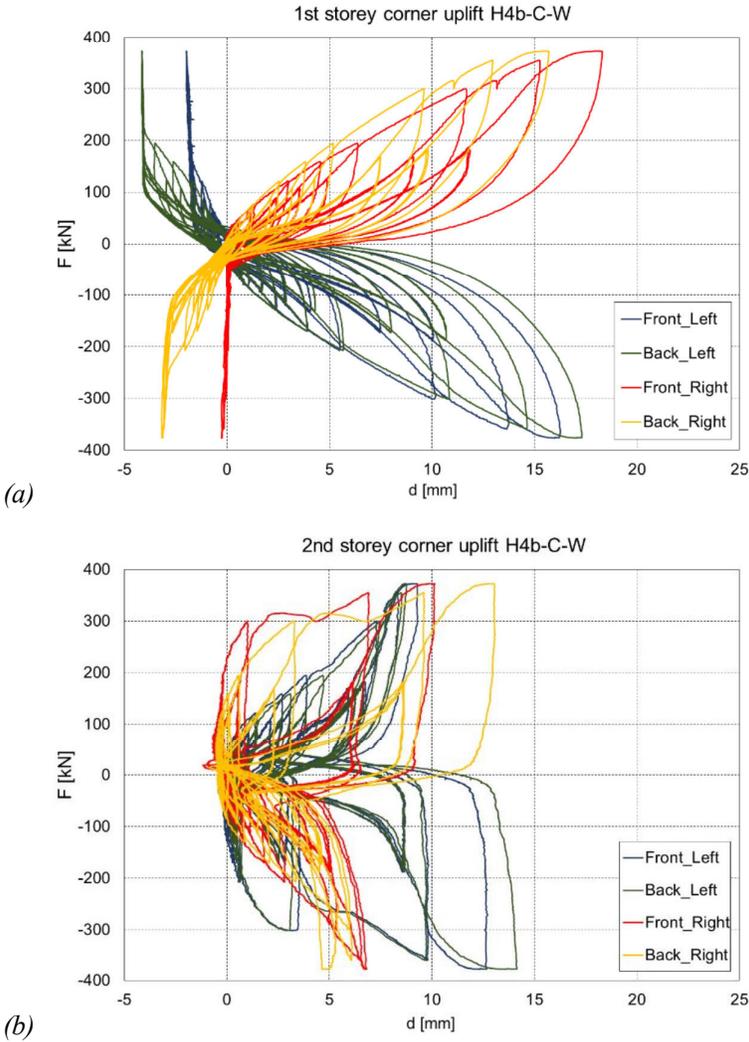
Figure 3.65. H4b inner corner uplifts at (a) 1<sup>st</sup> storey, (b) 2<sup>nd</sup> storey

Figure 3.65 illustrates the vertical uplift experienced in the four inner corners of the coupled shear walls. The load-displacement curves exhibited quasi-linear behavior up to the +100% target displacement, with a total load of 355 kN at  $F_{@+100\%}$ . In the 1<sup>st</sup> storey shear wall (Figure 3.65a), the corresponding right inner corner uplifts were measured 15.3 mm and 13 mm. At the -100% target displacement, the uplifts on the left side of the shear wall ranged from 13.7 mm to 14.6 mm. The differences between positive and negative target displacements were minimal. The negative uplifts corresponded to compression in

the panel corners, with the front left panel showing uplift close to zero and the other panels ranging between 2 mm and 4.1 mm.

In the 2<sup>nd</sup> storey shear wall (Figure 3.65b), the inner corner uplifts ranged from 6.1 mm to 9.8 mm at the +/-100% target displacements and increased to values between 10.1 mm and 13.6 mm during the subsequent cycle. No compression was observed as the inner corners were consistently slightly lifted by the opposite side panel during uplift.

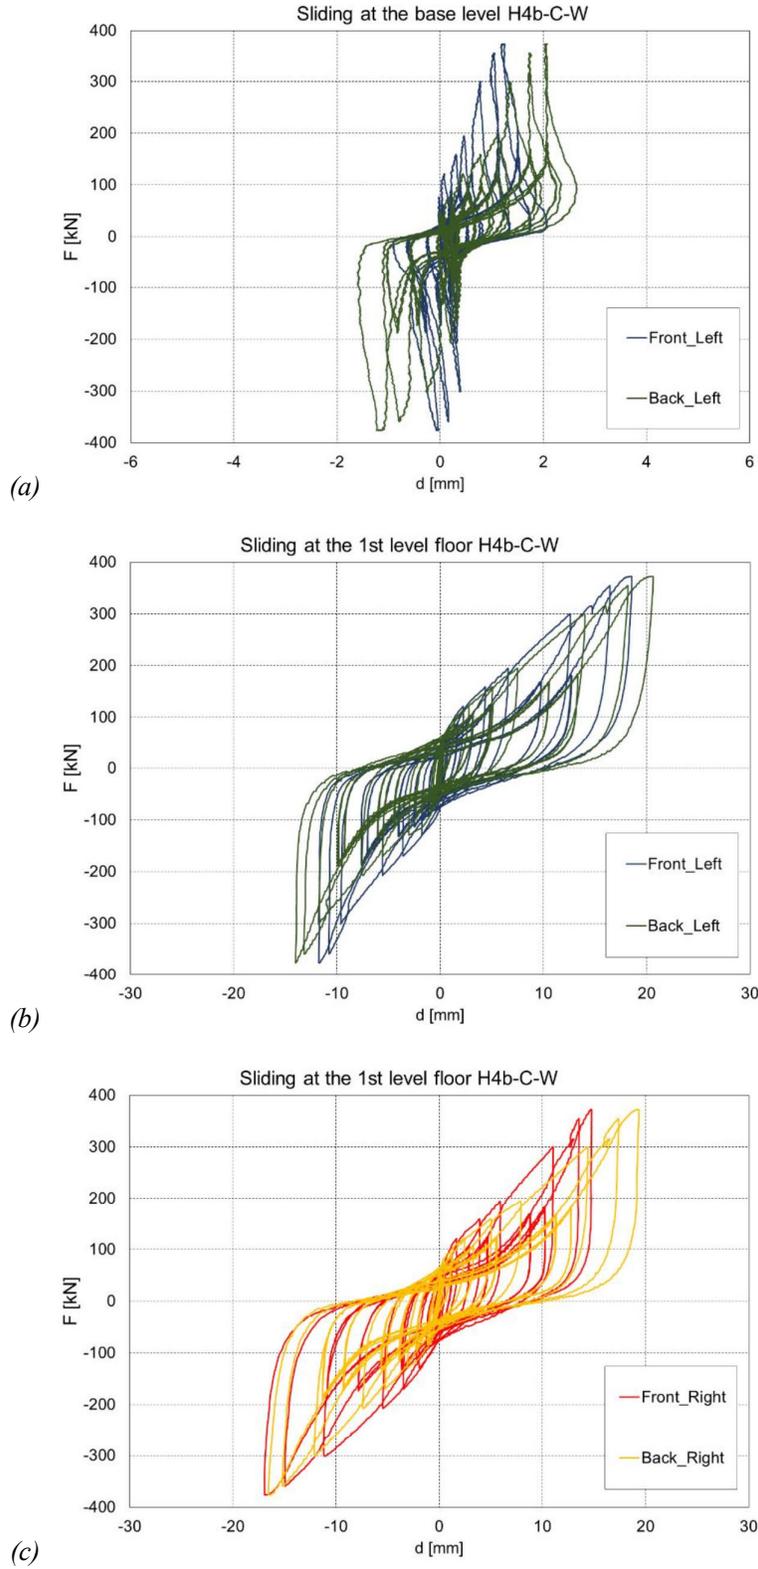
Figure 3.66. H4b panel sliding at a) base level, b) 1<sup>st</sup> level floor, c) 2<sup>nd</sup> level floor

The sliding values at each level (base level, 1<sup>st</sup> level floor, and 2<sup>nd</sup> level floor) are shown in Figure 3.66. Herein, all displacements are plotted against the total applied load. The base level sliding (Figure 3.66a) was minimal, with maximum values of 1.2 mm and 2.1 mm for the front and back side panels, respectively, at +130% target displacement. At the 2<sup>nd</sup> level floor (Figure 3.66c), the sliding was more significant, with values of 3.17mm to 17 mm at the +130% target displacement, and -2.6 mm and -20.8 mm at the -130% target displacement. Based on these findings, it can be concluded that the maximum sliding observed at the 2<sup>nd</sup> floor in this structure accounted for almost 10% of the storey displacement.

At the 1<sup>st</sup> level floor (Figure 3.66b), the sliding ranged from 14.8 mm to 20.5 mm at the +130% target displacement and from 11.8 mm to 17 mm at the -130% target displacement. These sliding values contribute approximately 10% to the overall lateral displacement of the 2-storey shear wall. No strength degradation was observed, and in fact, the stiffness appears to be increasing.

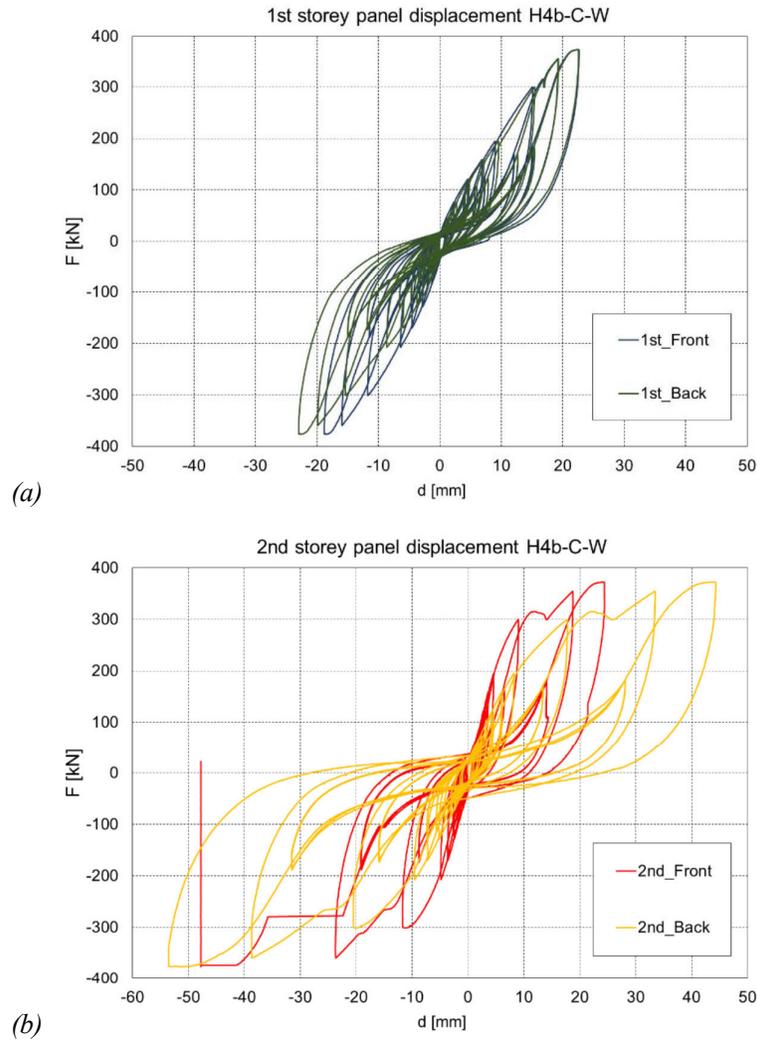
Figure 3.68. H4b panel displacements in test, a) 1<sup>st</sup> storey, b) 2<sup>nd</sup> storey

The Panel-to-panel slips are shown in Figure 3.68. The load-displacement curves of the 1<sup>st</sup> storey exhibited quasi-linear behavior up to the +100% target displacement, with a total load  $F_{@+100\%}$  355 kN (Figure 3.68a). The corresponding panel slips were approximately 19.2 mm; they reached 22.3 mm in the following cycle, with negligible variations between the back and front panels or positive and negative cycles.

The panel slips in the 2<sup>nd</sup> storey shear wall (Figure 3.68b) exhibited a linear envelope until reaching the +/- 70% target displacement. At +70%, the slipping values were 9 mm (front) and 17.8 mm (back), while at -70% target displacement, they were 11.6 mm (front) and 20.5 mm (back). However, during the subsequent cycles when pushed to the -130% target displacement, the spline connection in the front panel failed.

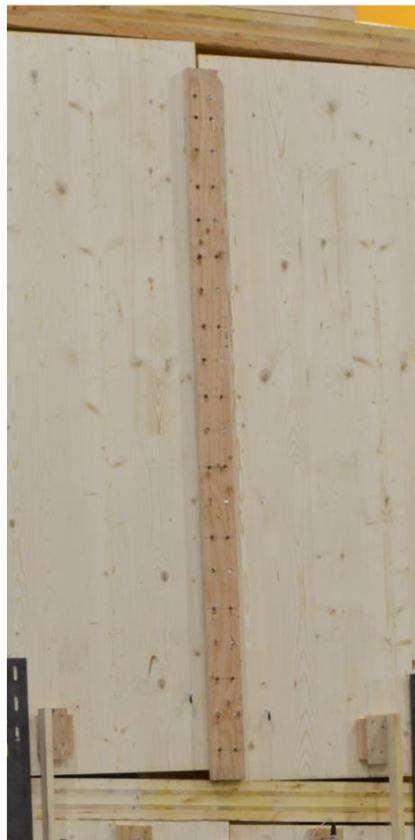
Spline connections with screw fasteners within vertical shear walls permitted some slipping between the wall segments as they rocked as is shown in Figure 3.69.

*Figure 3.69. Relative displacement of the wall segments during CW rocking*

All coupled walls displayed rocking behavior, and as lateral displacement increased, there were instances of slight plastic deformations in the spline joint connections. The significant vertical displacement among these segments led to the spline screws yielding, marking the initial occurrence of yielding in the structures that was followed by some local crushing of spline or CLT panel eventually. This was the main source of energy dissipation in the CLT structures and confirming the successful achievement of the fundamental design goal for a flexible spline joint. Figure 3.70 displays the failure of the plywood spline joint (Figure 3.70a), the screws within it (Figure 3.70b), and the CLT panel located beneath the spline joint (Figure 3.70c). In structure #H4b, the presence of a perpendicular shear wall constrained the uplift forces in HD and tension straps. Consequently, the failure of spline screws is most prominent in this structure.

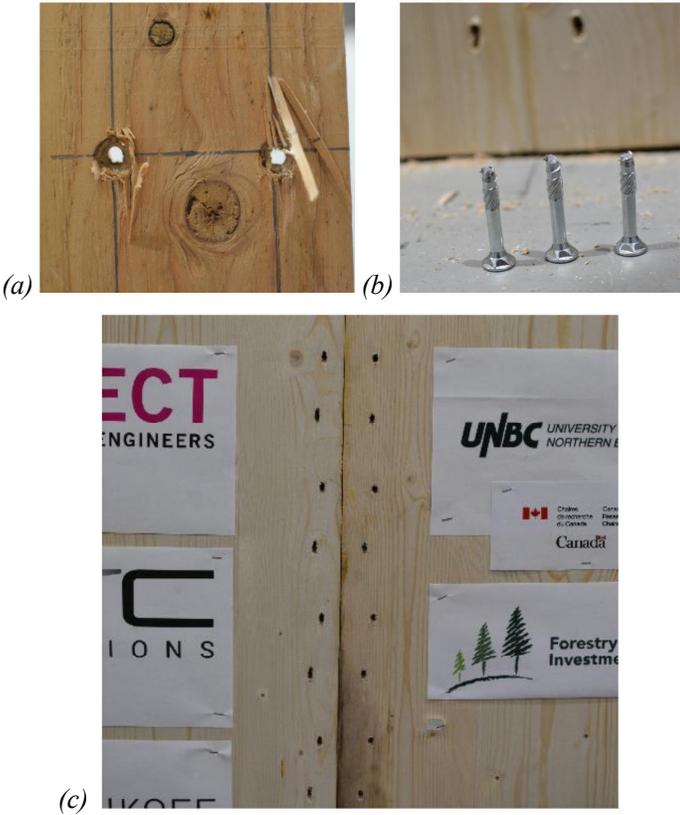
Figure 3.70. Spline joint after test: a) plywood, b) screws, c) CLT panel under spline

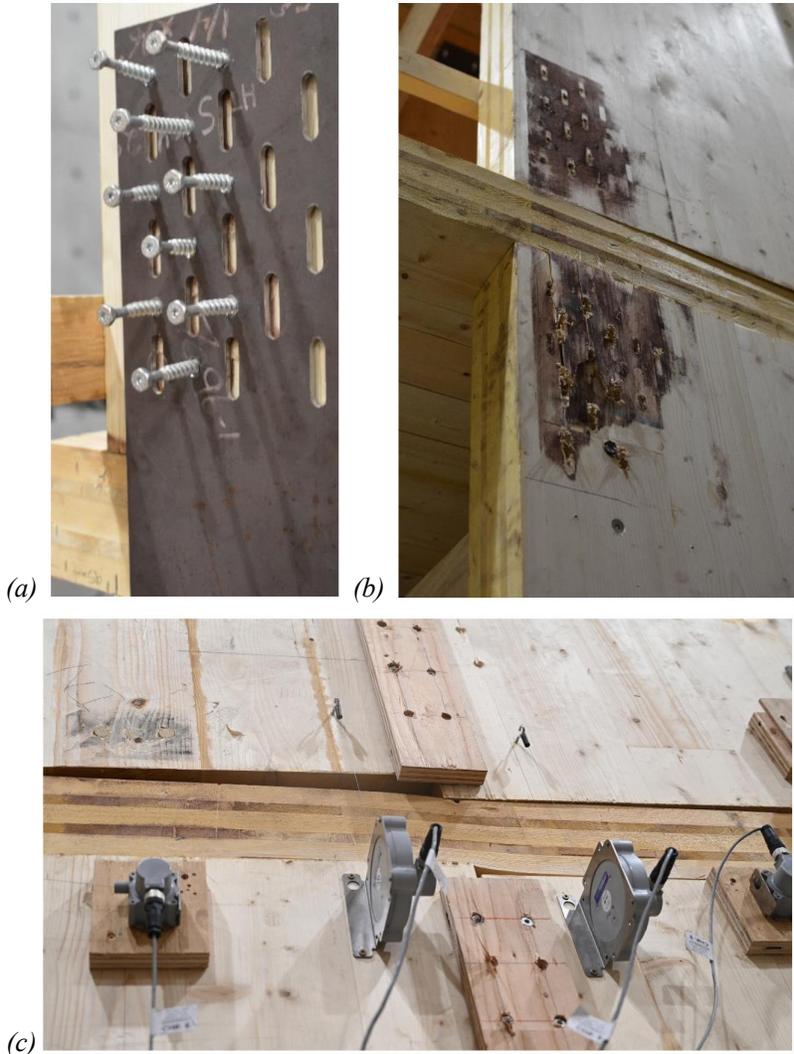
The rocking of the 2<sup>nd</sup> floor walls occurred due to the deformation of the screws holding the tension straps and consequently the penetration of the inner corners of the shear walls into the floor panels. Consequently, this rocking motion led to the failure of the tension strap screws and the CLT panel underneath it (see Figure 3.71) and the bending of the 1<sup>st</sup> floor panel that resulted in a slight rolling shear of minor layers of the 1<sup>st</sup> floor panel. The greater uplift in the tension strap of #H2a, caused by a 90° inclination angle, led to more embedment in the CLT panel under the tension strap compared to the other structures.

*Figure 3.71. Tension strap after test: a) screws, b) CLT panel under tension strap, c) floor panel bending*

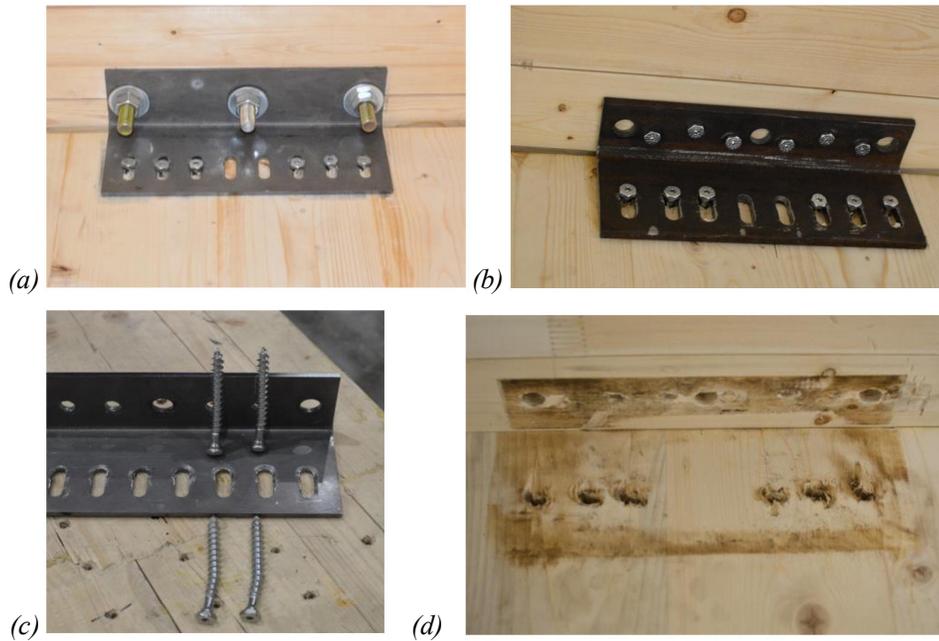
The sliding of the 1<sup>st</sup> storey SB, led to some deformation in the bracket (Figure 3.72a and b) and failure of their STSs as illustrated in Figure 3.72, in addition, the embedment in the CLT panel under SB was observed. Since the highest values of sliding, due to replacing the bolts with STSs, happened in the structure #H3b the maximum embedment was witnessed in this structure, see Figure 3.72d.

*Figure 3.72. SB after test: a, b) deformed SB, c) deformed screws, d) embedment in the CLT panel under SB*

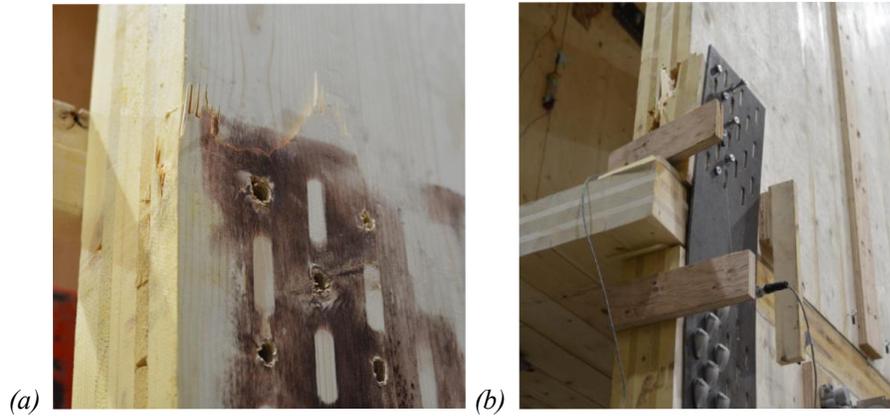
The least favorable type of failure is the brittle failure of the CLT panel, and this has happened in the region of the tension strap connections in the structures #H3a and #H4 at the final stages of testing, particularly when subjected to the highest tension strap uplift. As illustrated in Figure 3.73a, a tensile crack running parallel to the wood grain in the panel's surface layer formed along the upper row of the tension strap screws, ultimately resulting in the delamination failure. And as demonstrated in Figure 3.73b, the shear wall of the structure #H4a underwent the plug shear of lamellas just behind the tension strap. A combination of rolling shear and delamination can be observed in this zone.

*Figure 3.73. Brittle local failure in the corner of CLT panel after test: a) H3a, b) H4a*

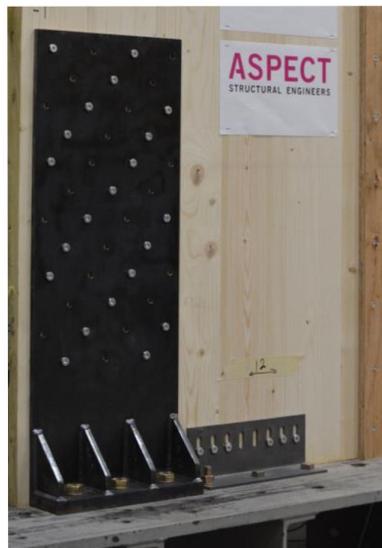
The 1<sup>st</sup> storey HDs remained intact because the wall uplift did not surpass the ultimate displacement capacity of the HDs. Only minor screw yielding was observed, while the HDs themselves were virtually undamaged. Since the structure #H1 lacked additional mass on the floors, the wall's rocking capacity was quite limited, and there was only minor failure in the 1<sup>st</sup> storey connections, see Figure 3.74. The base sliding in all structures was very small, and no signs of damage were evident in the base SB, thereby affirming the intended design objective of elastic shear brackets.

*Figure 3.74. HD after testing*

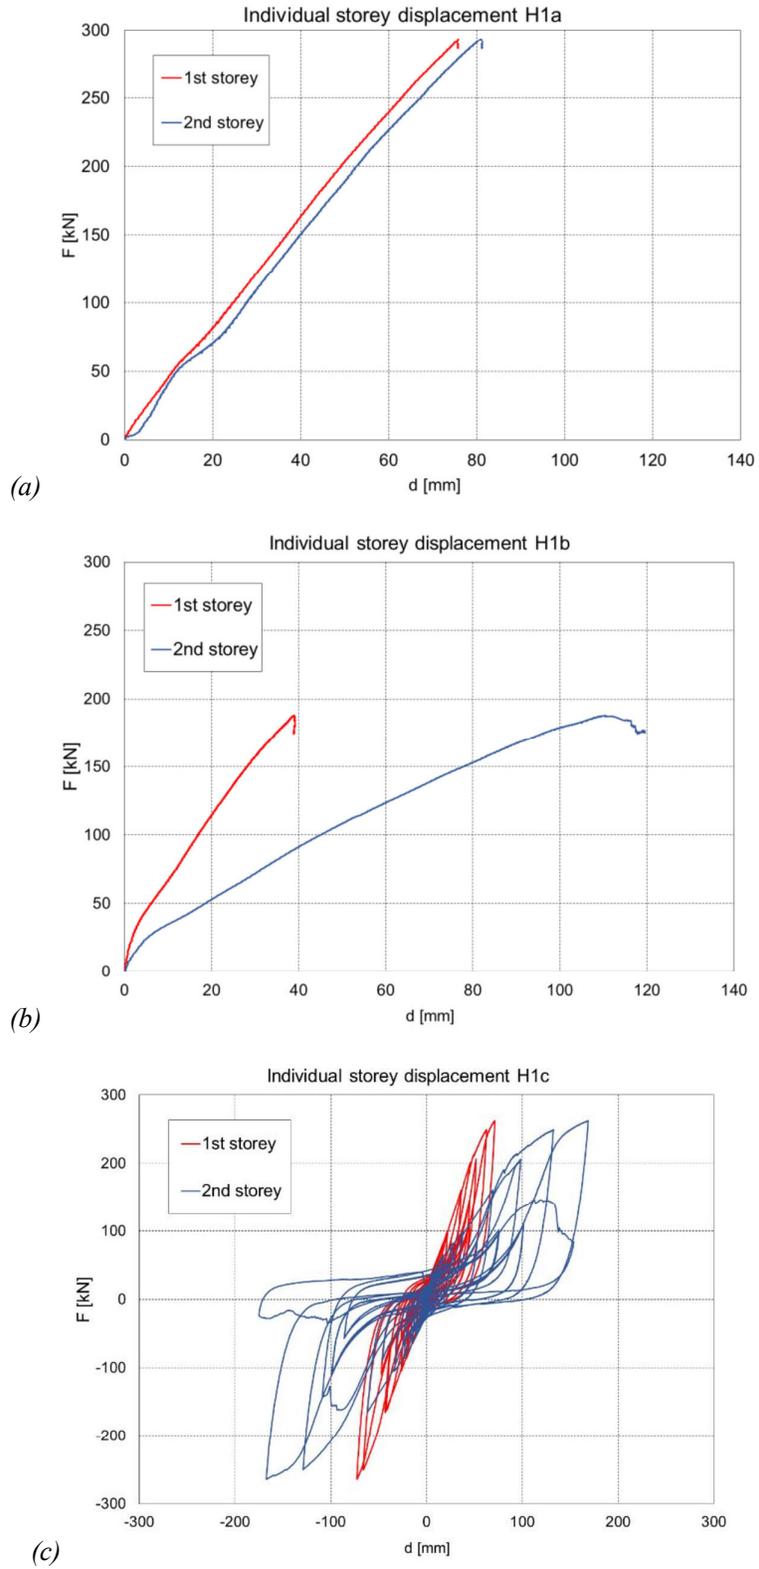
The monotonic tests conducted on structure #H1, designated as #H1a and #H1b for pulling and pushing forces, respectively, are compared with the findings of the cyclic test performed on the corresponding structure labeled #H1c. In the Figure 4.1 the load-displacement curves for these three tests are presented. The 2<sup>nd</sup> storey displacement in the test #H1a is almost equal to the 1<sup>st</sup> storey displacement while, it is 3 times in the #H1b, and two times in the cyclic test #H1c at +100% target displacement.

Figure 4.1. Individual floor displacements at the test: (a) H1a monotonic pulling, (b) H1b monotonic pushing, (c) H1c cyclic

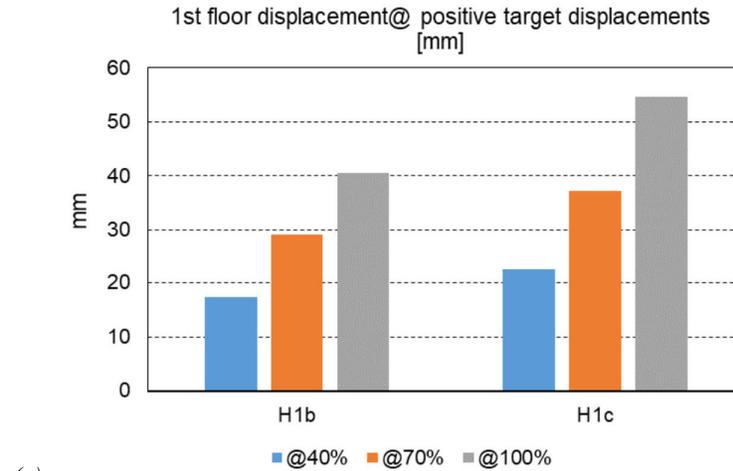
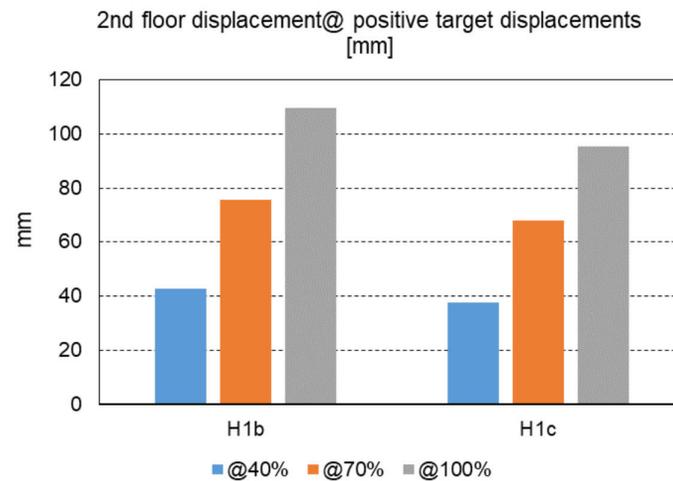
The 1<sup>st</sup> and 2<sup>nd</sup> storey displacements for these three tests at different target displacements can be seen in Figure 4.2 and Figure 4.3. Regarding structure #H1b, the 1<sup>st</sup> storey displacement in the monotonic test is smaller by approximately 27% and 34% compared to the corresponding values in the cyclic test #H1c at +70% and +100% target displacement. In contrast, the 2<sup>nd</sup> storey displacement in structure #H1b is higher by around 10% and 13% compared to the corresponding values of structure #H1c. The distribution of lateral displacement across different stories depends on the stiffness of their connections. Consequently, it was expected that the displacement of the 2<sup>nd</sup> floor, during cyclic tests, will be greater because of the stiffness degradation in tension straps compared to the monotonic test. In contrast, the stiffness of HDs remained relatively stable without significant degradation throughout the test to emphasise the importance of tension strap stiffness in lateral displacements.

Figure 4.2. Lateral displacements for the tests conducted on structure #H1b and #H1c at positive cycles, (a) 1<sup>st</sup> floor, (b) 2<sup>nd</sup> floor [mm]

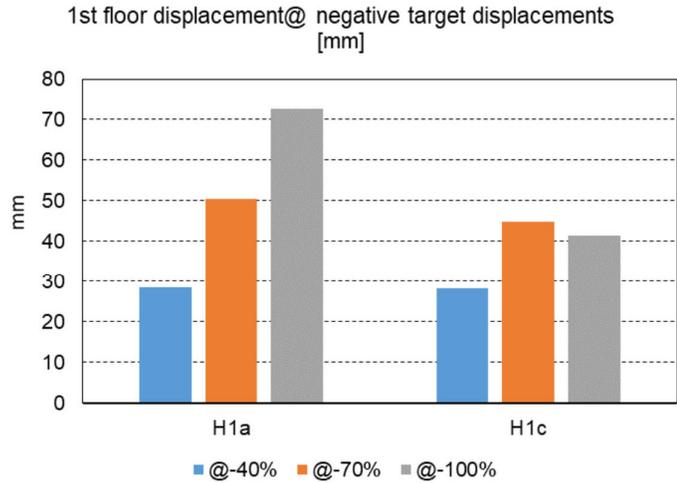
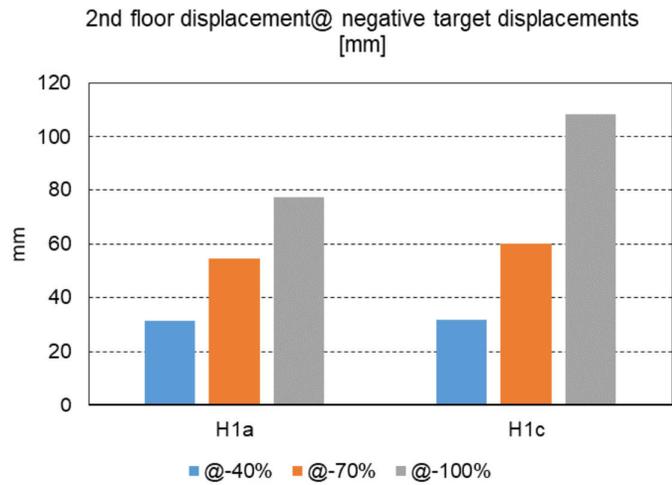
During test #H1a the load pattern differed from all other tests, as  $F_{total} = 2.1 F_{lead}$  indicating that  $F_2 = 1.1 F_{lead}$ , while  $F_2 = 0.5 F_{lead}$  in the cyclic test #H1c. The 1<sup>st</sup> storey displacement in the monotonic test is greater by approximately 10% and 40% compared to the corresponding values in the cyclic test #H1c at -70% and -100% target displacement due to different loading pattern used for this structure. Conversely, the 2<sup>nd</sup> storey displacement in structure #H1a is lower by around 11% and 40% compared to the corresponding values of cyclic test of #H1c.

Figure 4.3. Lateral displacements for the tests conducted on structure #Hb and #H1c at negative cycles, (a) 1<sup>st</sup> floor, (b) 2<sup>nd</sup> floor [mm]

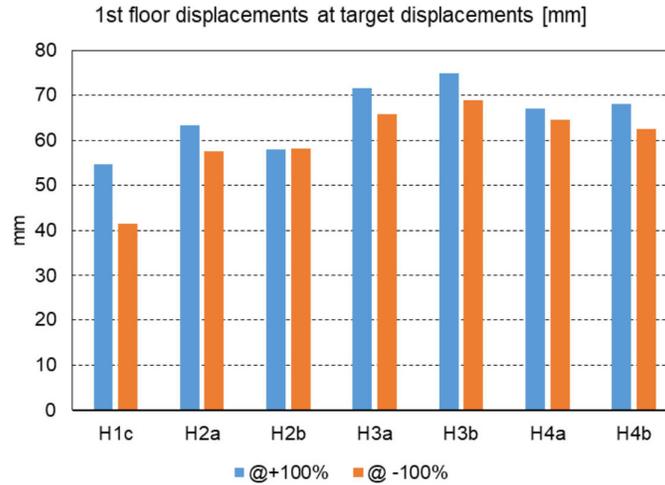
The horizontal displacements for the 1<sup>st</sup> and 2<sup>nd</sup> floors of all structures under cyclic loads at +/- 100% and +/-130% target displacements are represented in Figure 4.4 to Figure 4.7. The lateral displacements are contingent upon the structure's stiffness distribution, i.e. the SB resisting sliding, HD and tension straps controlling uplifts.

Figure 4.4. 1<sup>st</sup> storey displacements @ +/- 100% target displacement

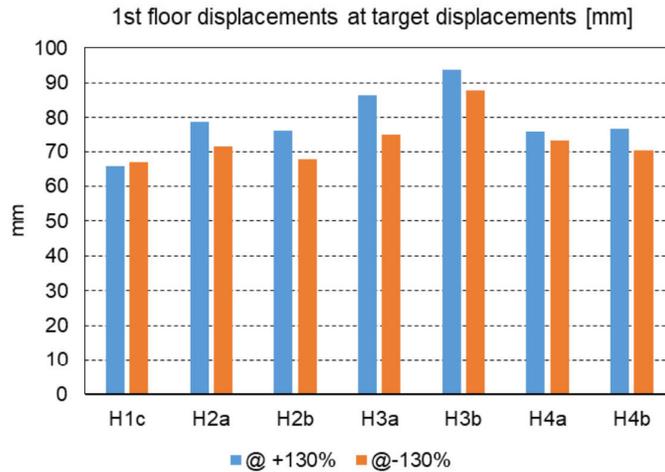
Figure 4.5. 1<sup>st</sup> storey displacements @ +/- 130% target displacement

Despite the same connections in the 1<sup>st</sup> storey, different lateral displacement values for the 1<sup>st</sup> storey are achieved. The largest 1<sup>st</sup> storey displacements were recorded for #H3b and #H3a that exhibited the minimum displacements on the 2<sup>nd</sup> floor (see Figure 4.6 and

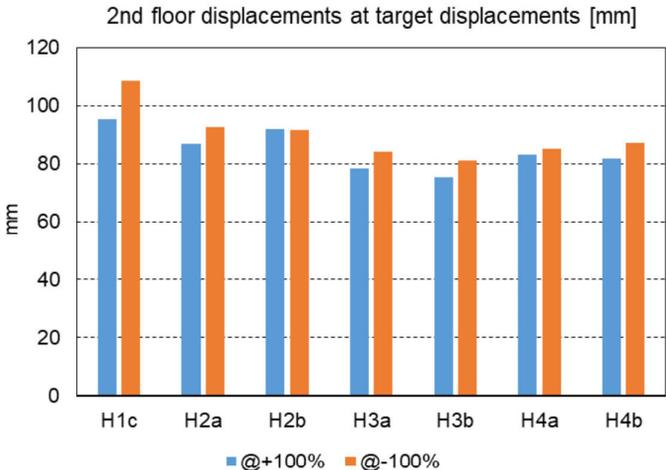
Figure 4.7). The largest displacement on the 2<sup>nd</sup> floor was observed in #H1c, accompanied with the smallest 1<sup>st</sup> storey displacement. Notably, #H1c featured the fewest STSs on the tension strap, set at 90° in while #H3a and #H3b in angle were equipped with additional STSs on the tension strap, set at 45° at the bottom. The difference in tension strap stiffness on the stiffness distribution within the structures resulting in a maximum difference of 40% in lateral displacements on the 1<sup>st</sup> floor across all structures.

Figure 4.6. 2<sup>nd</sup> storey displacements @ +/- 100% target displacements

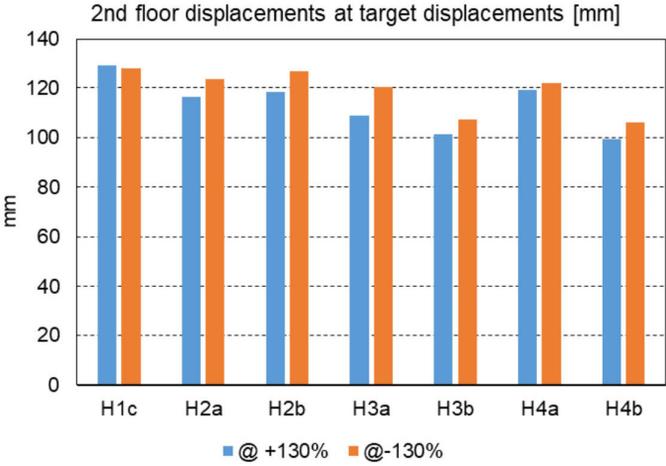
Figure 4.7. 2<sup>nd</sup> storey displacements @ +/- 130% target displacements

Structure #H2a, which included extra masses, displayed less variance in the lateral displacements of 78.8 mm and 116 mm in the 1<sup>st</sup> and 2<sup>nd</sup> stories compared to structure #H1c that exhibited 65.7 mm on the 1<sup>st</sup> floor and 129 mm on the 2<sup>nd</sup> floor. This suggests that strengthening the SB at the bottom of the 2<sup>nd</sup> storey shear wall and introducing dead load to the floors enhanced the overall performance. #H2a exhibited a 14% decrease in the difference between the ISD compared to #H1c.

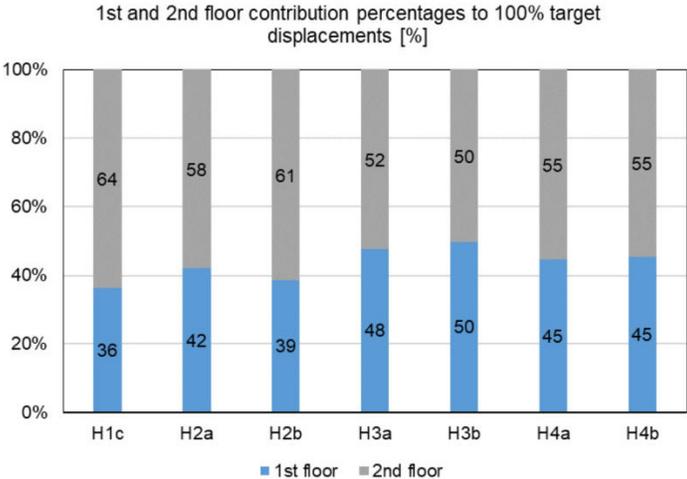
The cumulative lateral displacement, combining the lateral displacements of the 1<sup>st</sup> and 2<sup>nd</sup> floors, is assessed at the roof level to determine whether the structure has achieved the desired target displacements. The percentage contributions of the 1<sup>st</sup> and 2<sup>nd</sup> floors to a +100% target displacement (150 mm) and +130% target displacement (195 mm) are depicted in Figure 4.8 and Figure 4.9.

Figure 4.8. 1<sup>st</sup> and 2<sup>nd</sup> floor contribution percentages to +100% target displacement

bottom and top ends. Reviewing Figure 4.8, it is evident that the most comparable contributions of the 1<sup>st</sup> and 2<sup>nd</sup> stories to the lateral displacement were observed in #H3a, #H3b, and #H4b, which all utilized this tension strap configuration. While structure #H4b shared the same tension strap details as the others, the presence of a perpendicular shear wall limited the tension strap uplift to 10.8 mm at +130% target displacement.

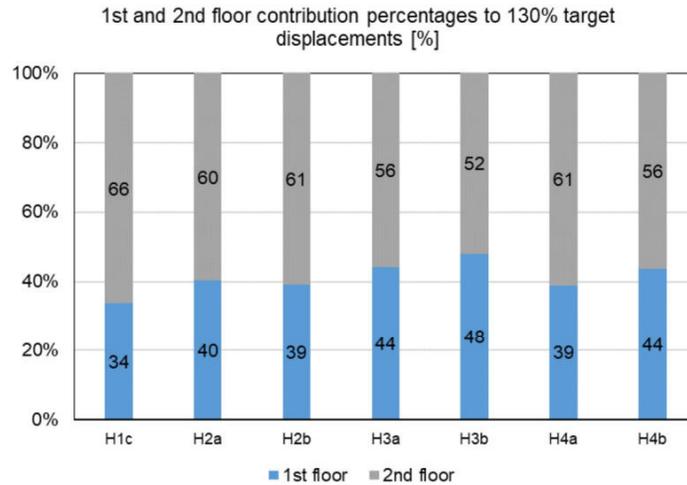
Figure 4.9. 1<sup>st</sup> and 2<sup>nd</sup> floor contribution percentages to +130% target displacement

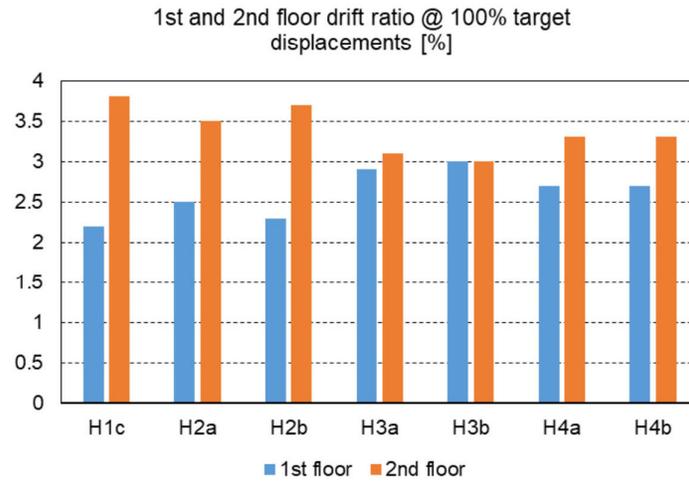
The corresponding drift ratios in the 1<sup>st</sup> and 2<sup>nd</sup> stories at 100% and 130% target displacement are shown in Figure 4.10 and Figure 4.11, the displacement at the 3% and 4% drift are illustrated in the Figure 4.12. Across all structures, the 2<sup>nd</sup> floor contribution percentages were higher than those of the 1<sup>st</sup> floor. Furthermore, as the target displacement increased from +100% to +130%, the contribution percentage of the 2<sup>nd</sup> floor also increased. This observation could be linked to the failure of the 2<sup>nd</sup> floor STSs, leading to a decrease in the spline joint and tension straps' stiffness, consequently resulting in increased displacement. Consistent ISD indicate uniform stiffness across a structure's height, offering many benefits including reducing damages to both structural and non-structural elements, improving overall structural integrity, and facilitating uniform energy dissipation throughout the height of the buildings.

Figure 4.10. 1<sup>st</sup> and 2<sup>nd</sup> floor drift ratios @ +100% target displacement

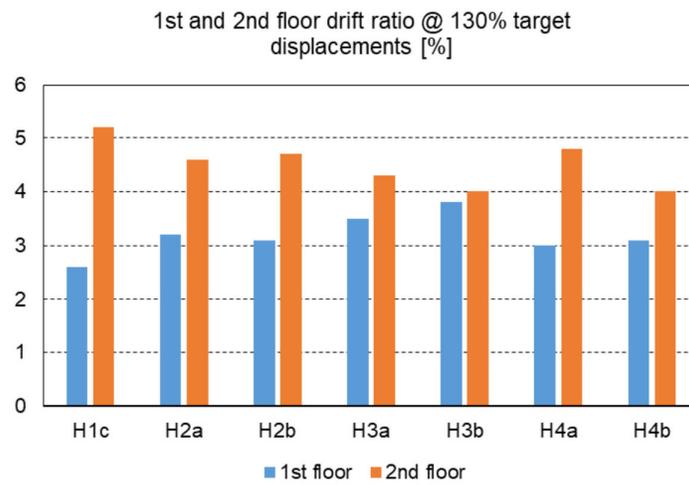
Figure 4.11. 1<sup>st</sup> and 2<sup>nd</sup> floor drift ratios @ +130% target displacement

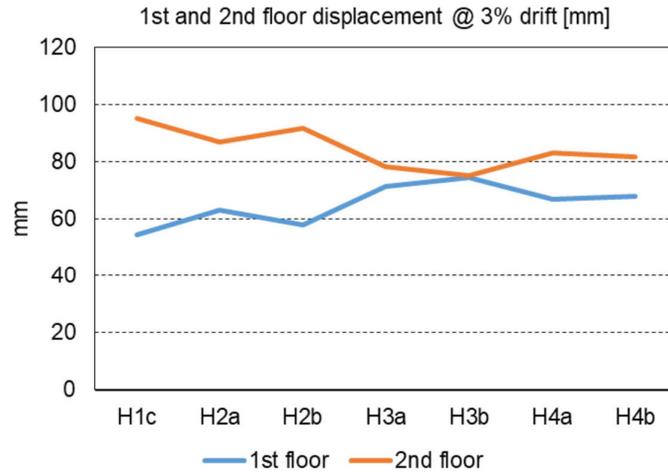
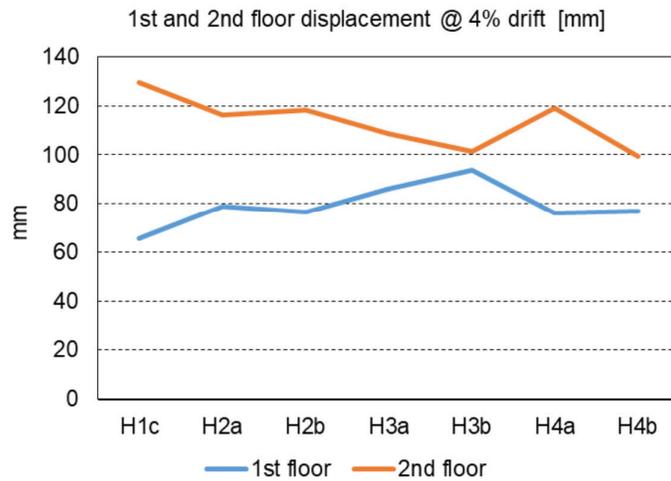
Figure 4.12. 1<sup>st</sup> and 2<sup>nd</sup> storey displacements @ (a) 3% drift, (b) 4% drift

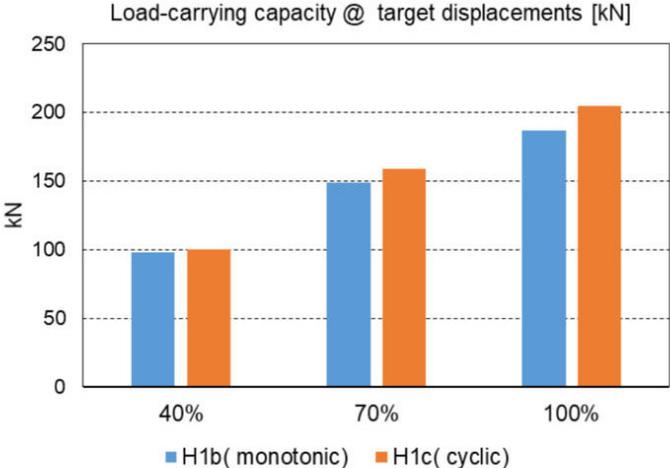
In the following section the effects of different parameters on the load-carrying resistances are discussed. The results of both monotonic and cyclic loading are shown in Figure 4.13 and Figure 4.14. The structure's load-carrying capacity under monotonic pulling force notably exceeds that under cyclic load, nearly doubling at 100% target

displacement. Conversely, under monotonic pushing force, the load-carrying capacity is marginally lower compared to the cyclic test, exhibiting an 8% increase in the cyclic test at 100% target displacement. Monotonic tests, conducted up to +/-100% target displacement, showcased a linear increase in load versus displacement. In contrast, the cyclic test extended until +/-160% target displacement. During this, there was a decrease in load-carrying capacity from -70% to -100% target displacement, followed by an increase in the subsequent cycle. Consequently, the cyclic load-carrying resistances were 10% and 21% lower than their corresponding values in the monotonic test at -40% and -70% target displacement, respectively.

Figure 4.13. Load-carrying capacity @ 40%, 70% and 100% target displacements for the monotonic and cyclic tests conducted on the structure #H1

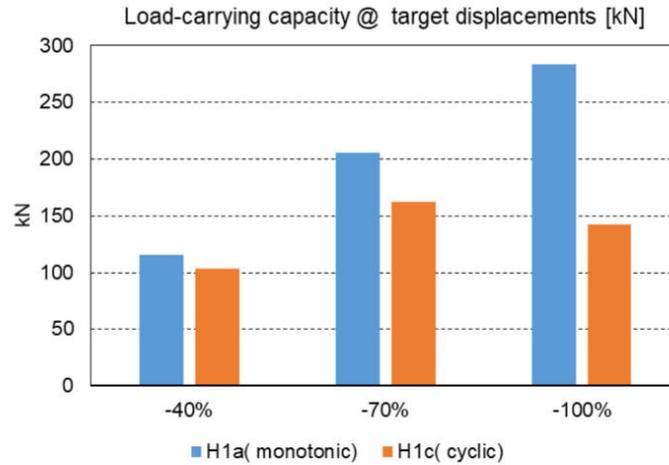
*Figure 4.14. Load-carrying capacity @ -40%, -70% and -100% target displacements for the monotonic and cyclic tests conducted on the structure #H1*

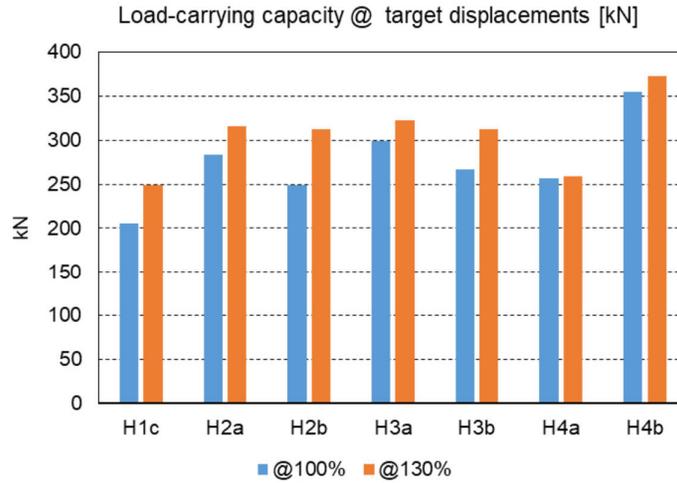
The load-carrying capacity for all structures under cyclic tests are illustrated in Figure 4.15 and Figure 4.16. The primary distinction between #H1c and #H2a lies in two key modifications: the enhancement of SB strength at the top of the 2<sup>nd</sup> storey shear wall and the addition of dead load to each floor in #H2a. These alterations had a positive impact on the structure's performance. Specifically, #H2a exhibited a 25% increase in capacity during positive cycles and a >15% increase during negative target displacements also showed a 28% increase in  $F_{max+}$  and a 17% increase in  $F_{max-}$  for #H2a.

Figure 4.15. Load-carrying capacity @ +100% and +130% target displacement

The effect of adding acoustic layers was investigated through the comparison of #H4a and #H3b. Adding the acoustic layers resulted in reduction of load-carrying capacity by 4% and 5% in +/-100% target displacement and 25% and 19% at +/-130% target displacement. These layers decreased the stiffness between the shear walls and the floor and led to 25% reduction in  $F_{\max+}$  and 19% in  $F_{\max-}$ .

The influence of perpendicular shear walls was explored by analyzing and contrasting the findings from structures #H4b and #H3b. The addition of perpendicular shear walls led to an increase in stiffness and load-carrying capacity. Specifically, at +/-100% target displacement,  $F_{100+}$  increased from 267 kN to 355 kN, marking a 33% increase, while  $F_{100-}$  increased from -273 kN to -359 kN, representing a 32% increase. Additionally,  $F_{\max+}$  and  $F_{\max-}$  showed a 15% and 12% increase, respectively.

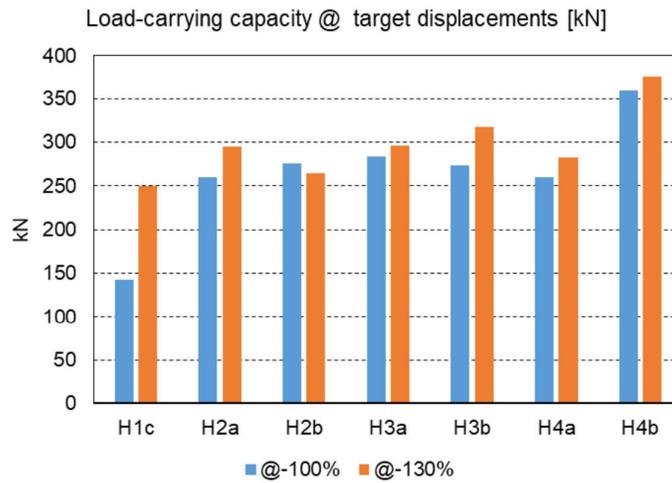
Figure 4.16. Load-carrying capacity @ -100% and -130% target displacement

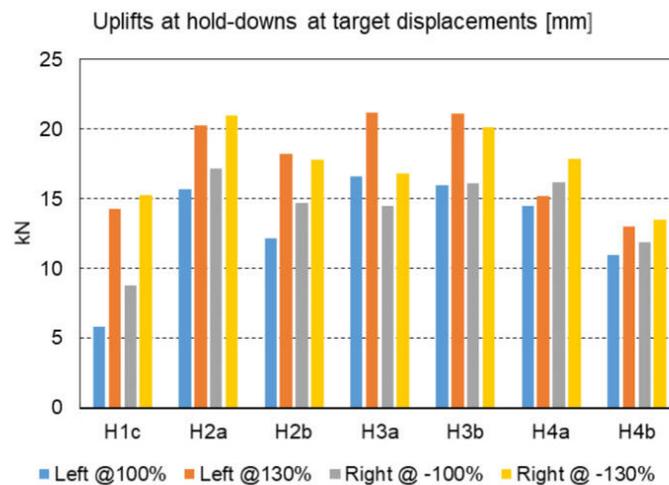
In all nine tests, the details of the HD remained unchanged. However, different uplift values were observed across. The uplift measurements for the shear wall at the left and right-side HD at +/-100% and +/-130% target displacement is presented in Figure 4.17.

Figure 4.17. Uplifts at HDs at target displacements [mm]

As can be seen in Figure 4.17, the lowest HD uplift, measuring 14.3 mm at 130% target displacement, was recorded in #H1c, which had the least stiff tension strap and the highest

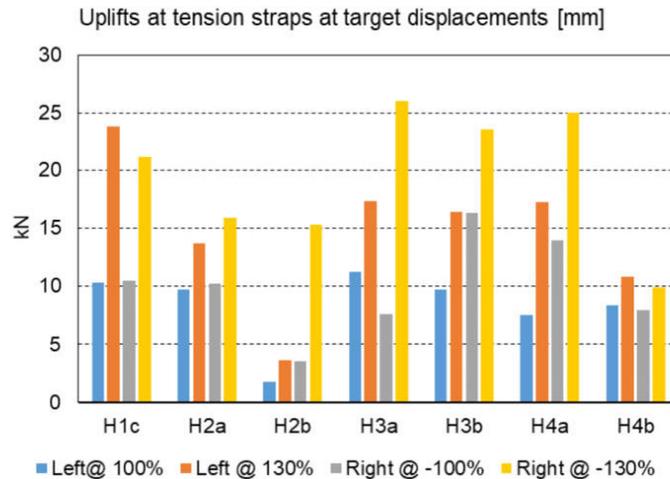
In Figure 4.18, tension strap uplifts at +/-100% and +/-130% target displacement is shown. The uplift values in tension straps showed a discrepancy. It is important to note that the HD configuration remained consistent across all tests, and the observed variations in HD uplifts can be attributed to changes in tension strap stiffness. This means that concerning the stiffness of HD and tension straps, the total uplift gets distributed across the 1<sup>st</sup> and 2<sup>nd</sup> stories. Consequently, the uplift experienced in both stories directly linked to the stiffness of the tension straps and variations in stiffness result in distinct uplifts across the structures.

tension strap uplift of 23.8 mm (see Figure 4.18). This was due to its configuration of having 8 STSs and an inclination angle of  $90^\circ$ , the most flexible tension strap.

Figure 4.18. Uplifts at left-side tension straps at target displacements [mm]

Although #H2b showed the least tension strap uplift it did not exhibit the lowest 2<sup>nd</sup> storey displacement due to the high HDs' uplift that provided the 2<sup>nd</sup> floor. The small tension strap was compensated by the highest value of Panel-to-panel slip. Structures #H3a, #H3b, and #H4a shared the same configuration for their tension straps, all showing uplifts of around 17 mm at 130% target displacement, as depicted in Figure 4.18. These tension straps had inclination angles of 45 and 90 degrees at their

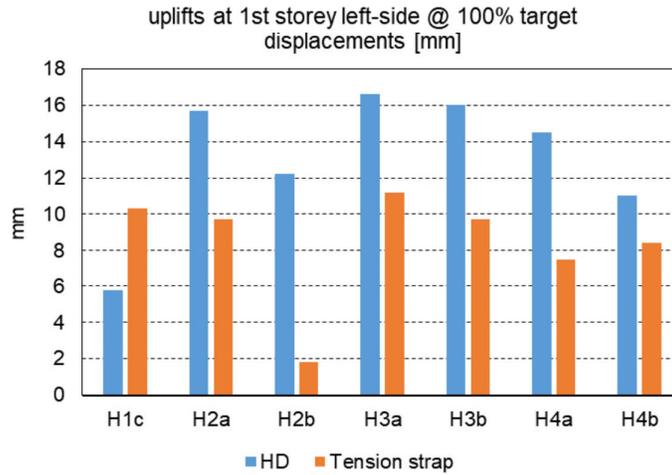
The shear wall uplifts at left-side HD and tension straps at 100% and 130% target displacement are provided in Figure 4.19 and Figure 4.20. Comparing the results of the #H2a and #H2b, the structures #H2b exhibited the lower tension strap uplift till 130% target displacement. This structure featured 9 STSs on each side of the tension straps, with an inclination angle of  $90^\circ$  stiffness in these fact tension straps and, as a result, the less uplift of 3.6 mm at +130% target displacement. This observation aligns with the expectation since #H2a had a perpendicular inclination angle, which provides greater ductility compared to the  $45^\circ$  inclination angle in #H2b.

Figure 4.19. Uplifts at left-side HDs and tension straps @ 100% target displacement

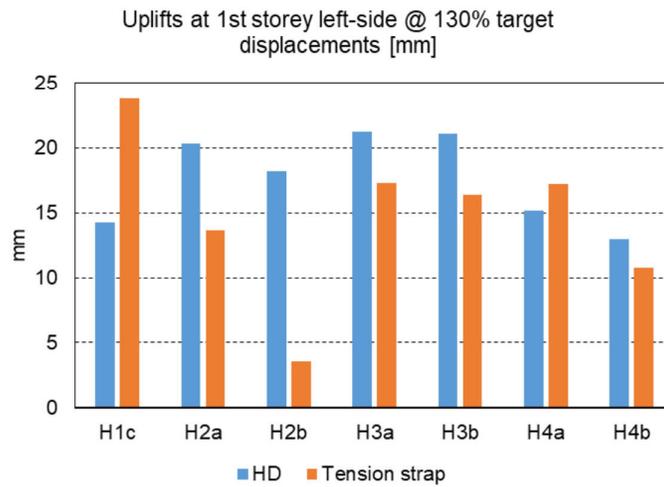
Figure 4.20. Uplifts at left-side HDs and tension straps @ 130% target displacement

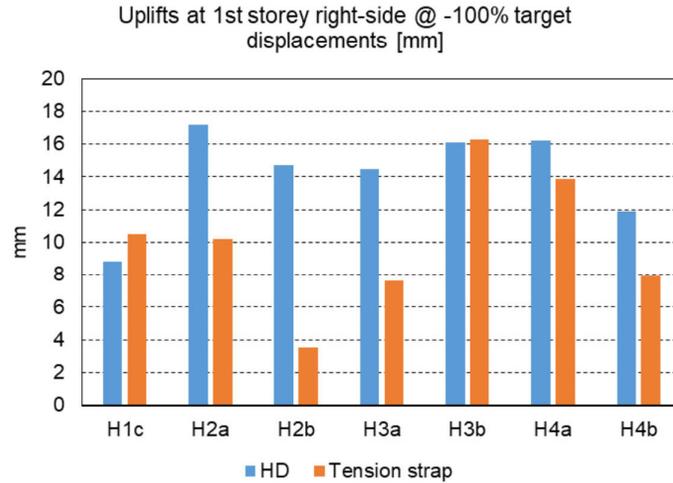
Similarly, in negative target displacements, the uplift values of #H2a in the right tension straps were higher than those in #H2b up to -130% target displacement that a failure happened in the tension strap of #H2b (see Figure 4.21 and Figure 4.22).

Figure 4.21. Uplifts at right-side HDs and tension straps @ -100% target displacement
