**EXPERIMENTAL INVESTIGATION ON THE STRUCTURAL PERFORMANCE  
OF TWO-STOREY CROSS-LAMINATED TIMBER SHEAR WALLS**

**Sedigheh Gheisari**

THESIS SUBMITTED IN PARTIAL FULFILLMENT OF  
THE REQUIREMENTS FOR THE DEGREE OF  
ENTER DEGREE NAME  
IN  
ENGINEERING

UNIVERSITY OF NORTHERN BRITISH COLUMBIA

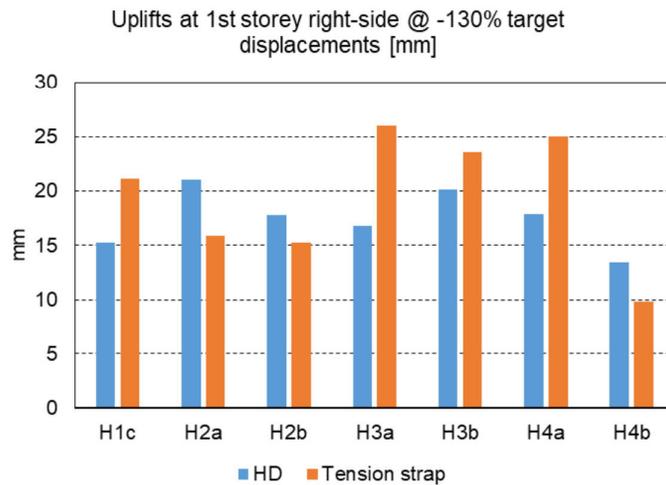
Similarly, in negative target displacements, the uplift values of #H2a in the right tension straps were higher than those in #H2b up to -130% target displacement that a failure happened in the tension strap of #H2b (see Figure 4.21 and Figure 4.22).

Figure 4.22. Uplifts at right-side HDs and tension straps @ -130% target displacement

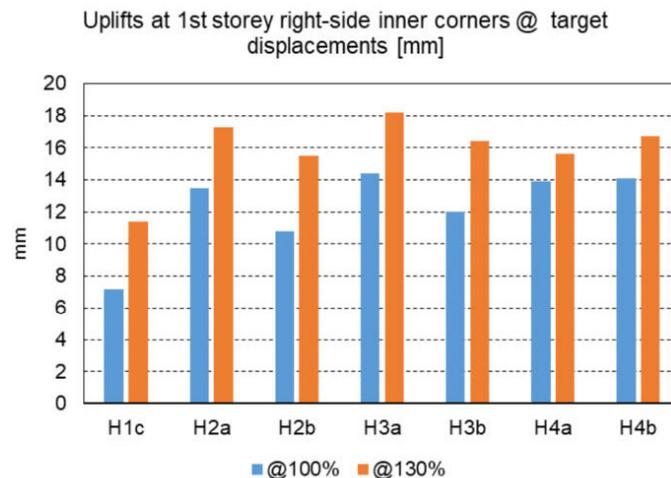
Figure 4.23. Uplift at 1<sup>st</sup> storey right-side inner corner @100% and 130% target displacement [mm]

A close correspondence between the right-side corner uplifts in the 1<sup>st</sup> storey and the left-side HD uplifts and left-side corner uplifts and right-side HD was observed. To provide a more detailed explanation, this correlation is further depicted in Figure 4.23 and Figure 4.24, where the structures #H2a and #H3a exhibited the highest right-side corner uplifts of 17.3 mm and 18.2 mm at 130% target displacement, and they correspondingly achieved the highest left-side HD uplifts among the structures, with values 20.3 mm and 21.2 mm, respectively, while the least values of HD and inner corner uplifts were observed in the structure #H1c.

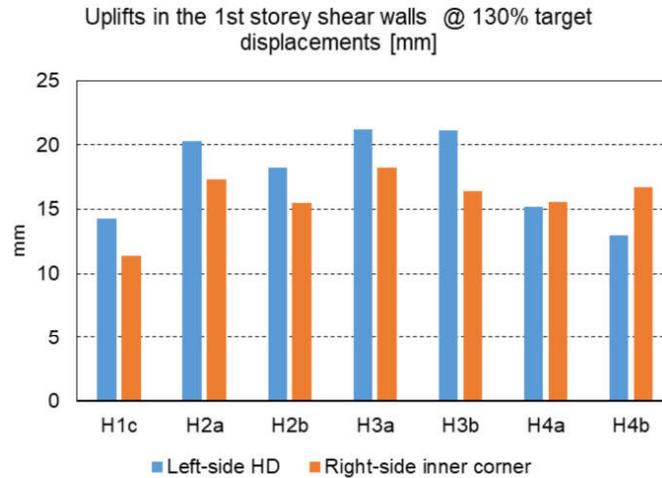
*Figure 4.24. Uplift at left-side HD and right-side inner corner @ 130% target displacement*

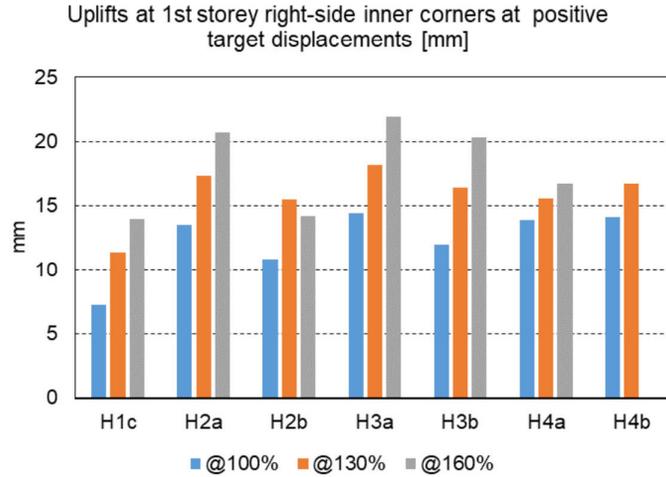
Figure 4.25. Uplift at 1<sup>st</sup> storey right-side inner corner at positive target displacements

One of the goals in designing a CLT shear wall is to achieve a CP behavior, aiming to dissipate energy in spline connections. This occurs when each panel individually rotates around its corner, allowing for relative displacement between panels. Figure 4.25 and Figure 4.26 show no uplift in the right-side corners in positive target displacements and no uplift in the left-side panel in negative target displacements.

The values ranged from almost 7 mm to 15 mm and from 12 mm to 18 mm at +/-100% and +/-130% target displacements respectively. There is a minimal difference between positive and negative cycles. The houses with higher load carrying capacity exhibited the higher inner corner uplifts due to more storey shear.

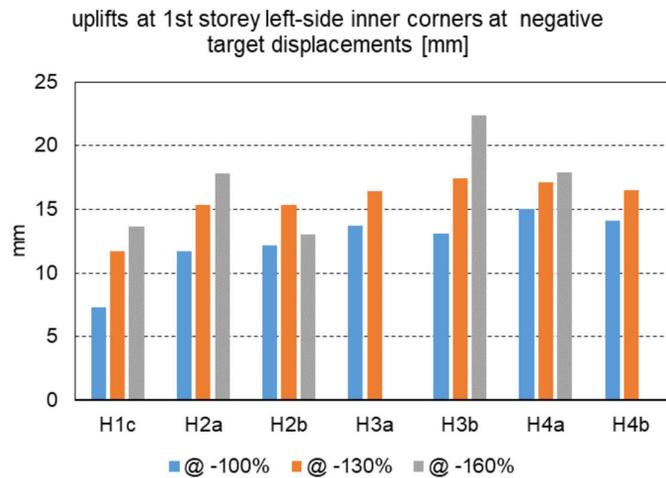
Figure 4.26. Uplift at 1<sup>st</sup> storey left-side inner corner at negative target displacements

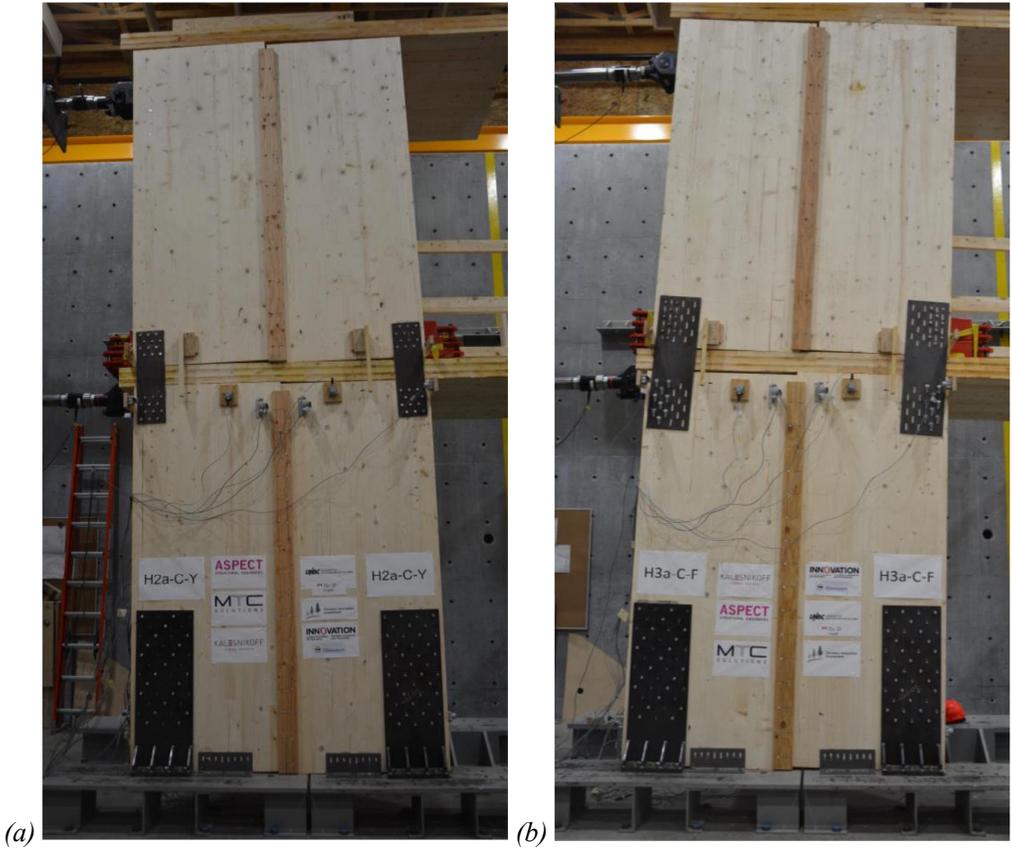
Figure 4.27. individual rotations of CP shear wall panels after test: (a) #H2a; (b) #H3a

These small negative values indicate that the compression zones at the rotation centers were small, providing support for the assumption that the panels rotate at their corners following CP behavior. This phenomenon is supported by the photos in Figure 4.27, showing that each panel had its own rotating center and was rocking individually. Notably, no compression was observed in the 2<sup>nd</sup> storey, as the inner corners were

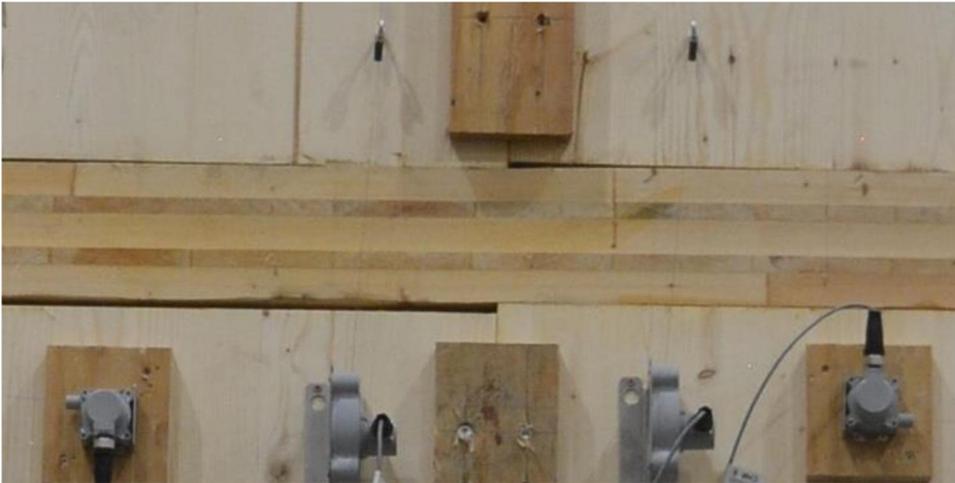
Figure 4.28. Lifting the left corner upward due to the uplift in the right corner.

consistently lifted slightly by the opposite side panel in an uplifting manner as shown in Figure 4.28.

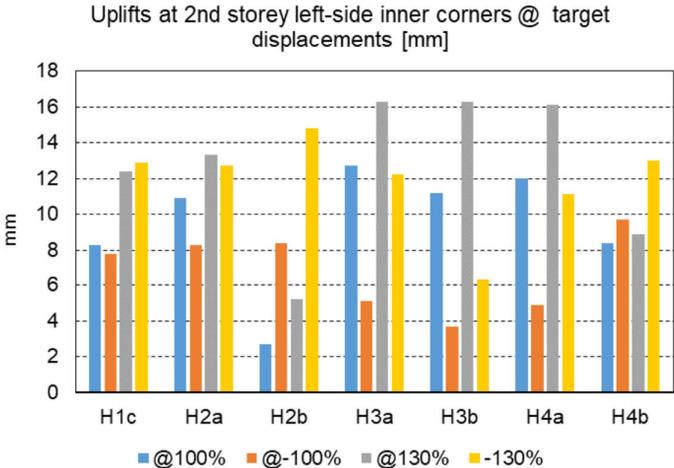
Figure 4.29. Uplift at 2<sup>nd</sup> storey left-side inner corners @ target displacements

As detailed in Figure 4.29 and Figure 4.30, the inner corner uplifts in the 2<sup>nd</sup> storey ranged from 5 mm to 18 mm at the +/-130% target displacements. These values increased to a range of 9 mm to 23 mm during the subsequent cycle when the structure reached +/-160% target displacement. Therefore, it can be mentioned that there is no compression in the 2<sup>nd</sup> storey, also it was observed that the maximum values at +/-130 target displacement are related to the structures #H3a, #H3b and #H4a with the same stiffest tension straps.

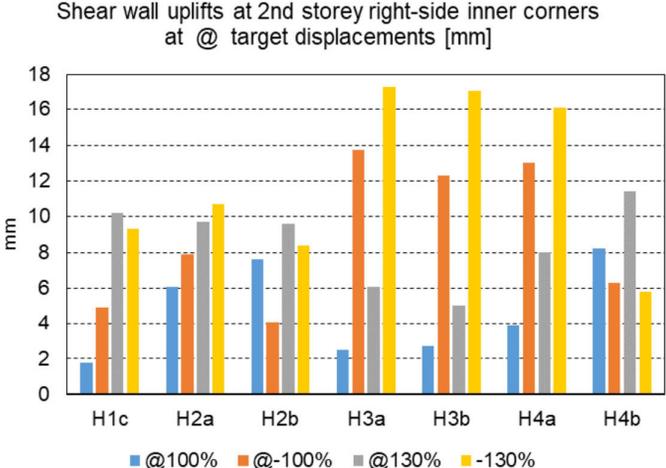
Figure 4.30. Uplift at 2nd storey right-side inner corners @ target displacements

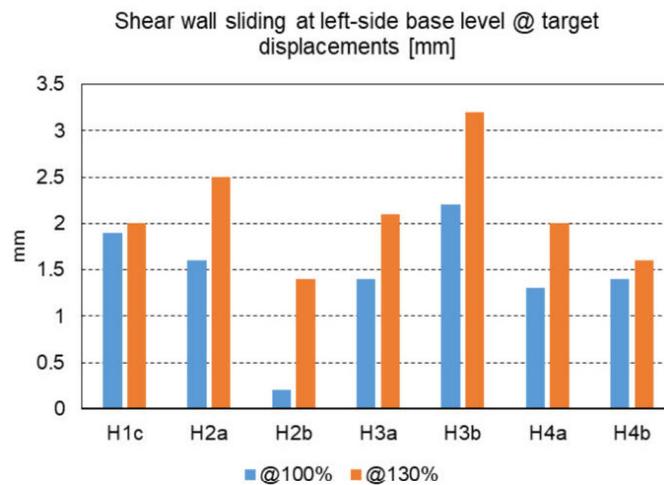
*Figure 4.31. Shear wall sliding at left-side base level at +100% & +130% target displacements*

Sliding at the left side of the base level, monitored by sensors #12 and #28 (see Figure 3.15), is presented in Figure 4.31. Sliding at the left side of the 1<sup>st</sup> floor, recorded by sensors #6 and #22. Sliding at the right side of the 1<sup>st</sup> floor, captured by sensors #9 and #25, 1<sup>st</sup> floor sliding can be found in Figure 4.32 and Figure 4.33. Sliding at the 2<sup>nd</sup> floor, monitored by sensors #15 and #31, is illustrated in Figure 4.34.

A comparison of the results reveals variations in the base level sliding, despite having the same base SB details in all structures. Specifically, at the left side of the base level, the maximum sliding ranged from 0.2 mm to 2.2 mm at +100% target displacement and from 1.4 mm to 3.2 mm (refer to Figure 4.31) at +130% target displacement. These small values and this fact that no major damage was observed in the failure modes of base SB confirm the elastic behavior of SB, which aligns with one the design objective.

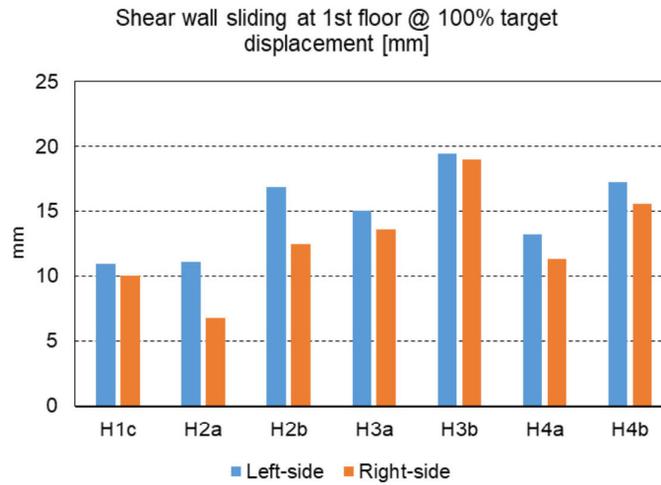
Figure 4.32. Shear wall sliding at 1<sup>st</sup> floor @ +100% target displacement

As depicted in Figure 4.32 and Figure 4.33, the 1<sup>st</sup> floor sliding values ranged from 7 mm to 19 mm at 100% target displacement and from 9 mm to 25 mm at +130% target

displacement. The sliding measured on the 1<sup>st</sup> floor was significantly higher than values of the base level since due to the sensors installation they are determined as the total relative displacement between the shear walls of the 1<sup>st</sup> and 2<sup>nd</sup> stories, also values include the cumulative overturning effect of the 2<sup>nd</sup> storey.

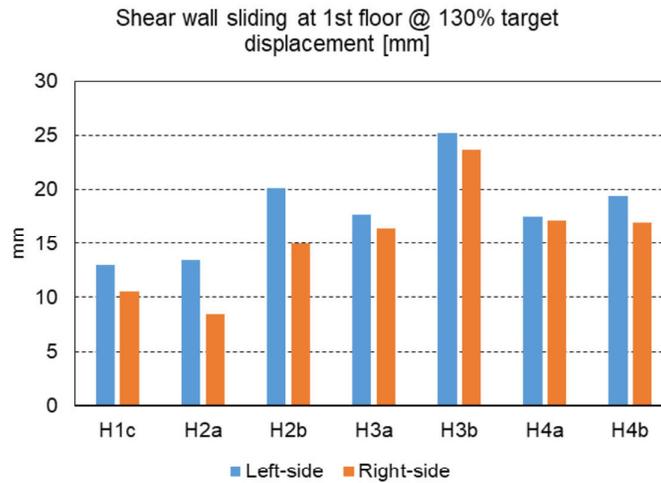
Figure 4.33. Shear wall sliding at 1<sup>st</sup> floor @ +130% target displacement

The left and right sides of the 1<sup>st</sup> floor recorded the highest values of 25.2 mm and 23.7 mm at 130% target displacement in #H3b, where 3 bolts of the SB were replaced

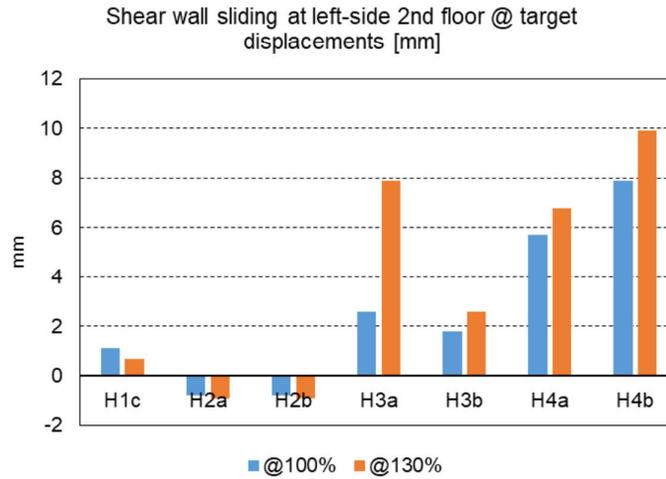
Figure 4.34. Shear wall sliding at left-side 2<sup>nd</sup> floor @ +100% & +130% target displacement

The values of 2<sup>nd</sup> floor sliding are illustrated in Figure 4.34, and they are smaller compared to the base sliding for two main reasons. Firstly, this is due to the smaller shear forces experienced in the 2<sup>nd</sup> floor level compared to the base shear. Secondly, in all structures (except for structure #Hc1, which had 4 STSs while the others had 8 STSs on the 2<sup>nd</sup> floor) the configuration of the 2<sup>nd</sup> floor SB had more STSs and was slightly stiffer than the base SB. The highest value of 2<sup>nd</sup> floor sliding, equal to 9.9 mm at +130% target displacement, was noticed in #H4b. This can be attributed to the presence of a perpendicular shear wall which confined the uplift of the CLT shear walls therefore, despite applying similar tension straps in structures #H3a, #H3b, #H4a, and #H4b, the increase in lateral load in the first three structures resulted in an uplift of approximately 17 mm at 130% target displacement, whereas the fourth structure exhibited a lesser uplift of only 10.7 mm in tension straps. Consequently, the amplified load led to more sliding and the highest observed sliding of the 2<sup>nd</sup> floor specifically happened in structure #H4b.

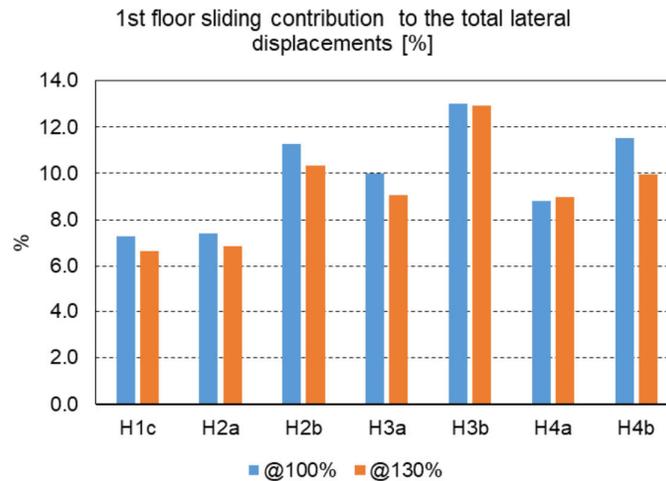
Figure 4.35. 1<sup>st</sup> floor contribution percentage to the total lateral displacement

As previously highlighted, the sliding values on the 1<sup>st</sup> floor are notably greater compared to those at the base and 2<sup>nd</sup> floor levels. Figure 4.35 and Figure 4.36 illustrate the impact of 1<sup>st</sup> floor, 2<sup>nd</sup> floor and base sliding on the overall drift. It is notable that with an increase in load from 100% to 130% target displacement, the contribution of sliding to drift decreases. This is because, initially, rocking was the primary cause of the drift. However, as the load increased, the uplift in tension straps also increased, leading to a greater share of contribution from rocking in the overall drift.

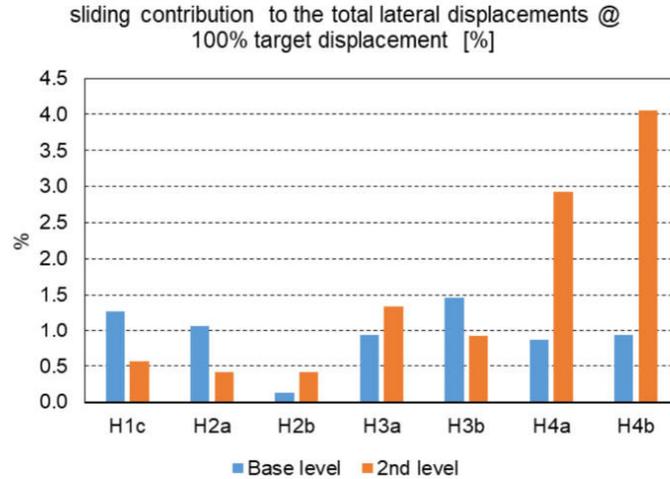
Figure 4.36. Base and 2<sup>nd</sup> level sliding contribution to the total lateral displacement [%]

Direct measurements were taken for the sliding at the base level and 2<sup>nd</sup> floor, gauged between the shear walls and either the base level or the 2<sup>nd</sup> level floor. However, upon reviewing the collected values, it became apparent that the combined contribution of these two sliding instances amounted to less than 5% of the total lateral displacement observed in the structures as shown in Figure 4.36.

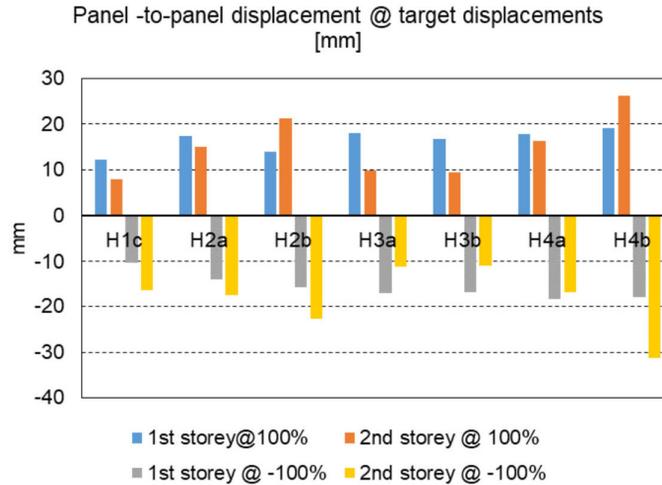
Figure 4.37. Panel-to-panel slip in the 1<sup>st</sup> and 2<sup>nd</sup> level @ +/-100% target displacements

The graphs in Figure 4.37 and Figure 4.38 present the Panel-to-panel slips for the 1<sup>st</sup> and 2<sup>nd</sup> stories at +/-100% and +/-130% target slips. All slips are positive during positive cycles, while no uplift occurs in the negative cycles. A notable observation is that the Panel-to-panel slips on the 1<sup>st</sup> floor were quite consistent across different structures, averaging around 15 mm at 100% and 20 mm at 130% target slips. Conversely, more significant variations were evident on the 2<sup>nd</sup> floor. This disparity in slips can be attributed to the specific characteristics of the tension straps, leading to varying degrees of rocking and panel-to-panel movement. Hence, variations in tension straps could impact the dissipation of energy on each storey, emphasizing that appropriately designed tension straps have the potential to ensure consistent energy dissipation across all levels. Notably, the maximum value of panel-to-panel slip on the 2<sup>nd</sup> storey was recorded in structure #H4b, measuring 33.7 mm at +130% target slip. The reason for this observation could be due to the presence of a perpendicular wall.

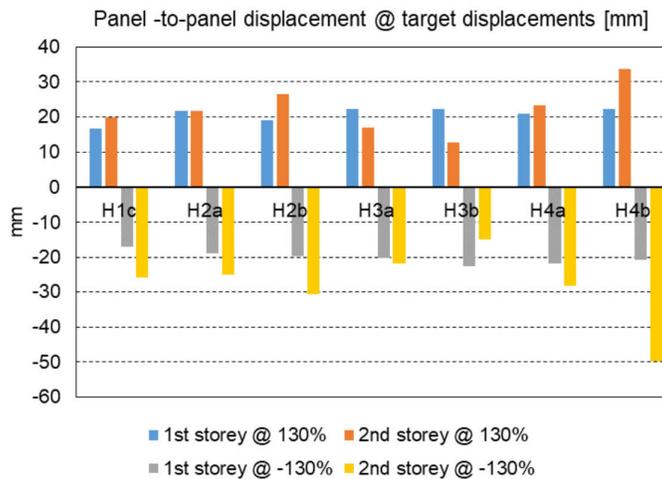
Figure 4.38. Panel-to-panel slip in the 1<sup>st</sup> and 2<sup>nd</sup> level @ +/-130% target displacements

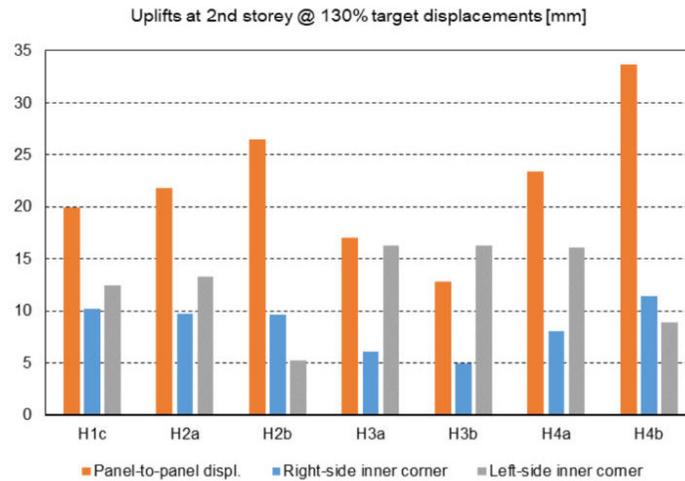
Figure 4.39. Panel-to-panel slips and inner corner uplifts of the 2<sup>nd</sup> floor @ 130% target displacement

As illustrated in the Figure 4.39, there are discrepancies between the panel-to-panel slips and the panel inner corner uplifts in the 2<sup>nd</sup> storey across all structures. The perpendicular shear walls restrict the movement or slip of the CLT shear walls on the 2<sup>nd</sup> storey. In scenarios where there is lateral movement or forces acting on the structure, the perpendicular shear wall may confine the CLT shear walls, limiting their ability to flex

or move freely. This confinement alters the way forces are distributed or resisted within the structure and hence a significant portion of the energy is dissipated in the spline joints in the 2<sup>nd</sup> storey, resulting in the highest value of panel-to-panel slip observed in the structure #H4b.

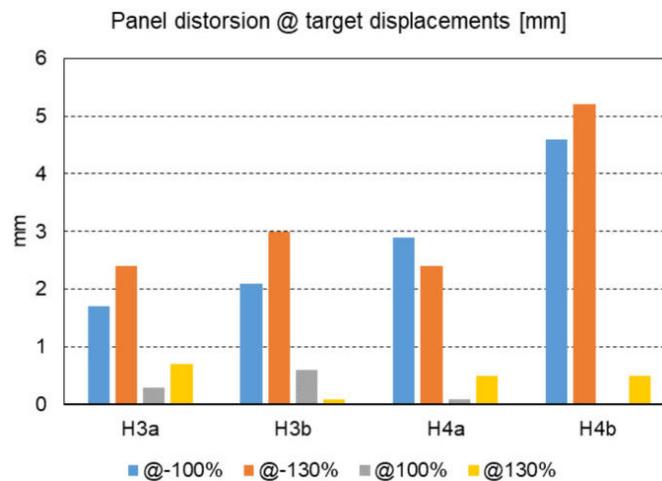
Figure 4.40. Panel distortion @ -100% and -130% target displacement [mm]

The panel distortion of the front and back panels of the 1<sup>st</sup> storey for structures #H3a, #H3b, #H4a, and #H4b is detailed in Figure 4.40. The distortion values during positive target displacements, when CLT panels undergo compression, are lower than the values observed during negative target displacements when the panels are subjected to tension forces, and the maximum distortion was observed in #H4b, with values of 4.6 mm and 5.2 mm at -100% and -130% target displacements, respectively. This indicates that the presence of perpendicular walls results in increased structural stiffness, a higher load-carrying capacity and higher in-plane forces as a result, and greater panel distortion.

On the other hand, in the structures without perpendicular shear walls, the panel distortion values ranged from 0.1 mm to 2.9 mm at +/-100% target displacement and from 0.1 mm to 3 mm at +/-130% target displacement. When considering the 1<sup>st</sup> storey displacement, which was approximately 70 mm, the contribution of panel distortion to the lateral displacement is less than 5% at 130% target displacement. This further supports the assumption of rigid body behavior of CLT panels under lateral loads.

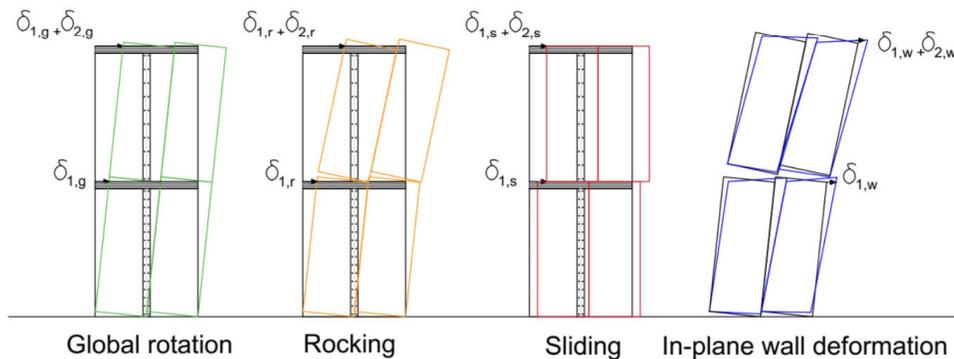
Figure 4.41. Lateral deformation components for a two-storey CLT building

represents storey deformation caused by the global rotation of the structure, or the deformation of a specific storey (i) in a building caused by the overall rotation of the entire structure. Global rotation refers to the rotation of the entire building as a single unit. while is the deformation resulted from rocking of the panels or the deformation of a specific storey (i) caused by the rocking motion of the individual panels in that storey. The deformation specifically captures the contribution of rocking motion to the overall deformation at a particular storey indicates the contribution of sliding and denotes the contribution of in-plane deformation of the wall panels. For the 1<sup>st</sup> storey, components and describe the same phenomena, necessitating consideration of only one component. These deformation components are presented in Figure 4.41.

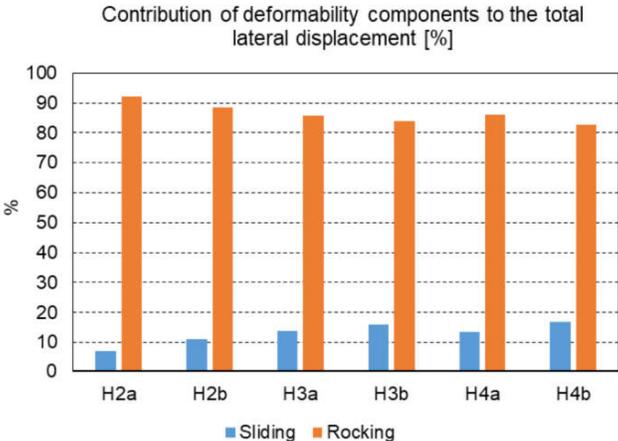
Figure 4.42. Comparison Sliding and rocking contribution percentages to the total lateral displacements in all structures

reaching the maximum capacity of one actuator. Table 4.1 and Figure 4.42 show the percentage contributions of factors contributing to lateral displacement across all structures. The values indicate that almost 90% of the total deformation is attributed to uplift and that sliding contributes approximately 10%. Panel distortion of 5-ply CLT panels does not appear to have a significant share with less than 4% contribution.

The discrepancy in rocking percentages between structure #H2a and #H2b by 4% stems from the 90° inclination angle, generating greater uplifts in tension straps and consequently more rocking in #H2a. The sliding percentages between structures #H3a and #H3b differed by 2% due to the substitution of bolts with STSs, rendering the SB more flexible in #H3b. Structure #H4a exhibited 2% higher rocking than #H3b because of an acoustic layer reducing shear wall-floor friction, facilitating easier rocking. Notably, #H4b had the highest sliding percentages among all structures due to the perpendicular shear wall eliminating rocking potential. Consequently, increased lateral load led to heightened sliding, resulting in the maximum 2<sup>nd</sup> floor sliding values in this structure.

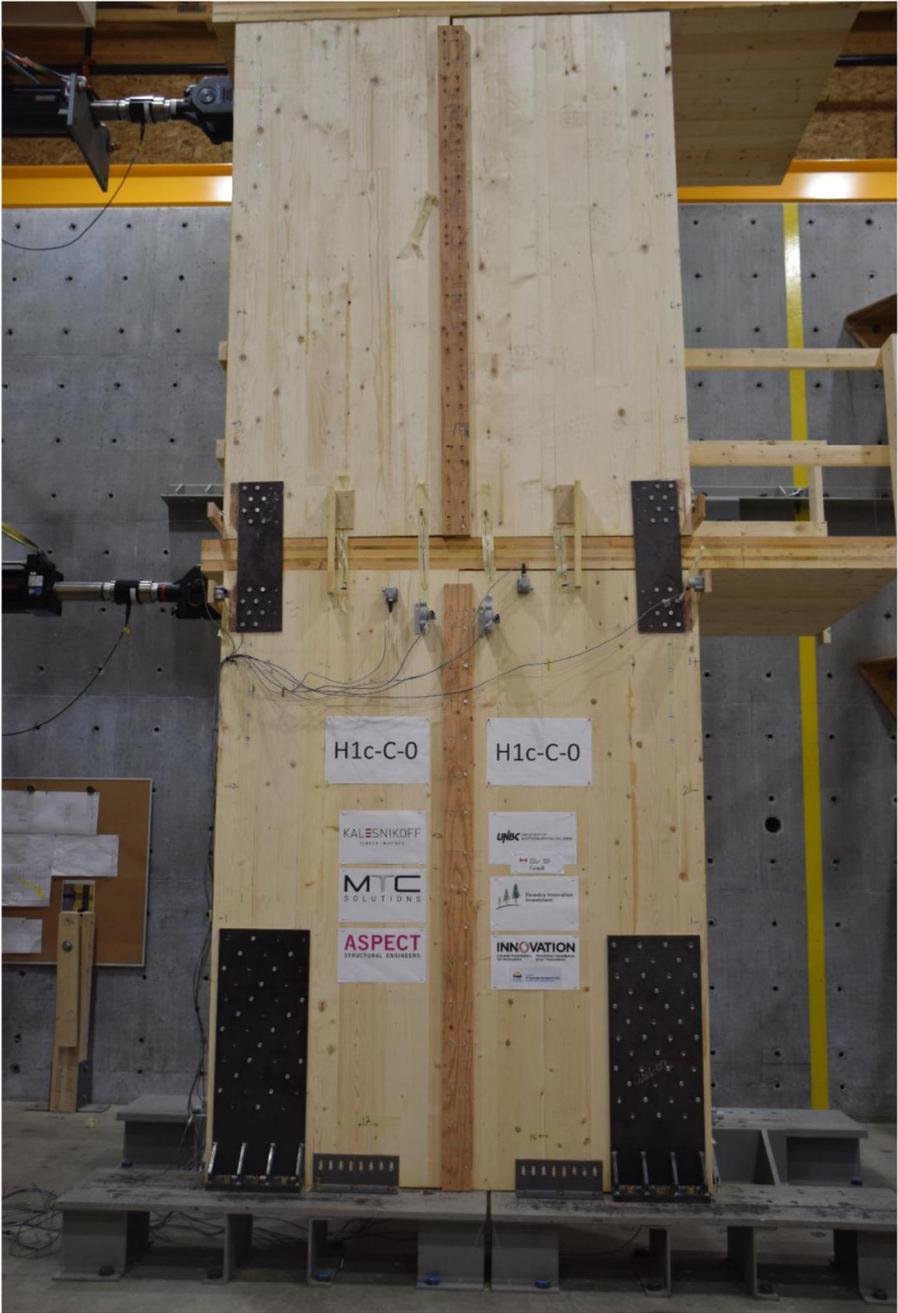
Figure A.1. H1c deformed shape of structure after test

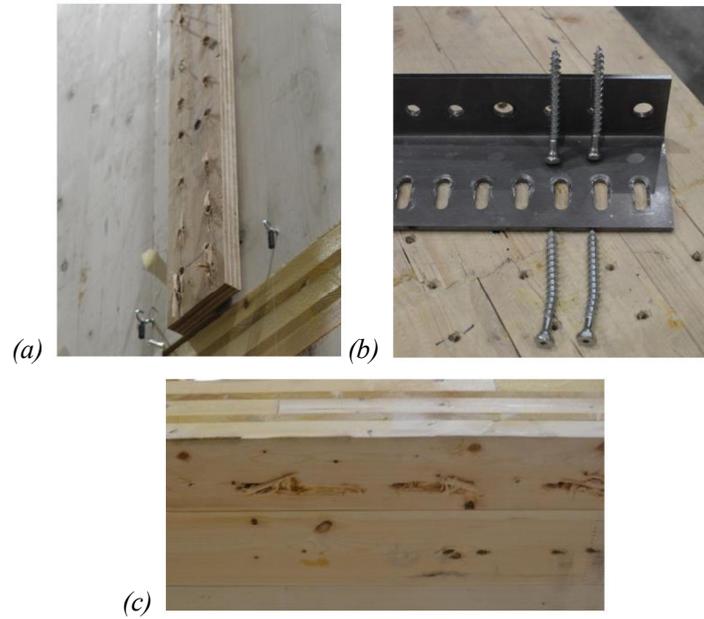
*Figure A.2. H1c elements after test: a) spline LVL, b) SB screws, c) CLT panel under spline joint*

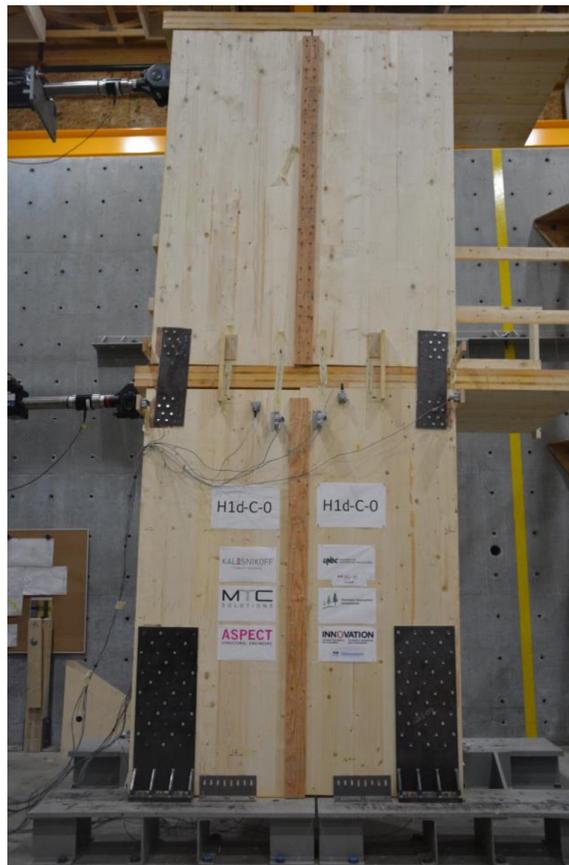
*Figure A.3. H1d deformed shape of structure after test*

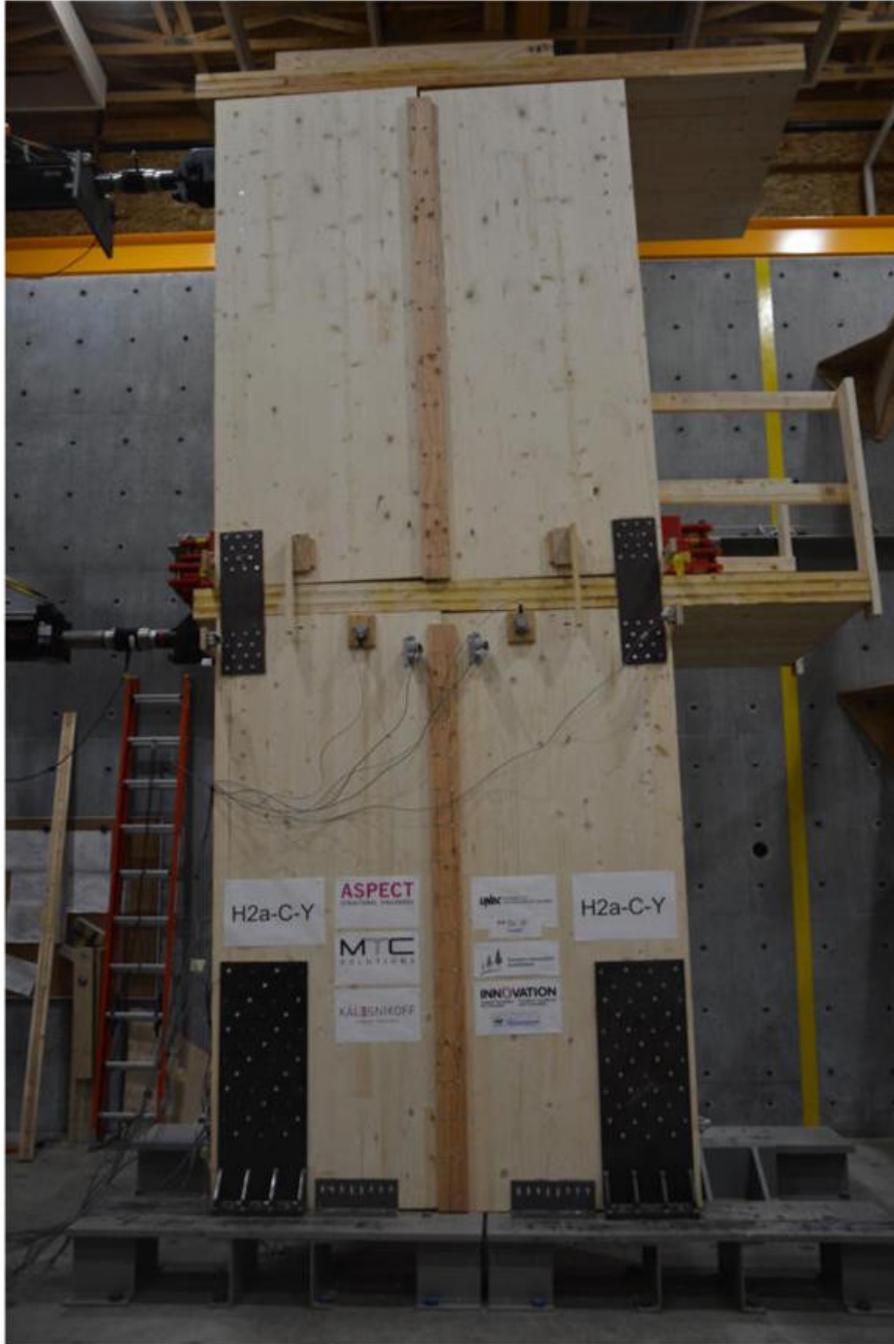
*Figure A.4. H2a deformed shape of structure after test*

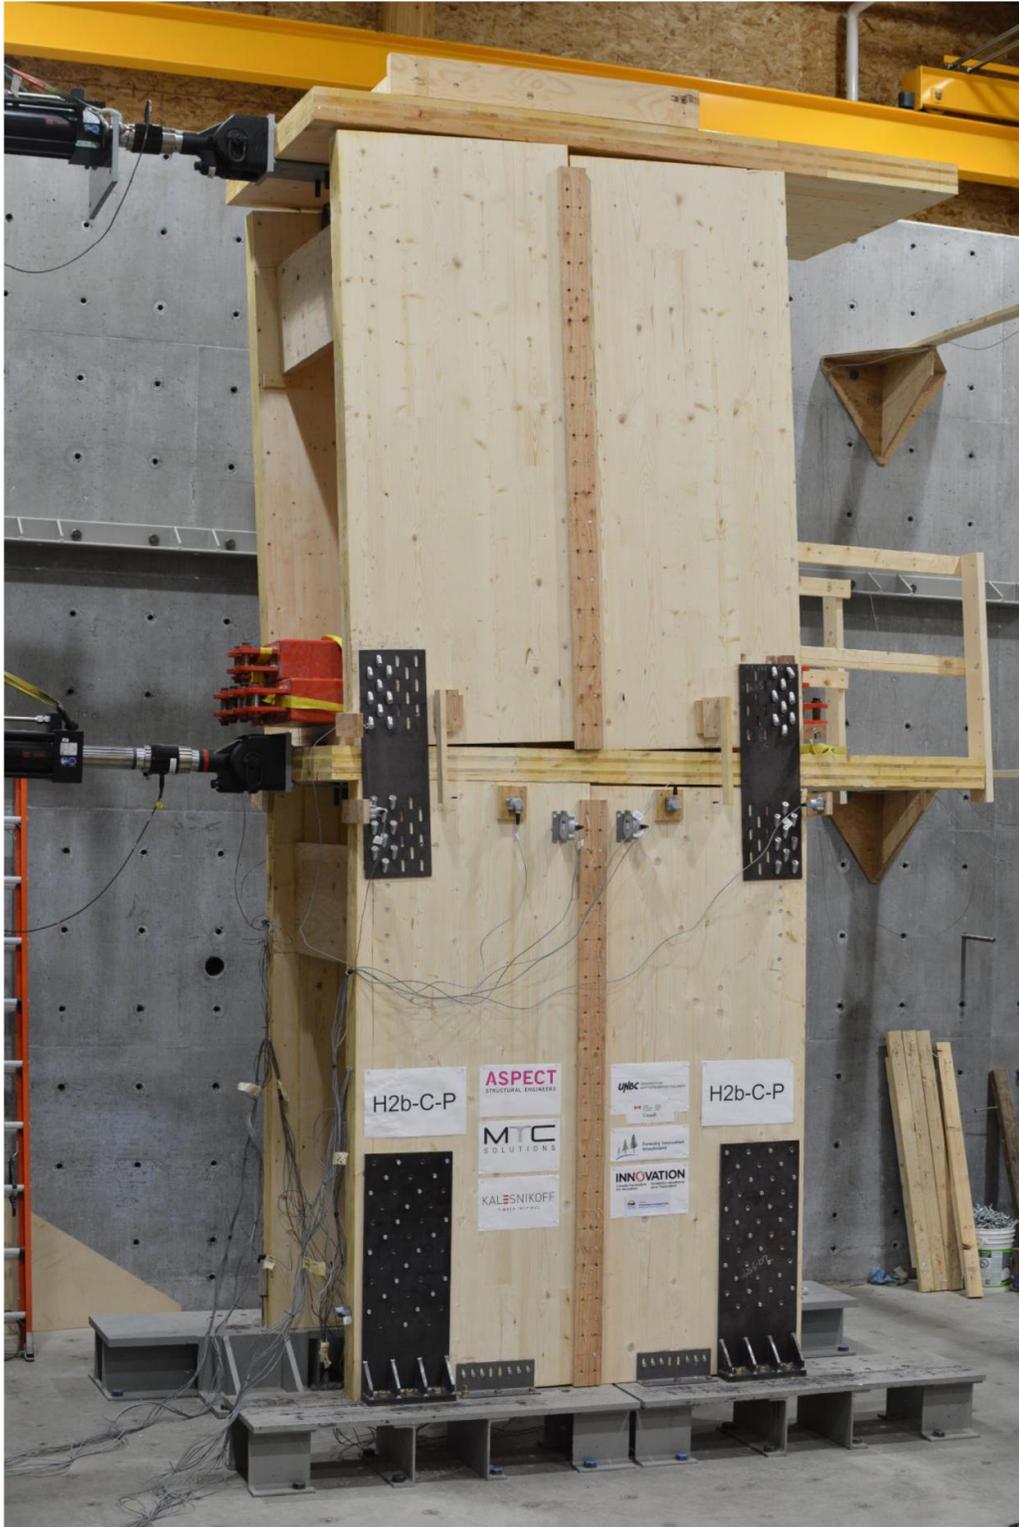
*Figure A.5. H2b deformed shape of structure after test*

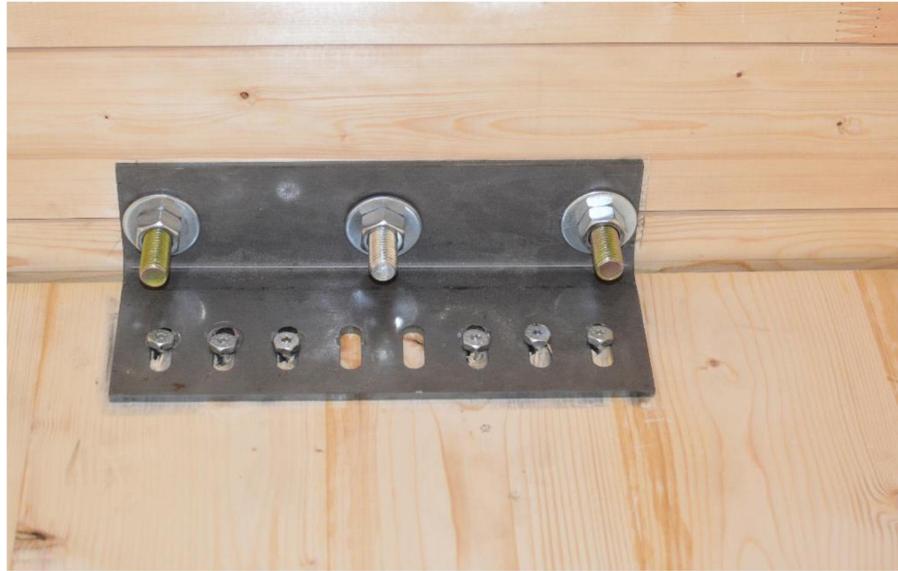
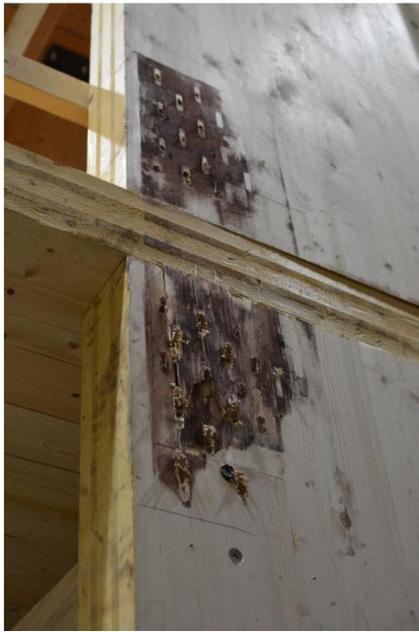
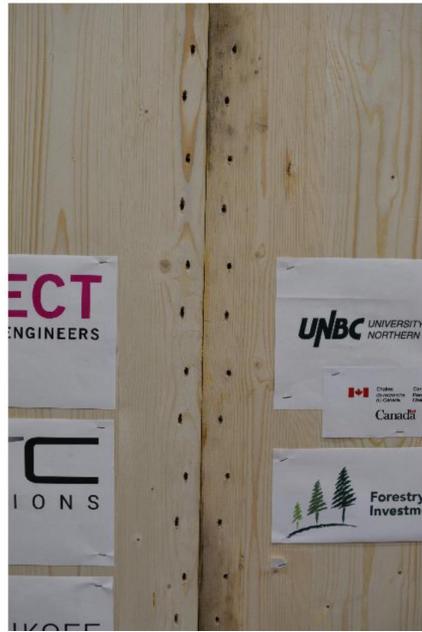
Figure A.6. H2b deformed elements after test: a) SB b) CLT panel under tension strap, c) CLT panel under spline joint

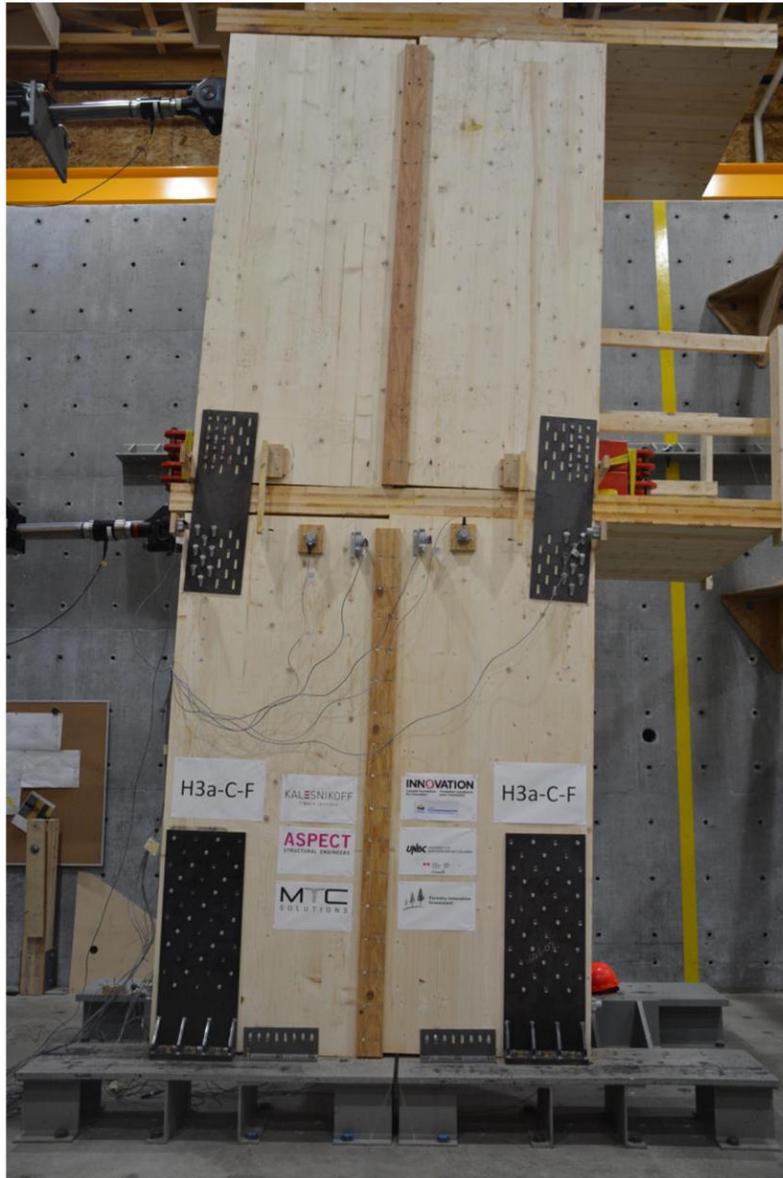
*Figure A.7. H3a deformed shape of structure after test*

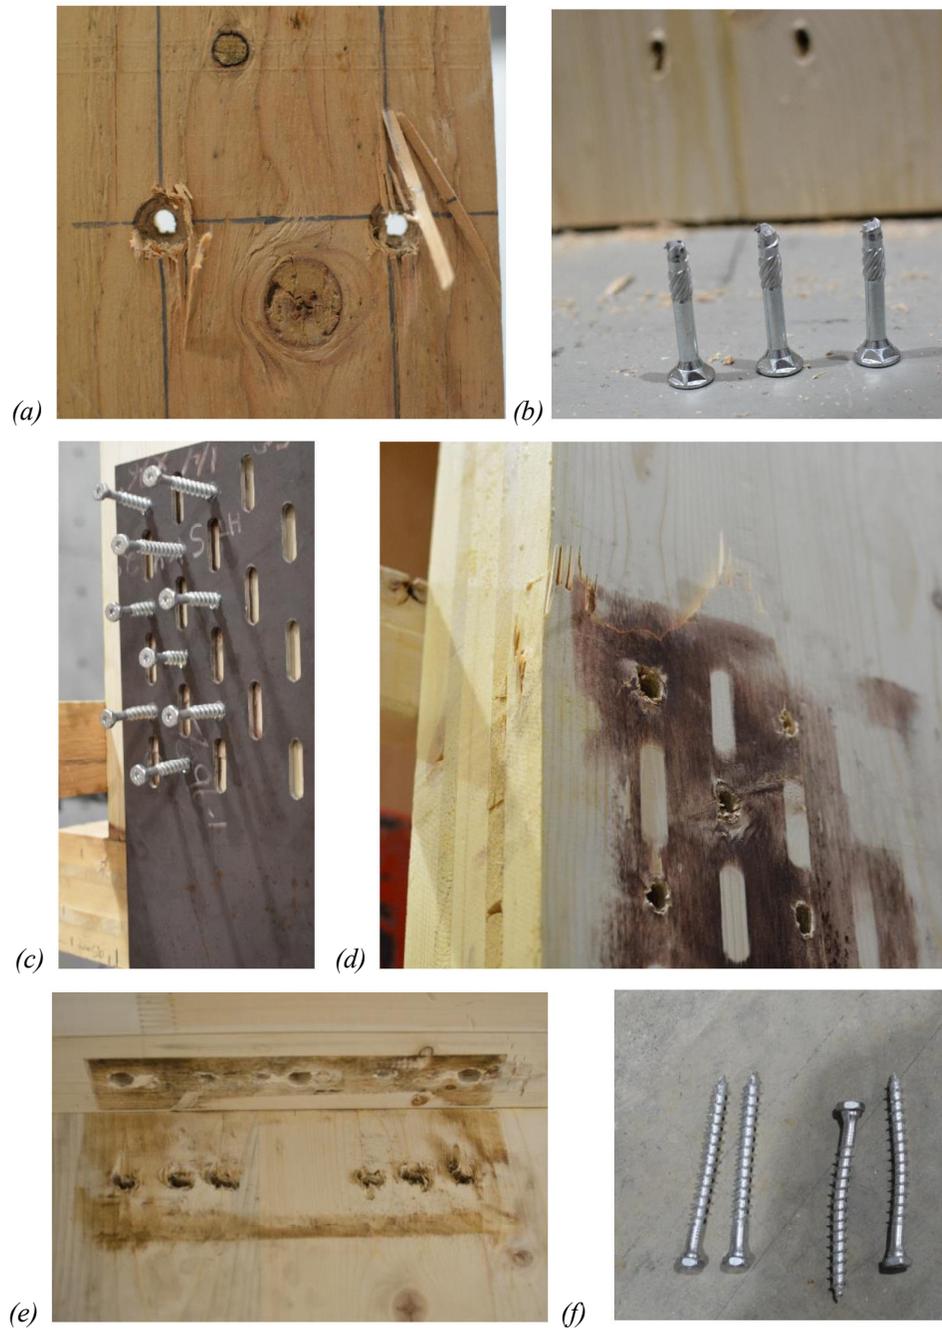
*Figure A.8. H3a elements after test: a) spline plywood, b) spline joints screws, c) tension strap screws, d) failure of CLT panel under tension strap, e) embedment in the CLT panel under SB, f) deformed HD screws*

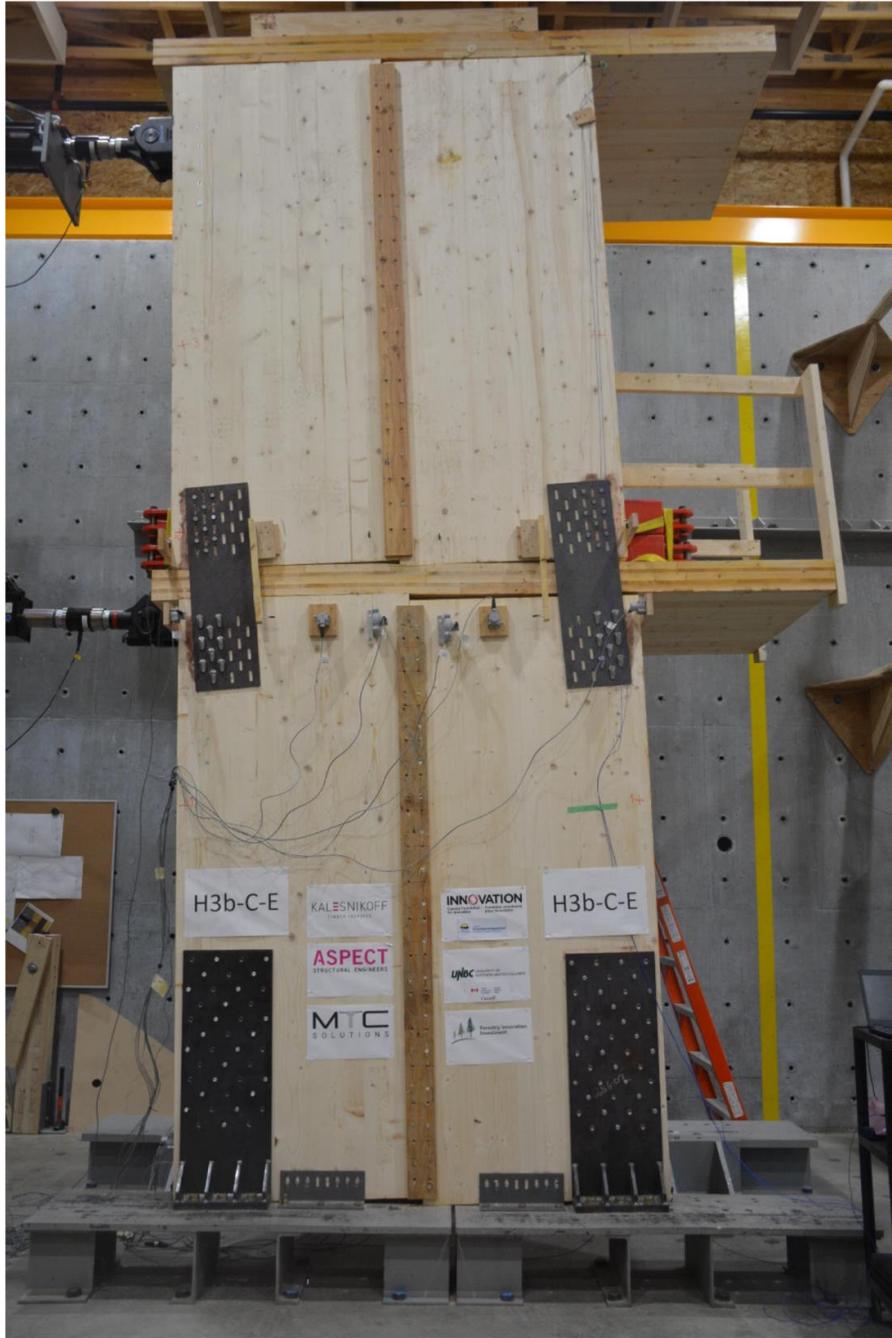
*Figure A.9. H3b deformed shape of structure after test*

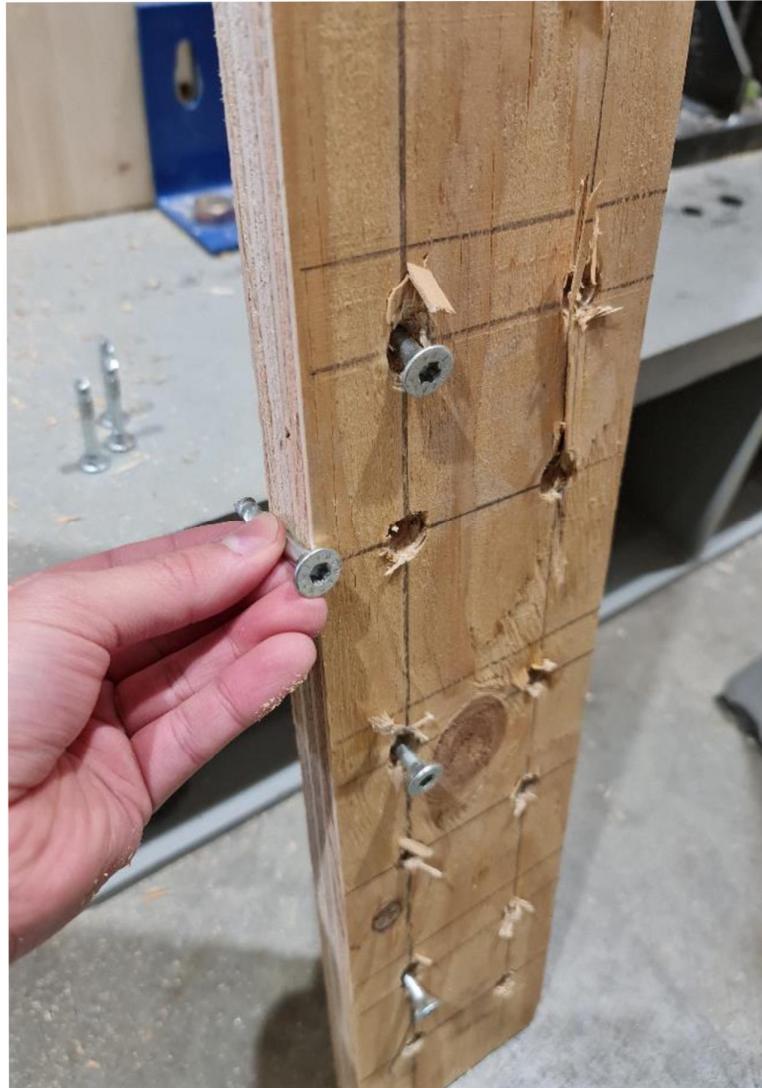
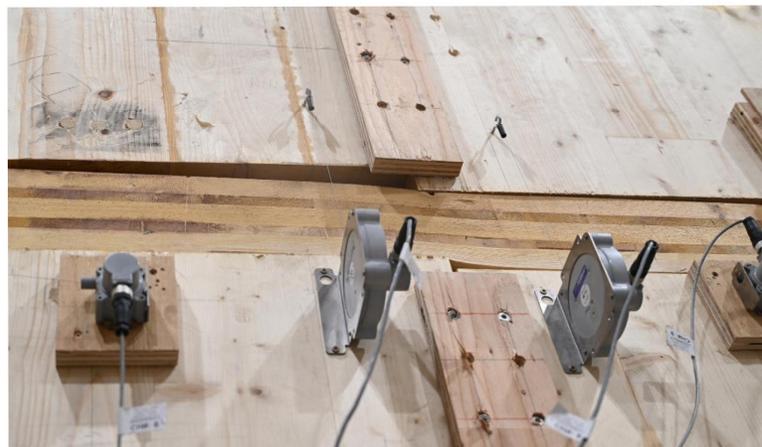
*Figure A.10. H3b deformed elements after test: a) crushed LVL spline and shear failure of spline screws b) floor panel bending*
