**EXPERIMENTAL INVESTIGATION ON THE STRUCTURAL PERFORMANCE  
OF TWO-STOREY CROSS-LAMINATED TIMBER SHEAR WALLS**

**Sedigheh Gheisari**

THESIS SUBMITTED IN PARTIAL FULFILLMENT OF  
THE REQUIREMENTS FOR THE DEGREE OF  
ENTER DEGREE NAME  
IN  
ENGINEERING

UNIVERSITY OF NORTHERN BRITISH COLUMBIA

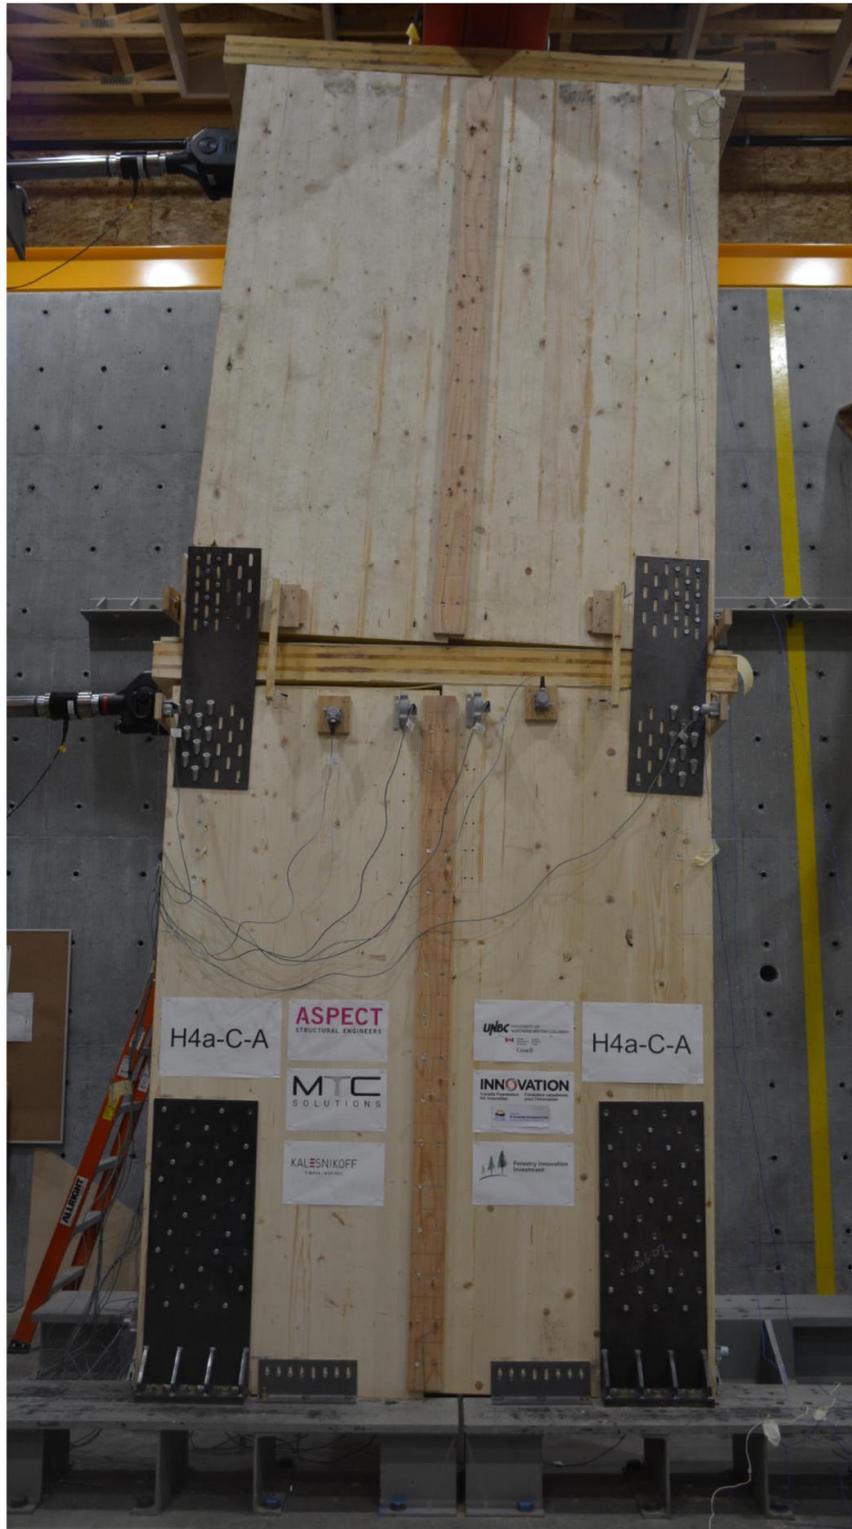
*Figure A.11. H4a deformed shape of structure after test*

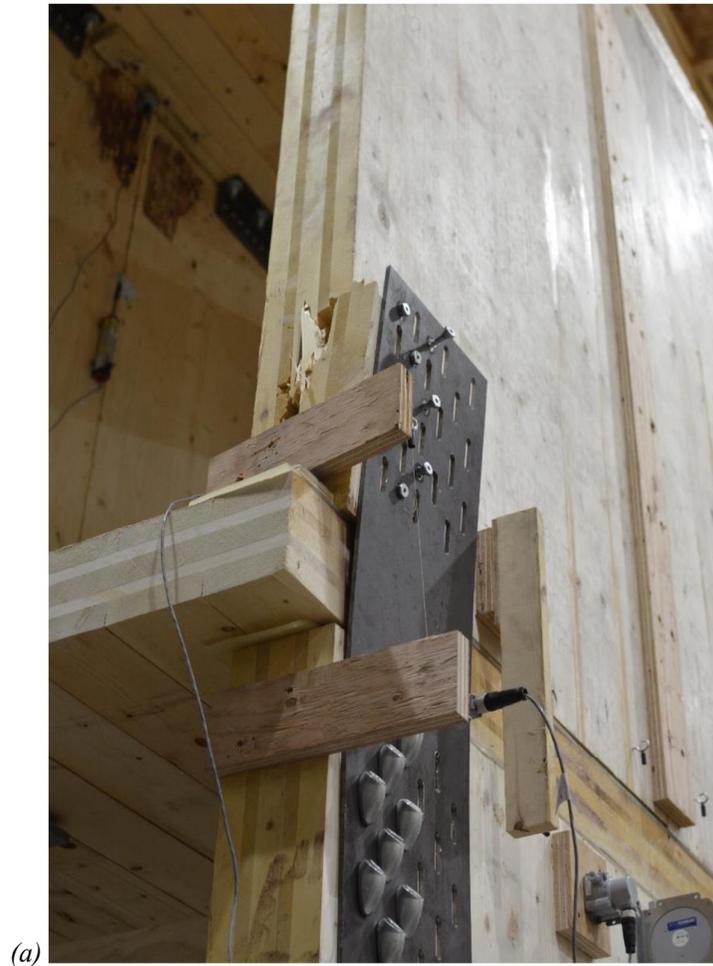
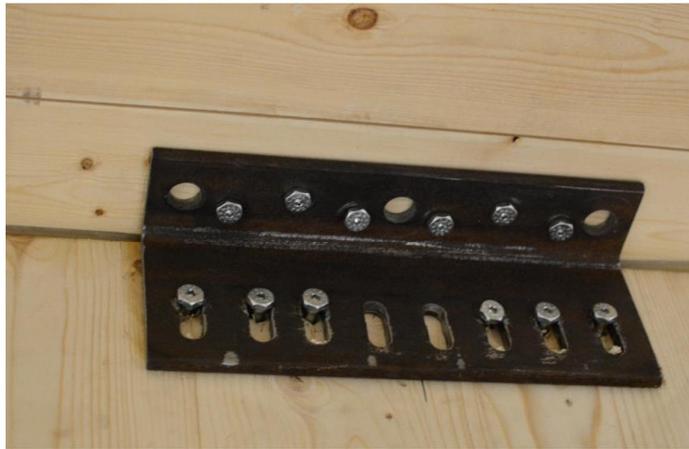
*Figure A.12. H4a deformed elements after test: a) brittle local failure in the corner of CLT panel b) SB deformation*

The least favorable type of failure is the brittle failure of the CLT panel, and this has happened in the region of the tension strap connections in the structures #H3a and #H4 at the final stages of testing, particularly when subjected to the highest tension strap uplift. As illustrated in Figure 3.73a, a tensile crack running parallel to the wood grain in the panel's surface layer formed along the upper row of the tension strap screws, ultimately resulting in the delamination failure. And as demonstrated in Figure 3.73b, the shear wall of the structure #H4a underwent the plug shear of lamellas just behind the tension strap. A combination of rolling shear and delamination can be observed in this zone.

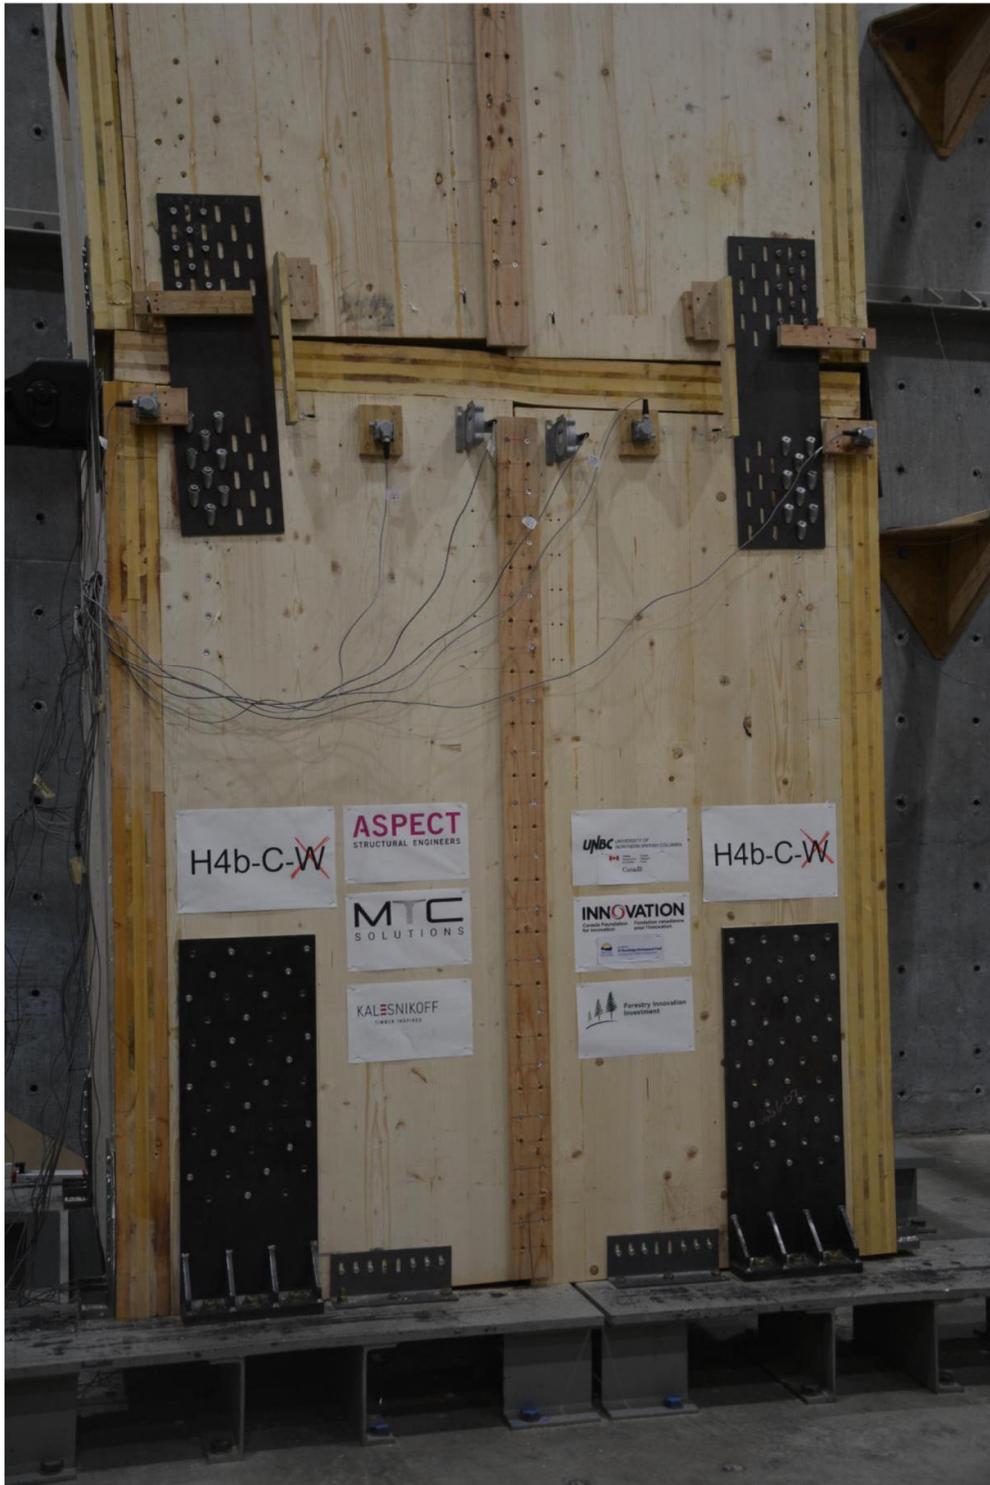
*Figure A.13. H4b deformed shape of structure after test*

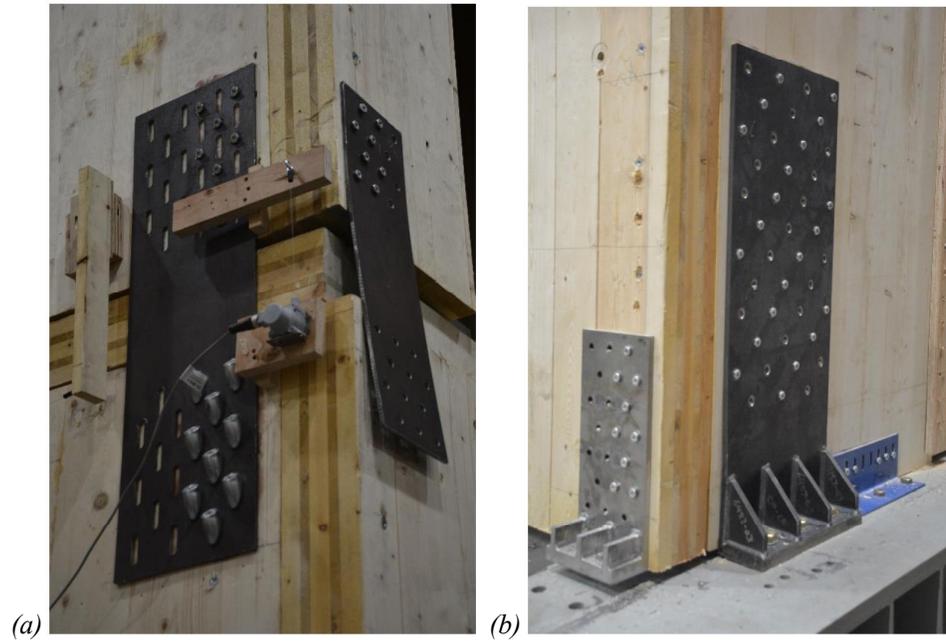
*Figure A.14. H4b deformed elements after test: a) rocking and sliding of the CLT panel in the 2<sup>nd</sup> storey b) rocking of the first storey*
